MEMORANDUM

FROM: JIM DAHM, ECO NOMOS LTD

SUBJECT: KAITUNA RIVER RE-DIVERSION AND ONGATORO/MAKETU ESTUARY
ENHANCEMENT PROJECT: EFFECTS ON COASTAL AND RIVERBANK EROSION
AND MORPHOLOGY

DATE: 11 JUNE 2014

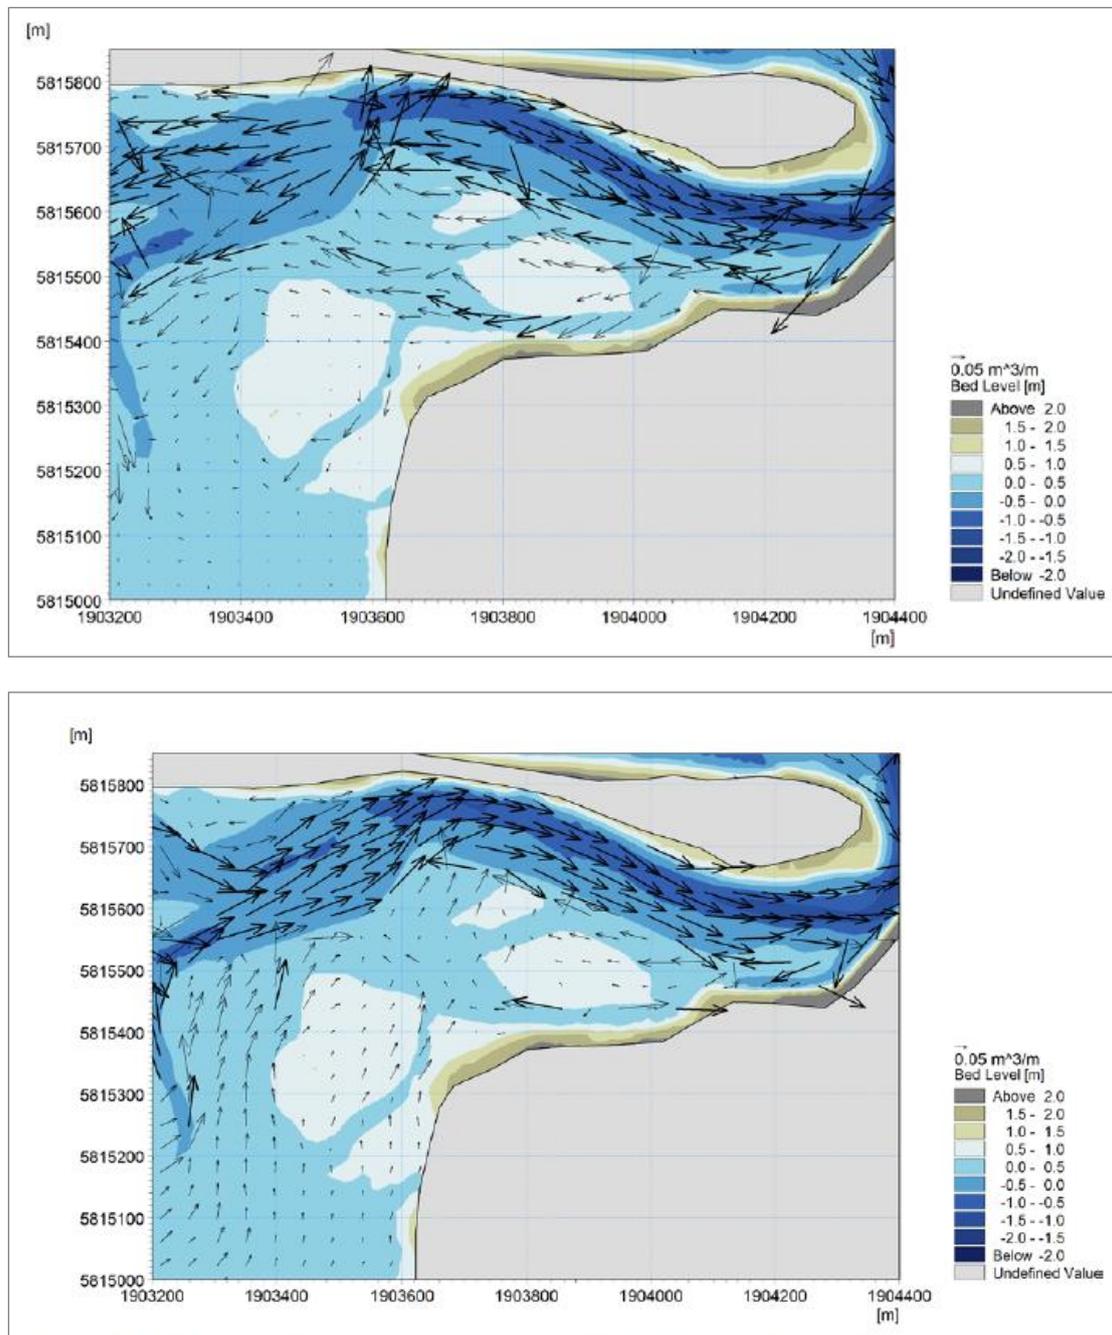
Figure 6: Residual sediment transport rates (m^3/m) over flood tide delta area for mean river flow and a neap-spring tidal cycle – showing existing situation (top) and predicted situation following the proposed re-diversion (bottom). (Figures provided by DHI from modelling reported in DHI, 2014).

The DHI modelling notes that the proposed re-diversion will significantly reduce flood tide directed sediment transport in this area (Figure 6). Over time, this is likely to reduce the expansion of the flood tide delta which pushed the channel close to the shoreline. While the final morphology is difficult to predict, the direction of change is likely to be back towards the gross morphology which existed prior to the diversion (see Figures, 2, 4 and 5). The changes are likely to lead to some shallowing and reduced erosional forces along the foreshore.

Modelling by DHI indicates the present dominance of flood tide directed sediment transport over the flood tide delta (e.g. top map in Figure 6), which is the cause of the ongoing growth and expansion of this feature. This map of residual (i.e. net) sediment transport directions also indicates cross-channel vectors at the apex of the delta opposite the present spit erosion. This reflects the current growth of the delta across the channel increasing currents in the main channel close to the landward margin of the spit and probably moving the channel closer to the spit over time. These increasing currents exacerbate the wave erosion which is occurring along the landward margin of the spit.

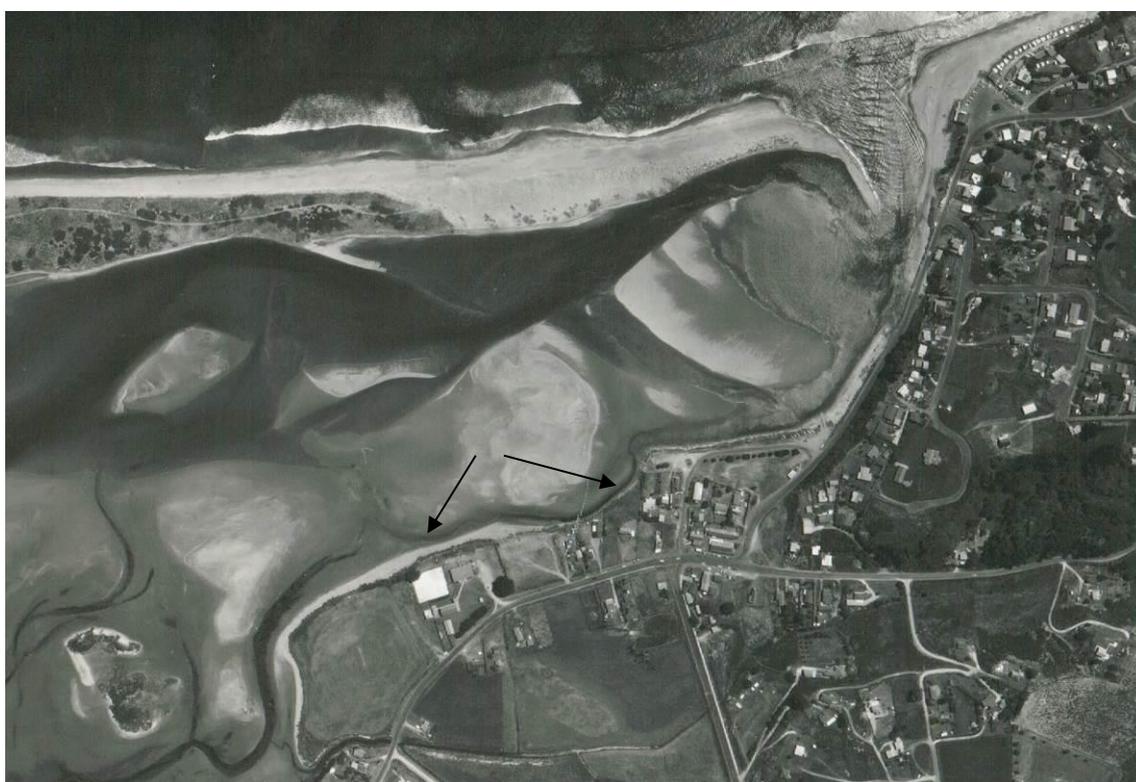
Following diversion, aerial photographs indicate that ongoing expansion of the flood tide delta into the estuary (accompanying the marked increase in flood tide inflows) gradually pushed a tidal channel close to the shoreline (e.g. Figure 1 and arrowed Figure 8).

The increased nearshore tidal currents and depths that occurred following the diversion appear to have exacerbated shoreline erosion during wave events, resulting in protection works being placed along much of the shoreline. Field inspections suggest that coastal erosion along this foreshore is primarily controlled by combined wave and tidal action. At present, various forms of erosion protection (some of poor engineering standard) are visible along the shoreline eastwards to about the marae.

Figure 8: 1988 aerial photograph showing growth of flood tide delta has pushed small channel (arrowed) hard against the foreshore fronting the marae and adjacent areas – as also occurred in the area fronting Park Road.

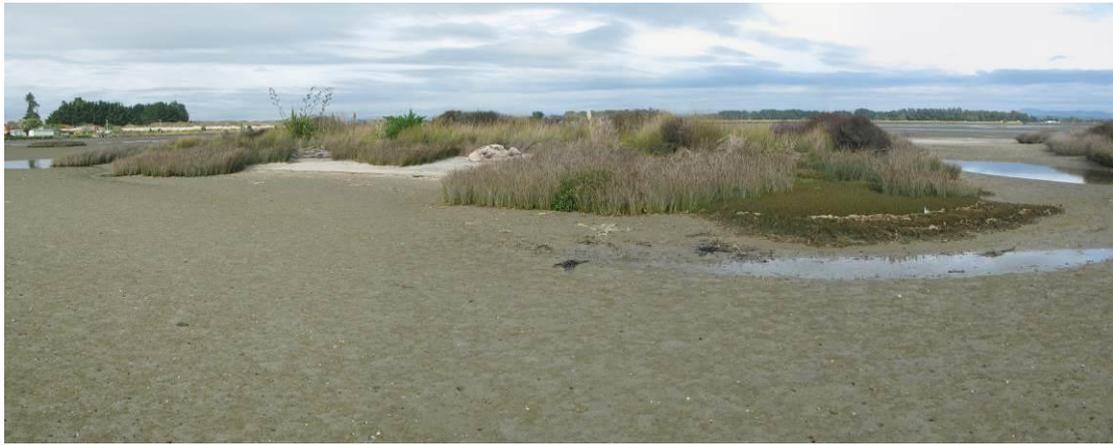
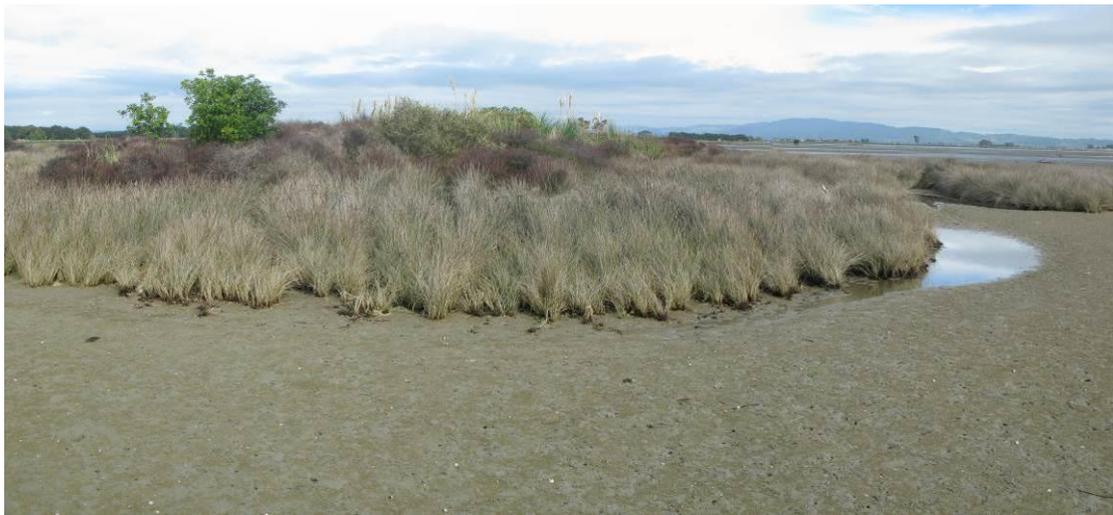
Figure 9: Chenier island features off from the southern shoreline of the township – with saltmarsh remnants and other maritime wetland and riparian vegetation communities. .

Field inspections suggest that there is potential to use sand placement to form more chenier island complexes similar to the natural islands which currently occur offshore. These features require only small volumes of sand and provide useful wave-sheltering to help reduce erosion. The features also provide a range of elevations enabling diverse wetland sequences ranging from riparian vegetation (e.g. saltmarsh ribbonwood, taupata) through salt meadow and *sarcocornia* to oioi and then sea rush (e.g. Figure 9).

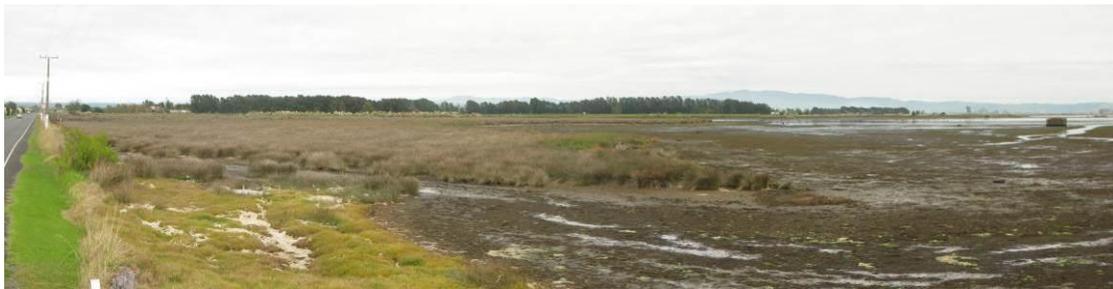
Figure 10: Rushland remnant adjacent to Maketu Road to south of township.

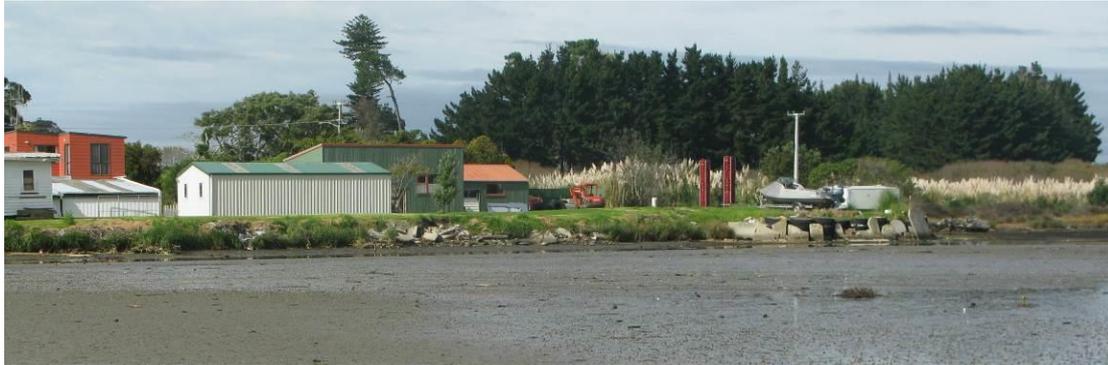
The only moderate erosion occurs towards the extreme southern end of the township where concrete and other rubble has been placed along the boundary of residential properties (Figure 11). In this area, the stream discharging from the township flows directly along the seaward edge of private properties and appears to exacerbate wave erosion.

Figure 11: Extreme southern end of township showing concrete and other rubble placed as shoreline protection

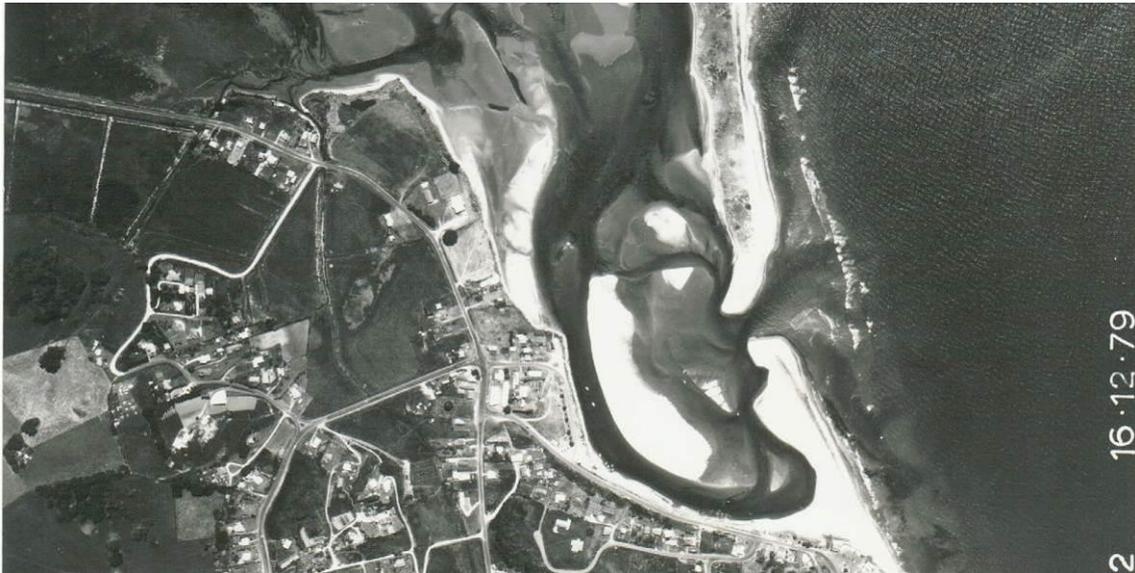
However, following the diversion, expansion of the flood tide delta has periodically caused severe erosion along the landward margin of the spit, leading to breaching of the spit on at least two occasions (1979 and 1994). The spit breaches cause significant but temporary changes to the pattern of channel and banks in the lower estuary (e.g. Figure 12).

Following the breaches, the entrance slowly migrates eastwards back to its original position and the pattern of channel and banks inside the estuary recovers; with this process taking at least 4-5 years following the breaches in 1979 and 1994.

Figure 12: 1979 aerial photo showing changes following a spit breach.

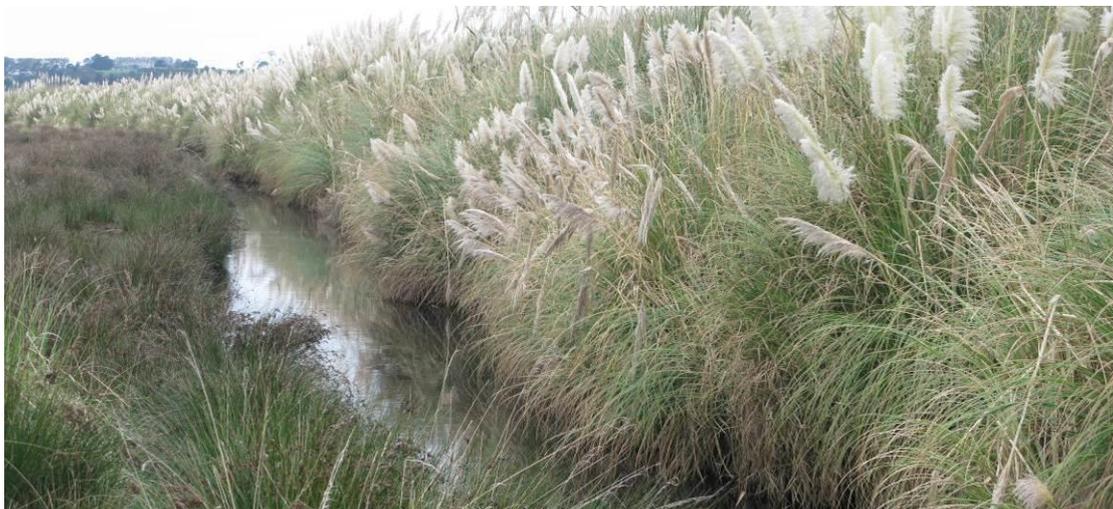
Figure 16: View of large sand stopbank (vegetated largely in pampas) along the landward margin of Papahikahawai Island. The view shows the island side of the stopbank.

Field observations indicate that the sand stopbank is subject to periodic wave erosion along most of its length, with a scarped face underlying the pampas. This erosion occurs during periods of elevated sea level (e.g. large high tides or storm surge) accompanied by wave action. Over time, this slow erosion will progressively erode the stopbank unless it is maintained.

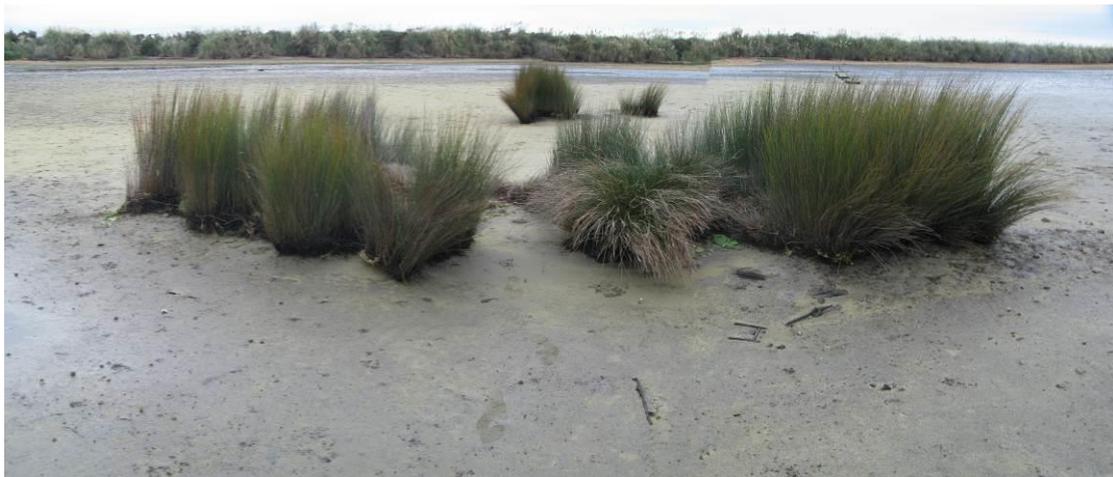
There is also evidence that bed level lowering causing erosional retreat of the rushland was a factor in some areas. In particular, a small isolated remnant of rushland (largely oioi) remains out in the estuary directly south of Papahikahawai Island (Figure 13 and Figure 17). The remnant has survived as sand levels around it are higher than the surrounding intertidal flats. However, even within the remnant high area the elevated sand levels are lower than the sediments in the rushland and the remnant is being gradually eroded (Figure 17).

Figure 17: Small remnant of oioi in estuary off Papahikahawai Island associated with remaining high area. Note that the sand levels around the remnant are lower than the peaty sand sediments in the rushland clumps and the rushland is gradually eroding. The intertidal flat elevations away from this high area are much (probably at least 0.2-0.3 m) lower.

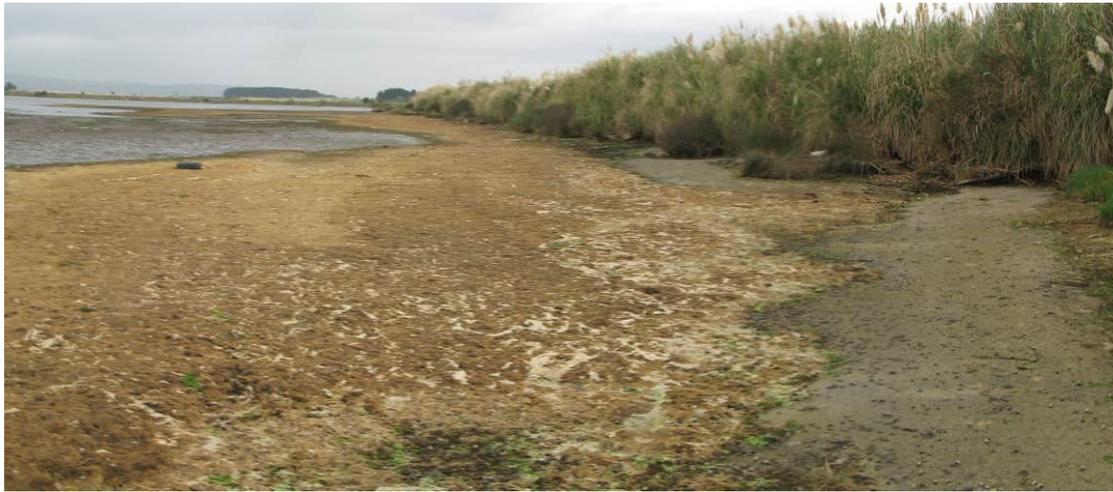
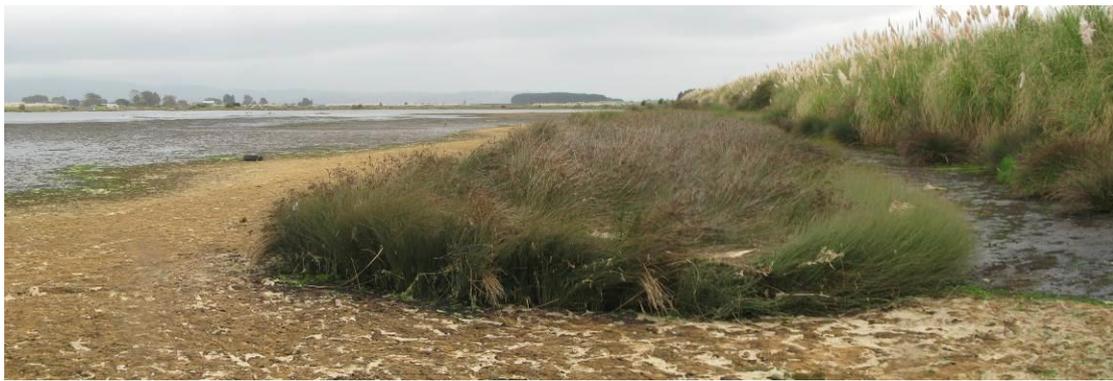
Figure 18: Estuarine shoreline of Papahikahawai Island - showing typical views (top) and isolated areas fronted by rushland (bottom).

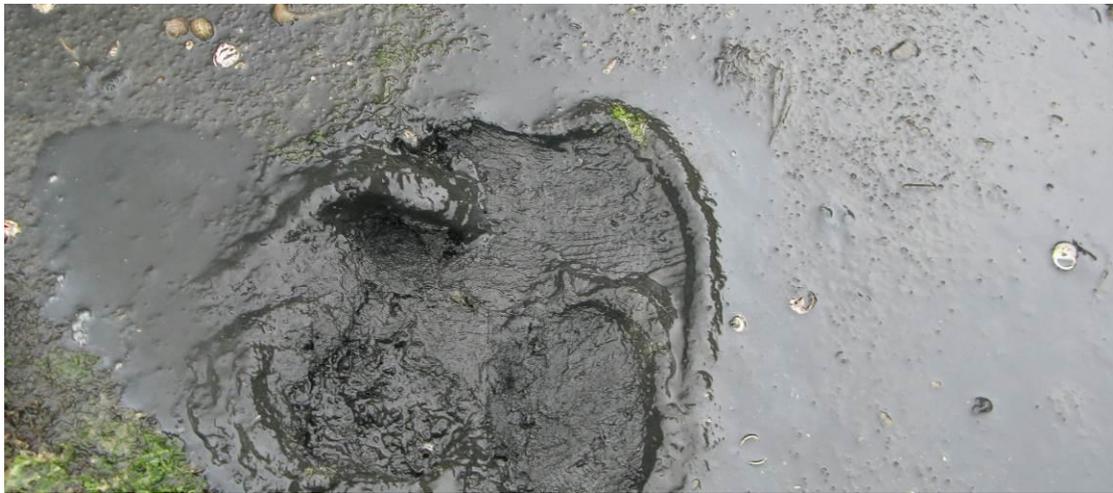
Figure 19: Anoxic muddy sediments which typically underlie the wave washed algal accumulations along the estuarine shoreline of Papahikahawai Island.

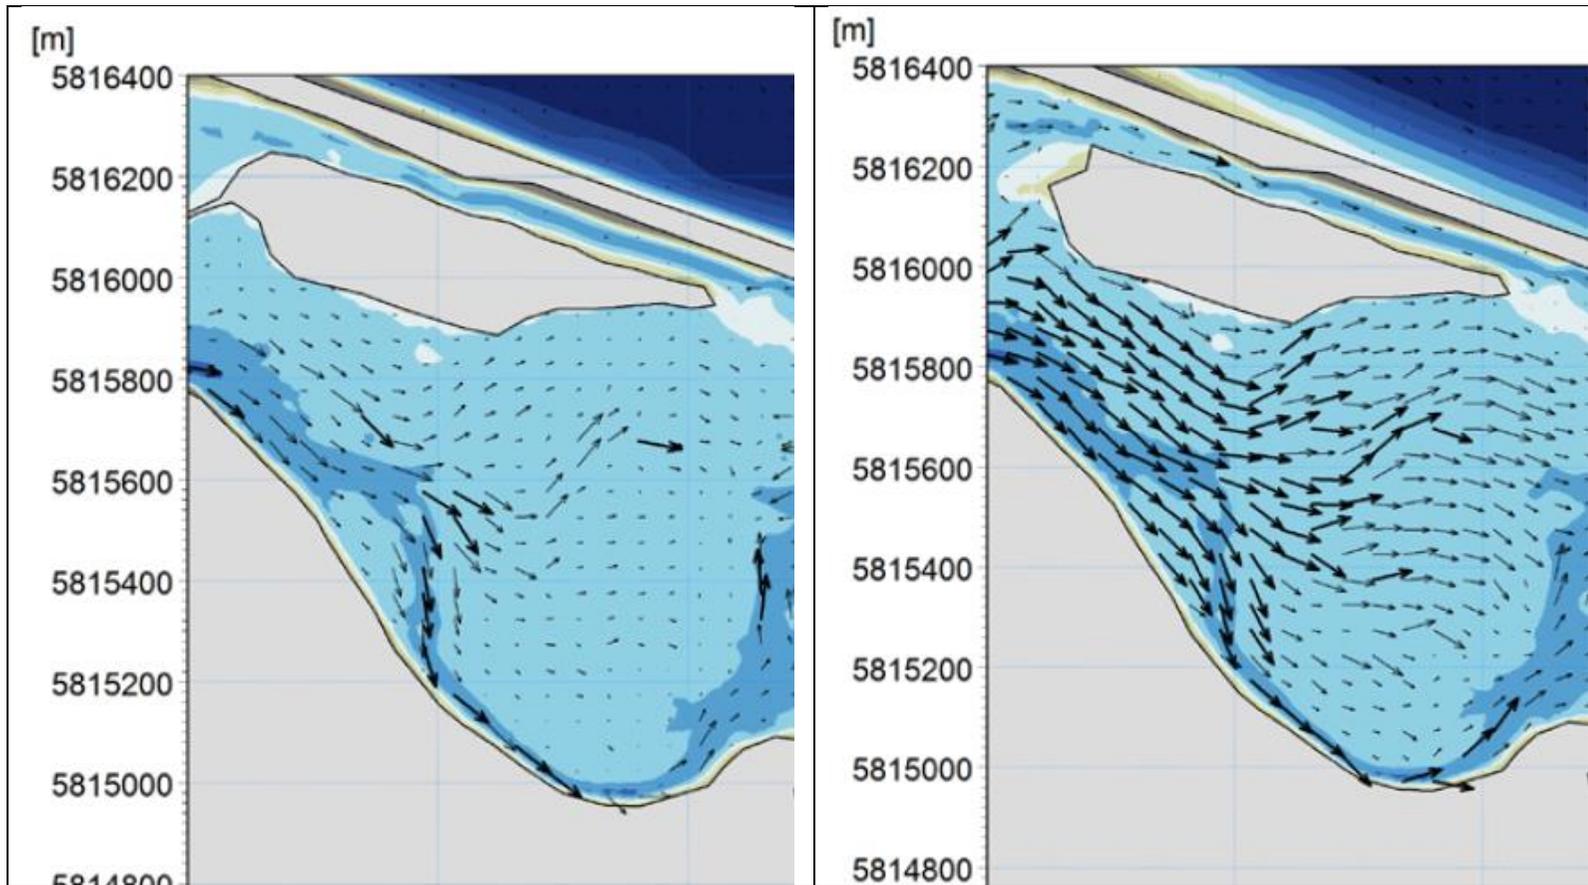
The modelling indicates that the proposed re-diversion will very significantly increase ebb oriented sediment transport over the intertidal flats adjacent to Papahikahawai Island (Figure 20).

Figure 20: Residual sediment transport rates and directions within the estuary for the existing situation (top) and with the proposed re-diversion (bottom). The sediment residuals are those that occur during mean river flow over a neap-spring cycle. (Figures provided by DHI from their modelling reported in DHI, 2014. Transport rates are low and arrows have been scaled so that differences can be seen).
