**REPORT FOR CONTRACT 2016 0083
Kopeopeo Canal Remediation Project - Dredging Trial**

**Bay of Plenty Regional Council
October 2015**

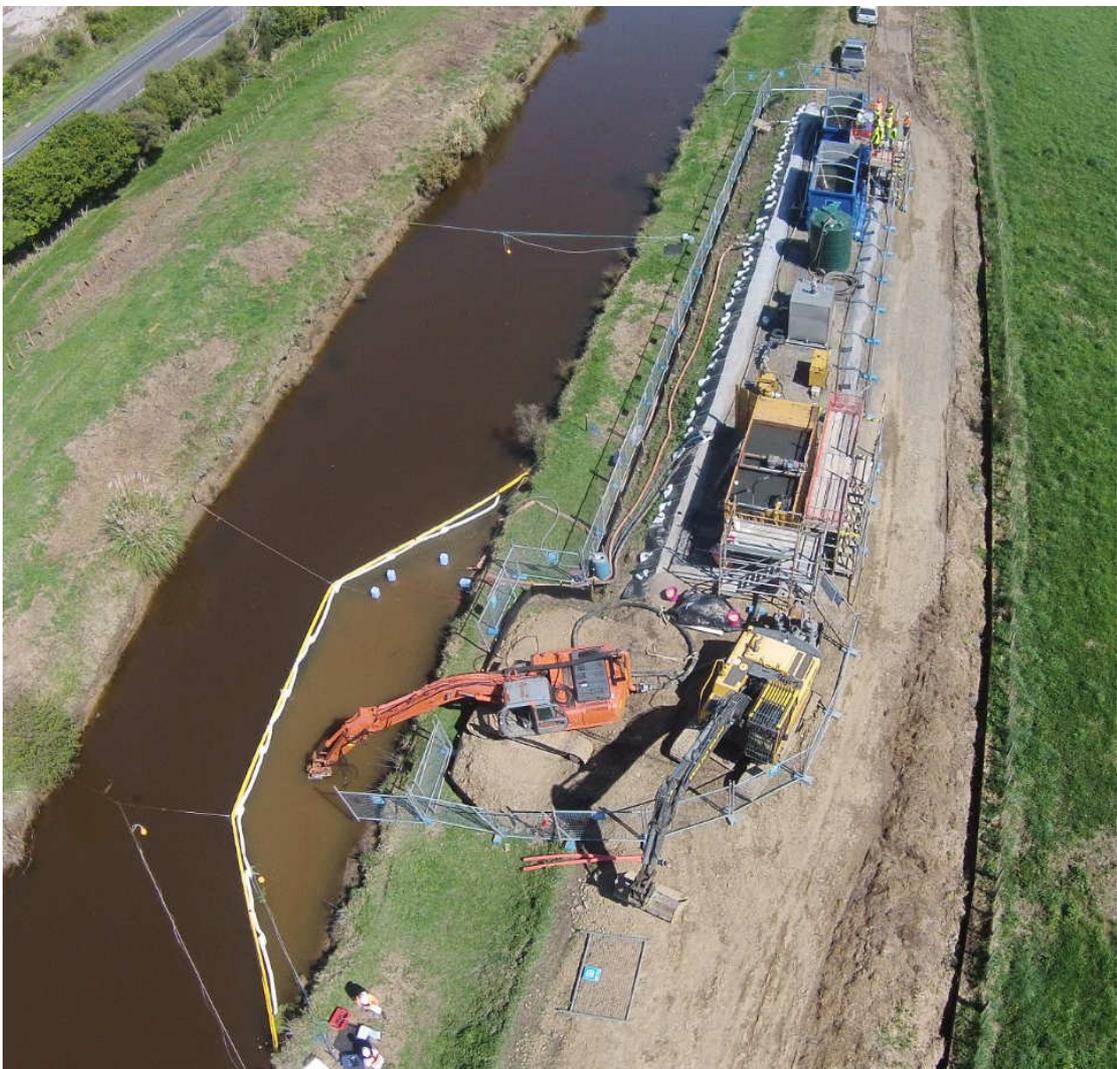
As seen in the cover page photo, the sediment curtain contained the vast majority of any turbid water that was generated during the project. The cover photo was taken on the 30th September 2015, at which point we were still commissioning and trialling various dredging techniques, which is discussed in more detail below.

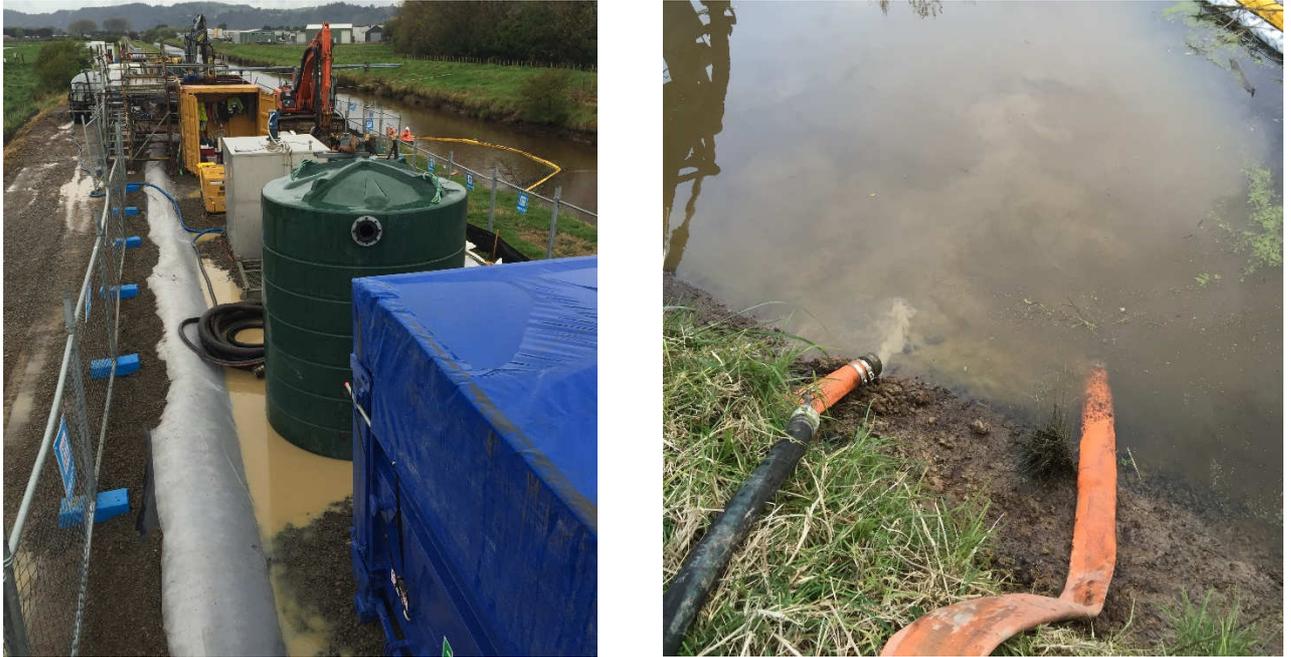
Initially the rainwater that was contained within lined bunded area where the processing equipment was placed had to be discharged back inside the sediment curtain once the monitoring equipment was in place. The river stone sourced by Waiotahi Contactors was not washed, and clearly contained some clay fines, which when initially discharged back to the canal, created an increase in turbidity inside the dredge zone (refer photos below). This was not an operational issue, but is certainly a key learning for the full scale project. Any drainage media used for the large scale bag dewatering project must be clean and washed river stone, or some other inert/clean media.

Figure 1 – Turbid Stormwater - Bund

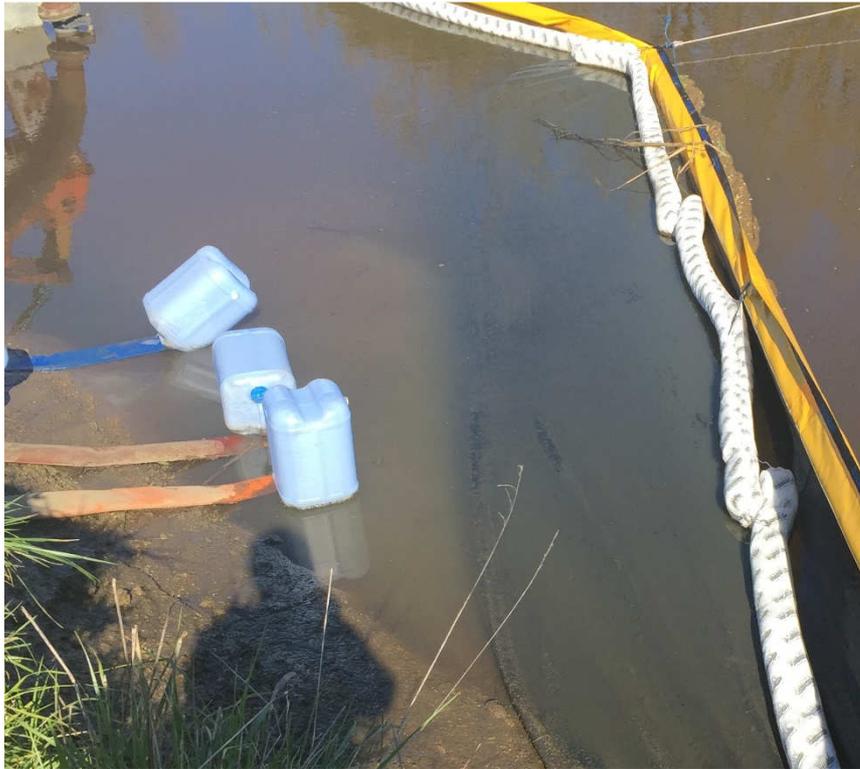
The third factor affecting turbidity was the layflat hose used to discharge the filtrate and stormwater back to the dredge zone. The layflat lay down and over the edge of the canal, and discharged into the water. While the ends of the layflat were suspended at water level using buoys (to minimise any potential of disturbance of the sediment below the water level), as the tide went out, the layflat was lying in the canal bank and sediment, and as the layflat surged with the filtrate coming out of the Geotube[®] bags, the layflat hose slapped the clay bank creating a turbidity cloud at those points. With 2 hoses continually discharging from the Geotube[®] dewatering process into the dredge zone an increase in turbidity was noticed during the trial from this, especially at low tide (see photo on the following page). We extended the length of the layflat, and secured this to the sediment curtain, as there was some turbidity being generated from the discharge of filtrate in low tide water levels. Rigid hose discharging into the centre of the canal into the surface water, rather than layflat would have eliminated this issue, however we did not have spare rigid hose on site to adapt and implement the change.

Figure 2 – Filtrate Hose Turbidity Plume

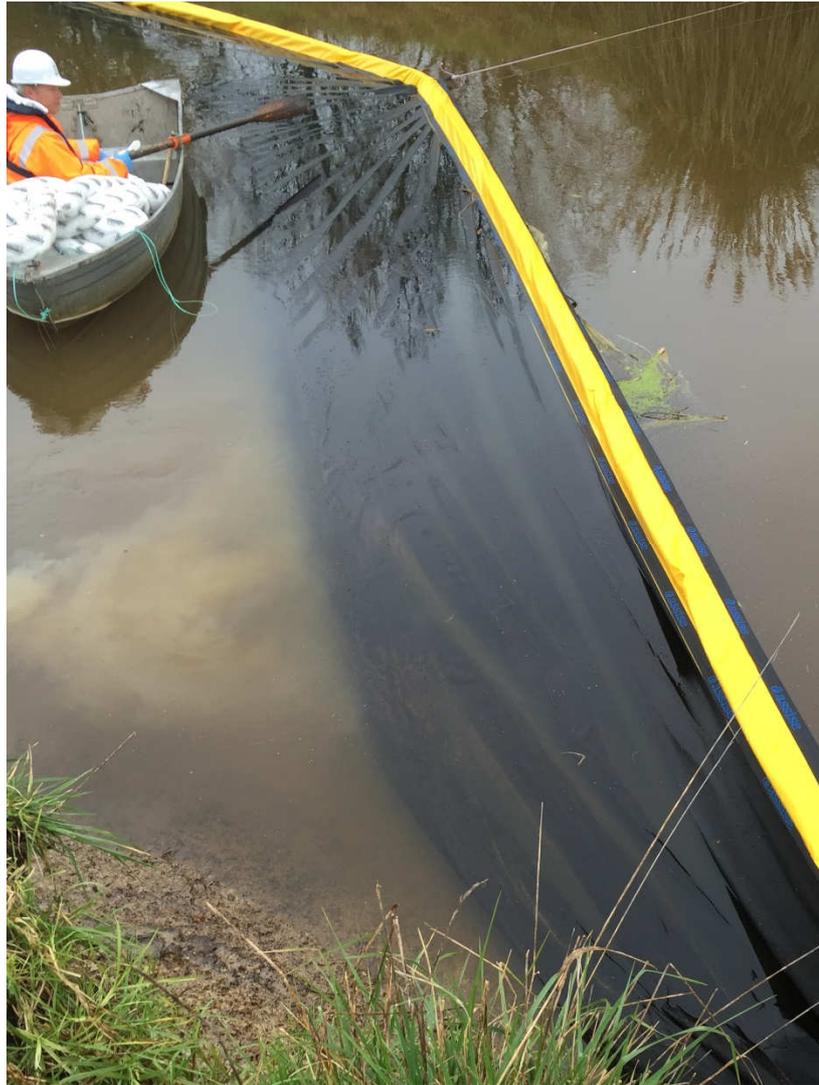
We also experienced some issues during high tidal flows with the sediment curtain bellowing inwards on an outgoing tide and creating turbidity issues inside the dredging zone (refer to the photo on the following page). This was rectified by the addition of some additional heavy chain, which we cable tied to the base of the curtain. This eliminated any further turbidity generation from this source.

Figure 3 – Sediment Curtain Turbidity Plume

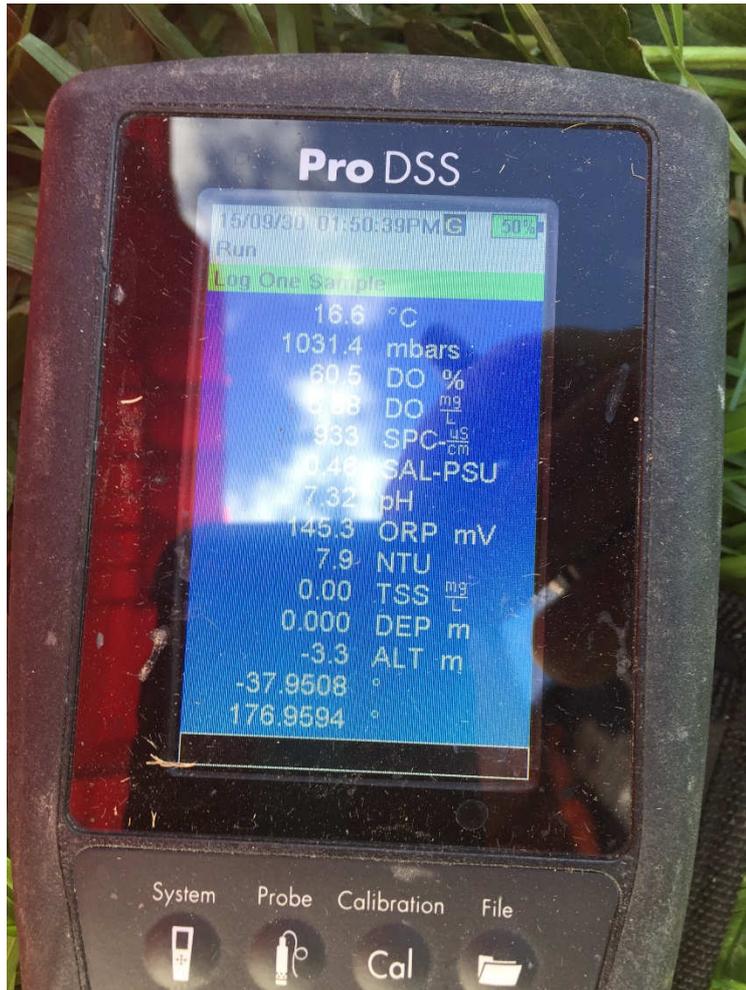
On one occasion, we did see a result from a discharge of the filtrate that showed Total Suspended Solids (TSS) in the filtrate measured by Opus to be 0.00mg/L (i.e. 100% removal of suspended solids), and turbidity of 7.9 NTU (refer photo on the page below).

Figure 4 – Filtrate Water Quality – 30/09/15 – 13:50pm
