Kopeopeo Canal Remediation CLG Update Report

September 2017

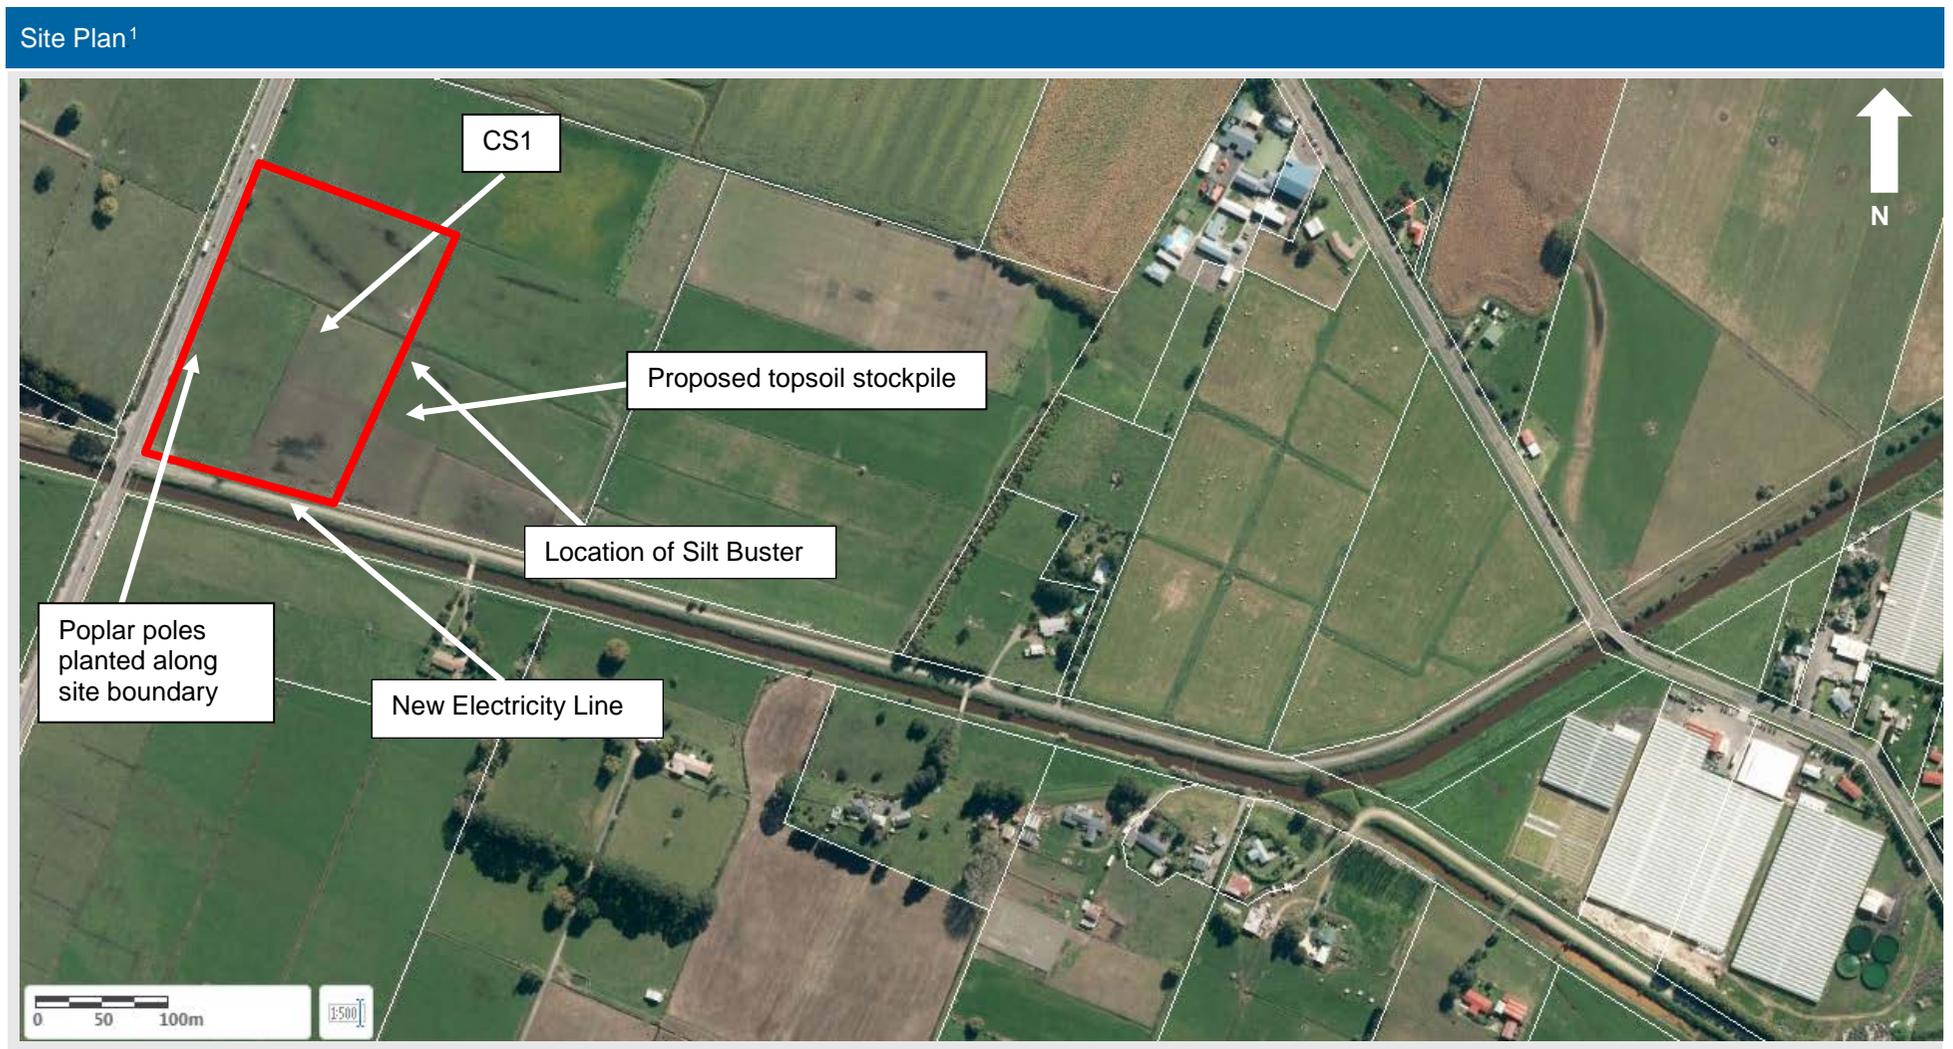
Figure 1: Site Plan

Construction at CS1 has been on hold since July, with only minor works ahead of the planned construction restart in mid-October. This has included the thrusting of an electricity line beneath Kope Drain Road, stockpiling of rock at CS1, progressing of enabling works, planting of poplar poles on site, planning for tree removal from the canal, and approval for top soil stockpiles on adjacent land during CS1 construction (See Figure 1).

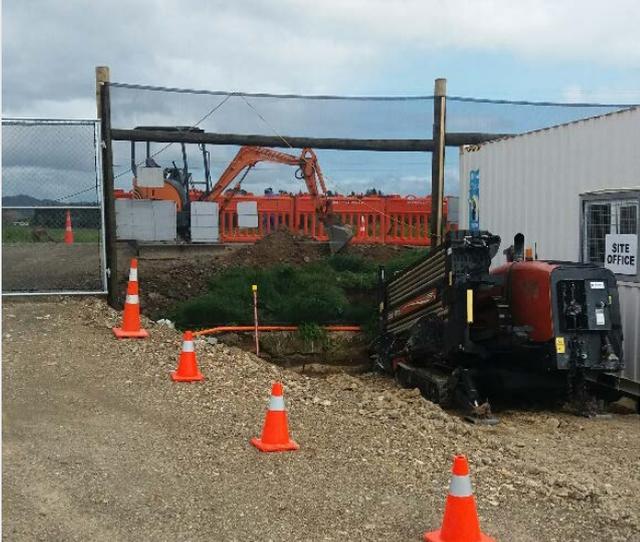
Photograph 1: Thrusting of electricity line beneath Kope Drain Road.

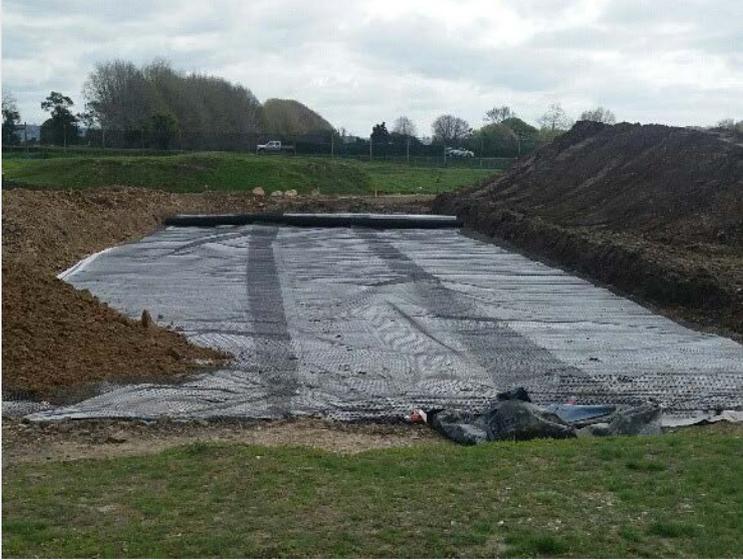
<p>Photograph 2: Preparation of one stockpile area at CS1.</p>

Stockpiling of rotten rock is being undertaken at three locations within CS1. One of these areas required the cutting and laying of approximately 21 m x 41 m of base course to provide a solid foundation for the stockpile (Photograph 2 in Table 2).

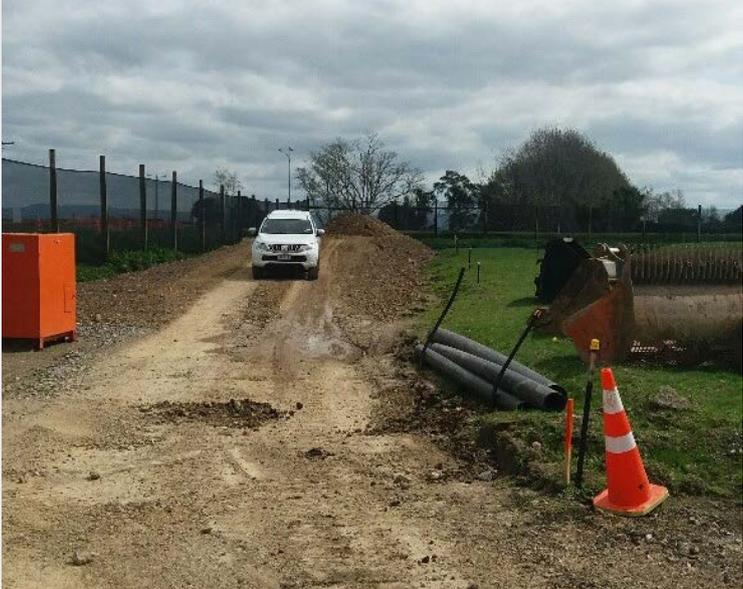
<p>Photograph 3: Stockpile area adjacent to the southern boundary.</p>
