The ecological condition of the Rotorua Lakes using LakeSPI-2011

Prepared for Bay of Plenty Regional Council

NIWA Client Report No:	HAM2011-050
Report date:	August 2011
NIWA Project:	BOP11201

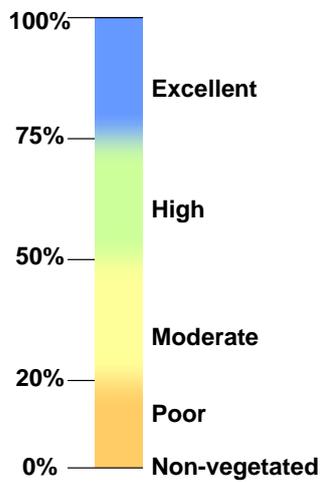
Figure 2: LakeSPI indices categorise lakes into five lake condition groups.

For the purposes of ranking and discussing results, lakes have been categorised into five main groups based on the LakeSPI Index. Lakes are grouped as being in an 'excellent', 'high', 'moderate', 'poor', or 'non-vegetated' condition (Figure 2). These new lake groupings support an MfE initiative to ensure national consistency in terminology and reporting and allow for better comparisons of lakes nationally and regionally.

Note: These categories are imposed on a continuum scale of scores; therefore we recognise some flexibility in the placement of lakes with scores close to the transition between categories. Lake placement in these cases will be made using expert opinion based on the current status of the lake and the pressures exerted on it.

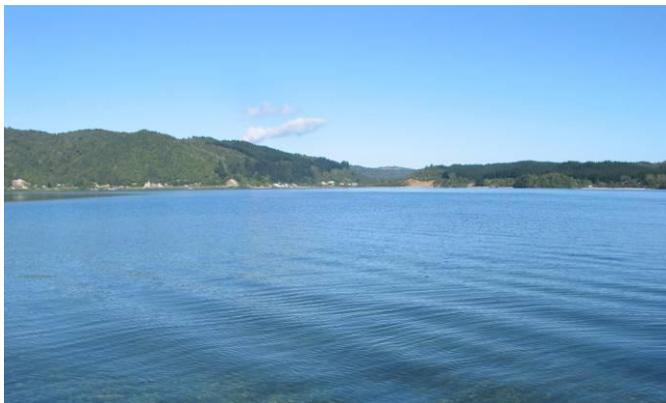
Lake condition: High

Stability: Stable

State	Year	LakeSPI Index (%)	Native Condition Index (%)	Invasive Impact Index (%)
Pristine		98	97	0
	1973	69	63	19
	1988	54	57	41
Historical data	2001	52	54	44
	2005	52	58	51
	2008	48	53	54
	2009	47	53	56
Present day	2011	51	58	52

Lake Rotoma is now the highest ranked lake in the Rotorua region after lake condition values have remained relatively stable over the last 23 years, from 1988 – 2011. In 1973 Lake Rotoma had a high LakeSPI score, which reflected the early stage of lagarosiphon invasion and the extensive high cover charophyte meadows in this lake. By 1988 the Invasive Impact Index had more than doubled, which in turn reduced both the Native Condition Index and LakeSPI score for this lake. Since then, Invasive Impact scores have increased more gradually, with smaller changes occurring to the Native Condition Index or LakeSPI score. As a result this lake presently has the highest Native Condition Index for any of the lakes and one of the lowest Invasive Impact Index which contributes to its high LakeSPI ranking.

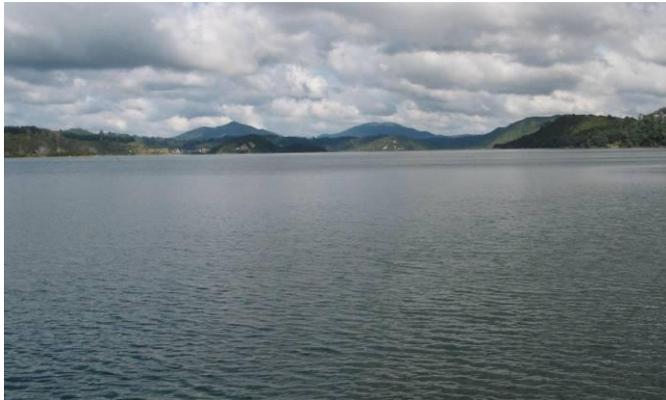
Lake condition: Moderate

Stability: Declining

State	Year	LakeSPI Index (%)	Native Condition Index (%)	Invasive Impact Index (%)
Pristine		94	90	0
	1988	72	64	13
	2002	73	61	7
Historical data	2005	70	66	19
	2008	66	63	24
	2009	63	61	30
Present day	2011	50	53	47

After being the highest ranked lake in the Rotorua region for more than 20 years, declining lake condition values have resulted in Lake Rotomahana sliding into second position. The LakeSPI Index has declined by 20% since 2005 which is the largest change recorded for any of the 12 Rotorua lakes over this 5 to 6 year time frame and Invasive Impact scores have more than doubled. This is largely due to the recent invasion and continued spread by two of New Zealand's worst aquatic plant species, egeria and hornwort. Discovered for the first time in April 2007, egeria was found to be established in only two areas of the lake, at the north-eastern end and in the southern embayment, while hornwort fragments were found growing amongst native plants in the southern embayment (Clayton & de Winton, 2007; Scholes and Bloxham, 2008). Since then both species have continued to spread, with egeria now present at all 5 LakeSPI baseline sites (2 sites more than 2009) and forming bands of weed growth down to a depth of 8.5 m. The most recently recorded average maximum depth of vegetation (8.1 m) had reduced by more than 3 m since the 2009 survey when aquatic vegetation was recorded down to an average maximum depth of 11.4 m. This reduction in the depth and extent of vegetation is concerning and as both egeria and hornwort continue to further impact

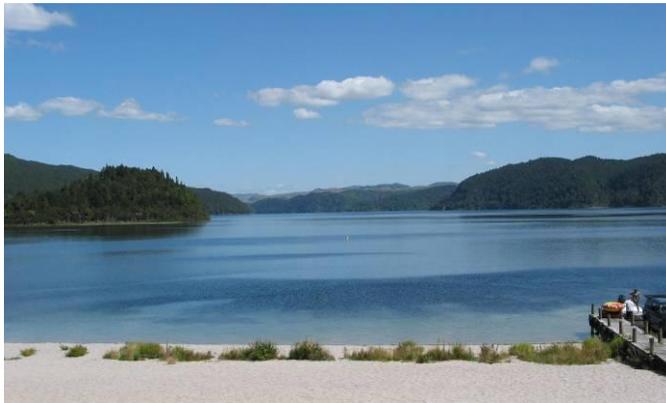
Figure 3: Invasive weed bed of hornwort (*Ceratophyllum demersum*) forming a wall of growth 8 m high and growing down to 12 m depth at the south-western end of Lake Okataina.

The discovery of an established bed of hornwort during the most recent 2010 survey poses a serious threat to the future condition of Lake Okataina. Hornwort fragments were found at the south-west end of the lake, with a search of the surrounding area revealing an established hornwort weed bed (Figure 3) growing in the middle bay west of Motuwhetero Island (authors pers obs.). Because only a couple of hornwort shoots were recorded from one of the five LakeSPI baseline sites, the Invasive Impact Index and other indices have not yet been greatly affected.

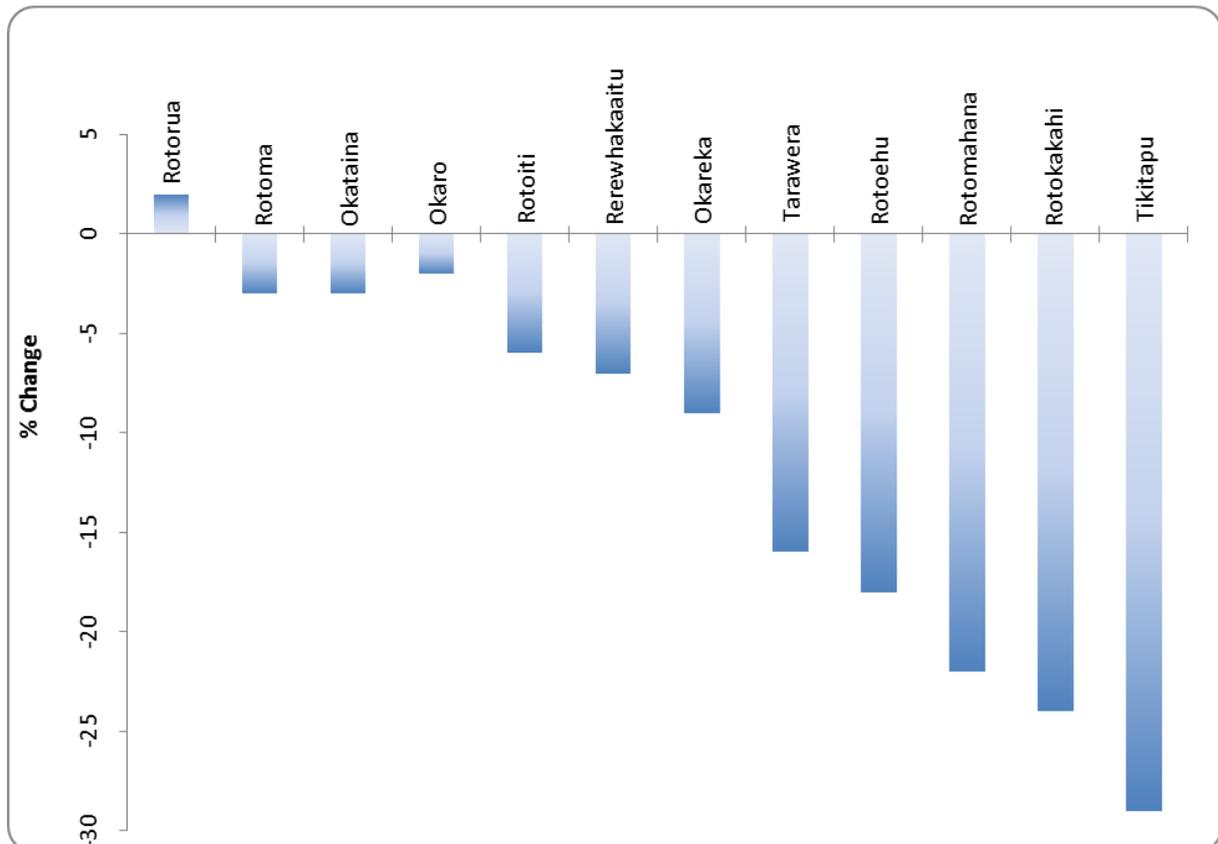
Figure 4: Percentage of change as indicated by the LakeSPI Index over the last 23 years, 1988 to 2010/11.

Many of the Rotorua Lakes have undergone significant change over the last two decades (Figure 4) and continue to be vulnerable to further changes from invasive plants and water quality deterioration. The submerged plant indicators used in LakeSPI provide an effective and alternative means to being able to assess these changes and monitor trends over time.

Lakes Tikitapu and Rotokakahi show the biggest change in lake condition over the last 20 years resulting from a notable reduction in the quality and extent of native submerged vegetation present in the lakes. There has been no new invasive species in either lake since full lake surveys in 1988, so these changes are likely the result of deteriorating water quality and clarity. Submerged plants are able to integrate long term changes in water clarity and nutrient status over time and often one of the first signs of deterioration is a retraction of the lower depth limit of plant growth (Schwarz et al. 1999). In many lakes the first valuable plant community to disappear is the charophyte meadow that grows into deeper water and this has been the case in Lake Tikitapu. In 1988 Lake Tikitapu supported extensive charophyte meadows at all 5 LakeSPI sites down to a mean depth of 19.5 m. By 2008, charophyte meadows ($\geq 75\%$ cover) were found at only one LakeSPI site with remnants ($\leq 5\%$ cover)

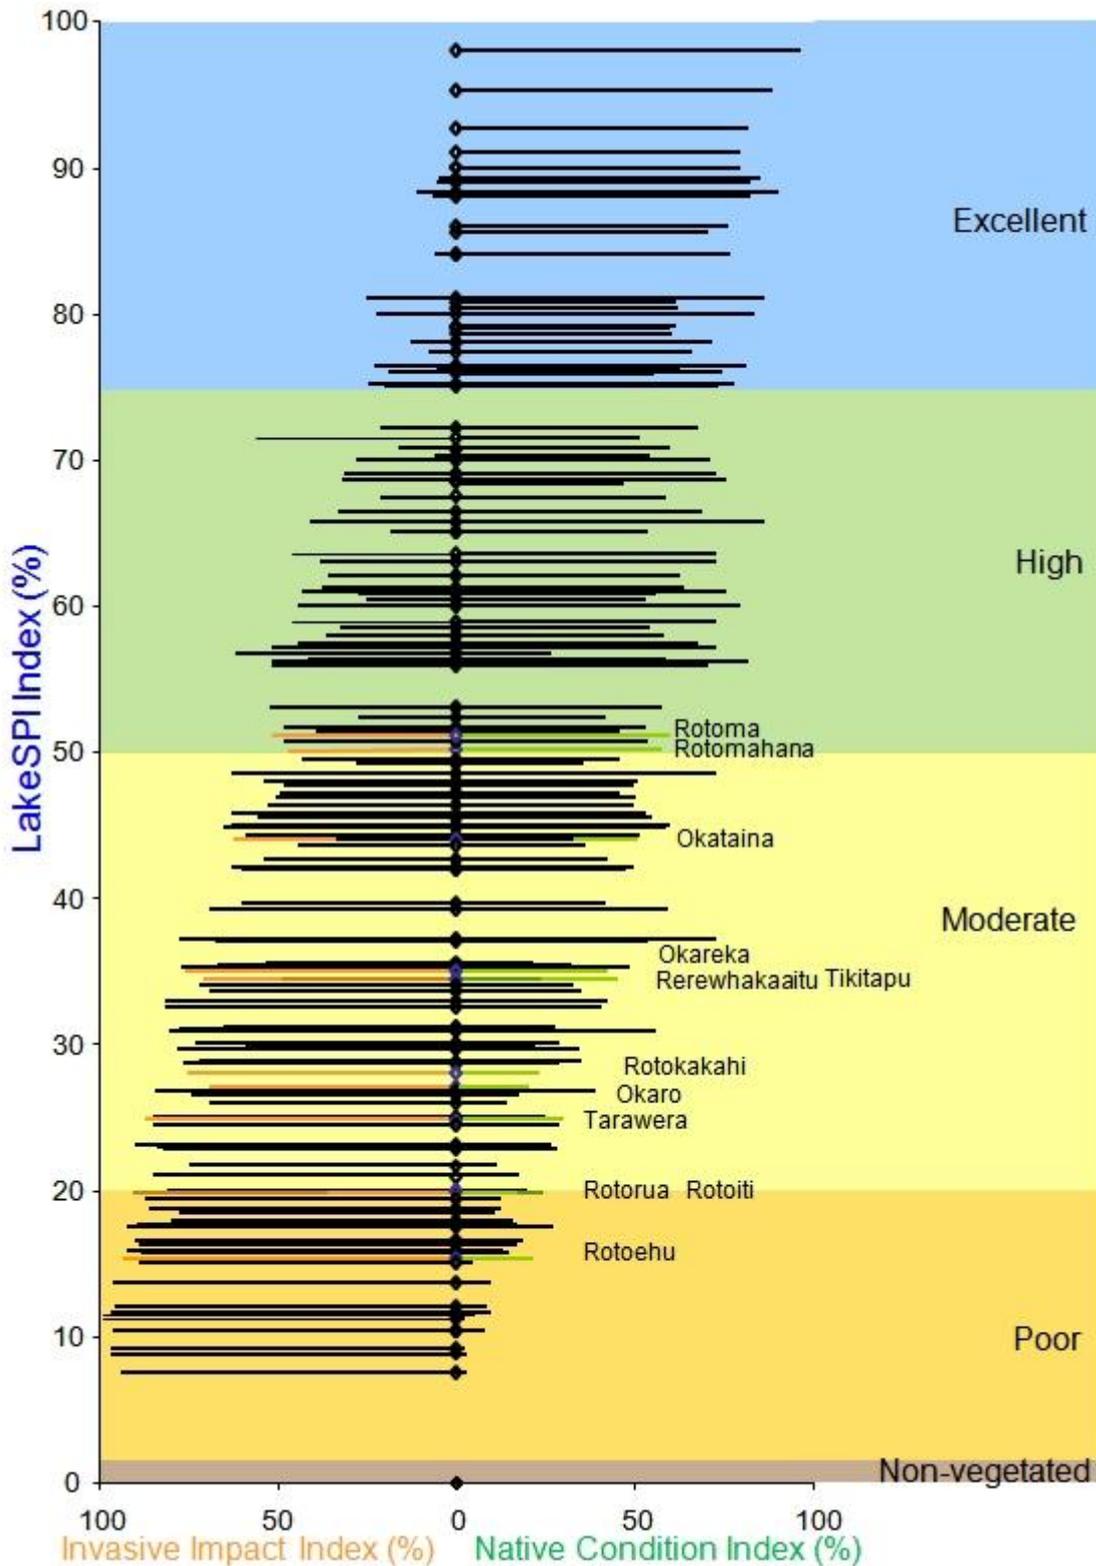
Figure 5: Current LakeSPI scores for 215 New Zealand lakes showing LakeSPI Index, Native Condition Index (right hand bars), and Invasive Impact Index (left hand bars).

Compared nationally, the Rotorua Region have no lakes classified as being in 'excellent' condition (representing those close to their maximum potential ecological condition) and only one lake classified as being in 'high' condition (Figure 5).

A 'moderate' condition category contains the majority of the Rotorua Lakes and contains the largest proportion of lakes nationally. This 'moderate' condition group of lakes are representative of those lakes that are impacted in varying degrees by invasive weeds.
