EBoP commissioned DHI to develop a three dimensional model of the lower Kaituna River and Maketu Estuary to investigate the effects of re-opening Papahikahawai Channel. A model was developed using MIKE3 FM, consisting of both hydrodynamic and advection/dispersion components.

Fords Cut Tidal Gauging

Subject: Fords Cut Tidal Gauging 12th December 2007

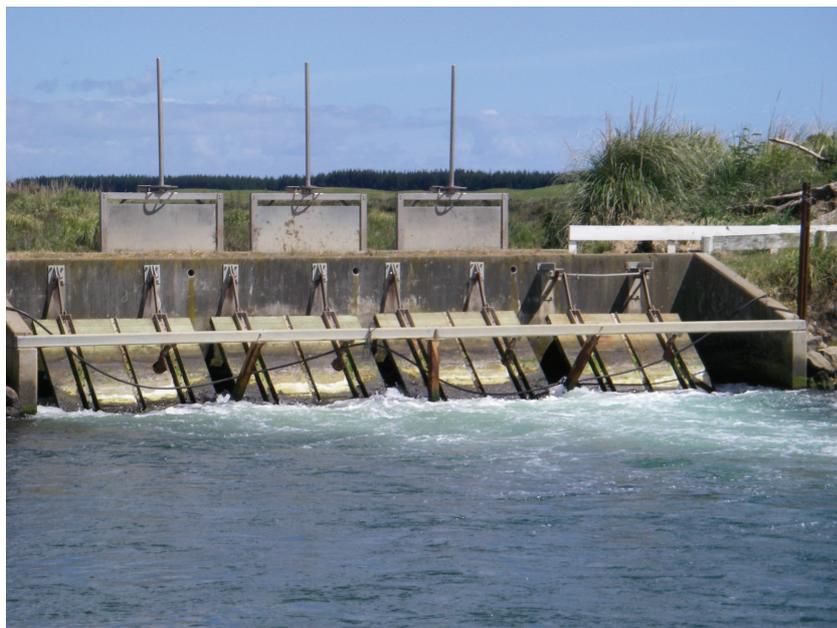
Several site inspections were carried out in the following months to ascertain the most practical, replicable and accurate method of completing the task. There is a series of 4 large culverts under the road with self closing tidal gates operating on the Maketu side of the culverts. These gates stop almost all of the reverse flow down the drain back into the Kaituna (Figure1).

Figure 0-1 Fords Cut Tidal Gates

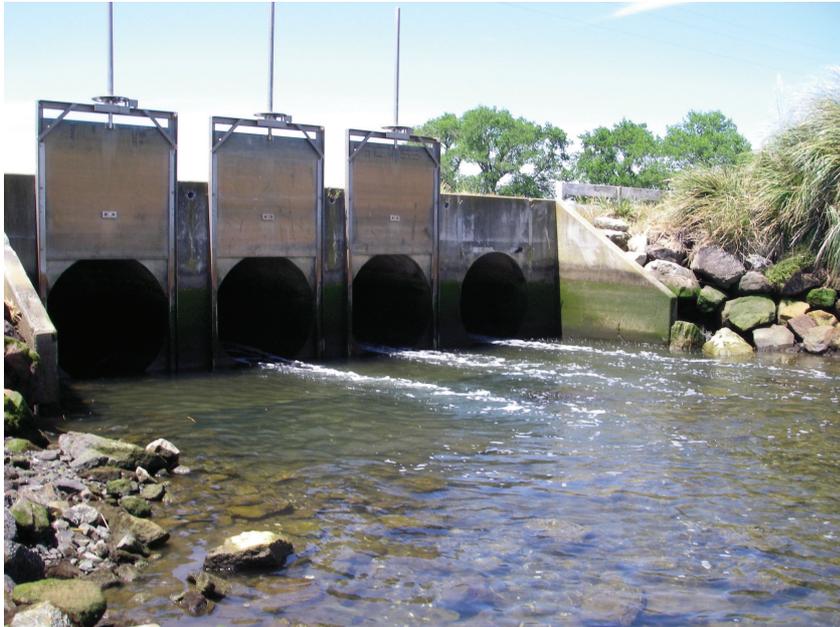
On the river side, there is a short abutment coupled with a concrete platform, approximately 11 meters wide, over which the water flowed, before it entered the culverts (Figure 2). At high tide the water level was approximately 2 metres deep. A gauging slack line was installed on the abutment 2 metres up from the culverts to allow safe measurement of flows.

Figure 0-2 Fords Cut Culverts
