Coastal Historic Heritage Review Project

Historic Heritage Inventory

**Environment Bay of Plenty,
Whakatane**

8 September 2006

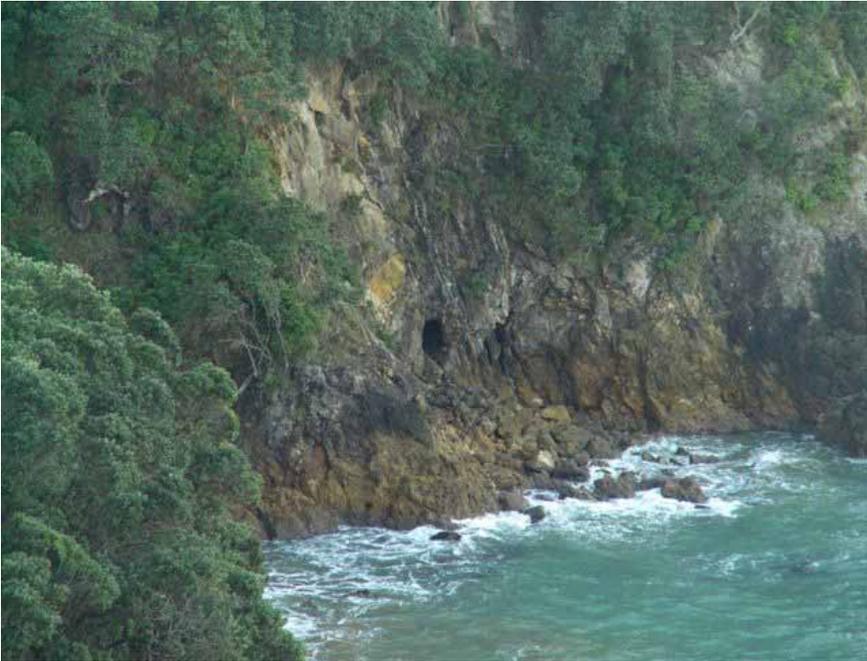
CH1 Waihi Beach Gold Mining Company

| <p>Physical description</p> <p>Three mine shafts.</p> | <p>Accurate location information</p> <p>On bluff between Waihi Beach and Orokawa Bay. Shaft 1: in south west corner of Shark Bay. Entrance 2m high by 1m wide. Extends for approximately 15m then turns, total length unknown. Shaft 2: Approximately 50-60m northeast of Shaft 1. Viewed from walking track, difficult access. Shaft 3: Approximately 250m south of Shaft 2, 20m up cliff face. Viewed from southern side of Shark Bay, difficult access.</p> | <p><i>Minesshaft 3 (Photo – K Phillips, 2006)</i></p> |
| <p>Condition of site</p> <p>Excellent - Visible features are intact and clearly defined.</p> | | |

| CRITERIA | Comments |
|---|---|
| <p>Integrity The condition, quality and state of original features of a place or area. Comparison with other examples of its class. The quality of any restoration, addition or modification of the place or area.</p> | Shafts are intact and have not been modified. |
| <p>Fragility or Vulnerability The components, form and structure of the place or area and the effect of this on its survival. Its vulnerability to deterioration or destruction. The degree to which it is threatened and its context in terms of protection and services.</p> | Vulnerable to coastal erosion processes. |

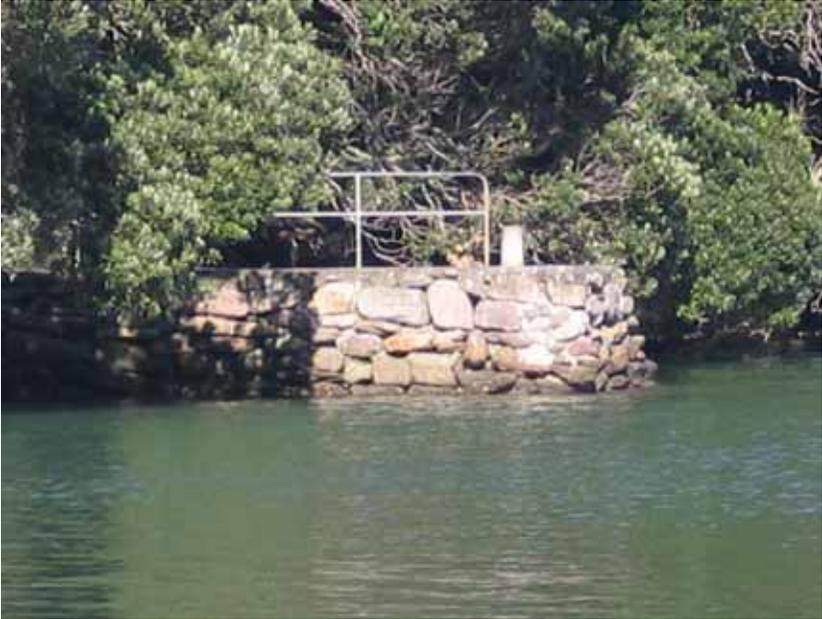
| <p>Physical description</p> <p>Jetty 35 by 5 ft 6 inches, height 8 ft, depth at high water 6 - 7 ft. Also a large shelter shed with an open fireplace. Reported as having been demolished by Wahine Storm in 1968 and rebuilt by volunteers in same year, but extent of intact fabric has never been determined by assessment.</p> | <p>Accurate location information</p> <p>Anzac Bay, Bowentown Heads.</p> <hr/> <p>Location (NZMG, Geodetic Datum 1949)</p> <p>E 2774313 N 6410542</p> | <p><i>Bowentown Jetty – Anzac Bay</i></p> |

| CRITERIA | Comments |
|---|---|
| <p>Integrity The condition, quality and state of original features of a place or area. Comparison with other examples of its class. The quality of any restoration, addition or modification of the place or area.</p> | Restored in 1968 and repaired since that date. Restoration done without conservation planning advice. The amount of intact fabric needs to be assessed. |
| <p>Fragility or Vulnerability The components, form and structure of the place or area and the effect of this on its survival. Its vulnerability to deterioration or destruction. The degree to which it is threatened and its context in terms of protection and services.</p> | Vulnerable to coastal erosion, storm events. Original jetty reported to have been demolished by Wahine storm. |

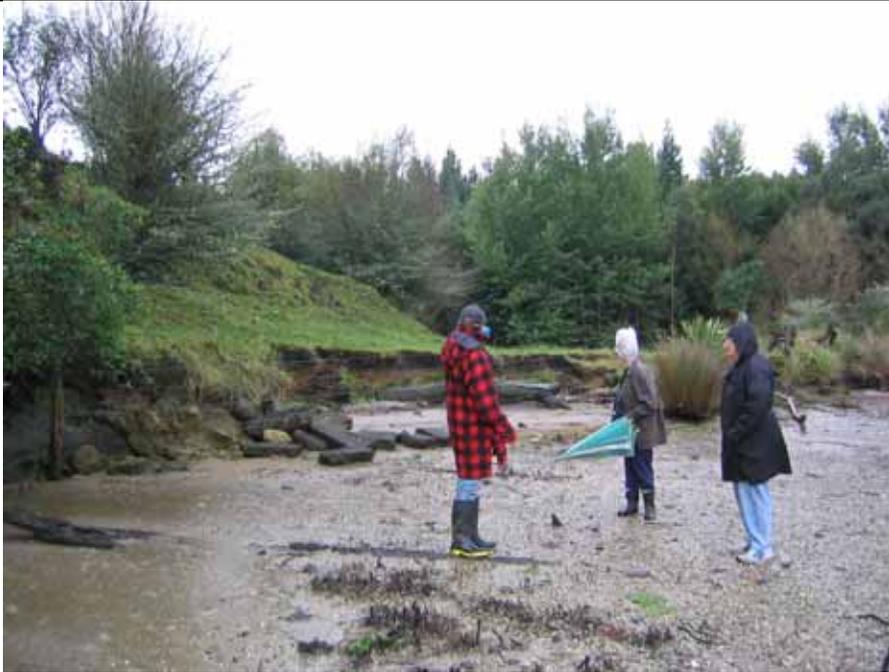
CH3 Martray Wharf

| <p>Physical description</p> <p>Some timber piles still evident in 2005.</p> | <p><i>Accurate location information</i></p> <p>Boat House Bay on 'Martray' estate property Ongare Point peninsular, Katikati.</p> <hr/> <p><i>Location (NZMG, Geodetic Datum 1949)</i> E 2770469 N 6403772</p> | <p><i>Martray Wharf, 2006</i></p> |
| <p><i>Condition of site</i></p> <p>Fair - Some intact features, but others may be unclear or damaged.</p> | | |

| CRITERIA | Comments |
|---|---|
| <p>Integrity The condition, quality and state of original features of a place or area. Comparison with other examples of its class. The quality of any restoration, addition or modification of the place or area.</p> | Timber piles still intact in 2005. |
| <p>Fragility or Vulnerability The components, form and structure of the place or area and the effect of this on its survival. Its vulnerability to deterioration or destruction. The degree to which it is threatened and its context in terms of protection and services.</p> | Vulnerable to erosion. |

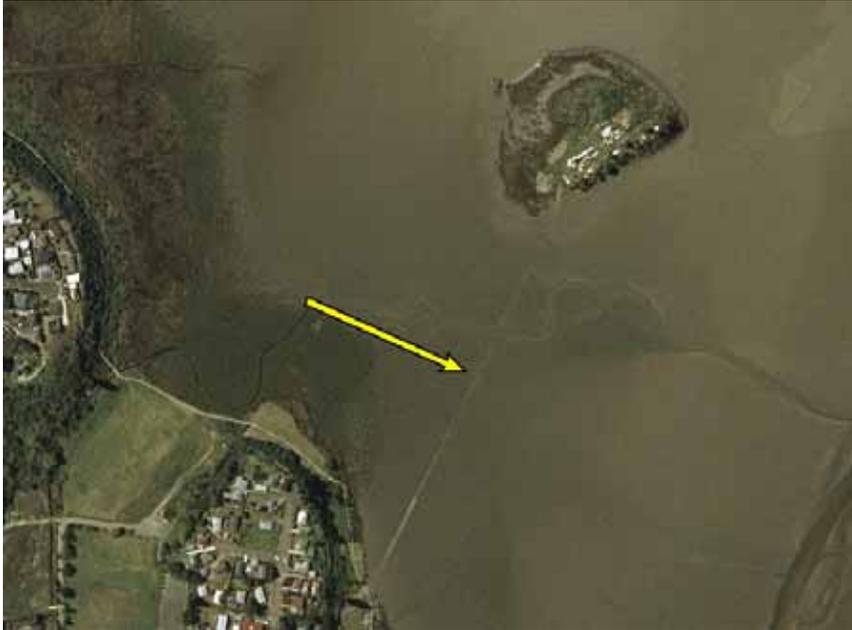
CH4 Motuopae causeway

| <p>Physical description</p> <p>Rock causeway accessible at low tide for vehicles to Maori urupa on islands.</p> | <p><i>Accurate location information</i></p> <p>From Judea to Motuopae Island in Waikareao Estuary, Tauranga.</p> <hr/> <p><i>Location (NZMG, Geodetic Datum 1949)</i></p> <p>E 2788080 N 6385700</p> | |

| CRITERIA | Comments |
|---|---|
| <p>Integrity The condition, quality and state of original features of a place or area. Comparison with other examples of its class. The quality of any restoration, addition or modification of the place or area.</p> | Intact, no modification. |

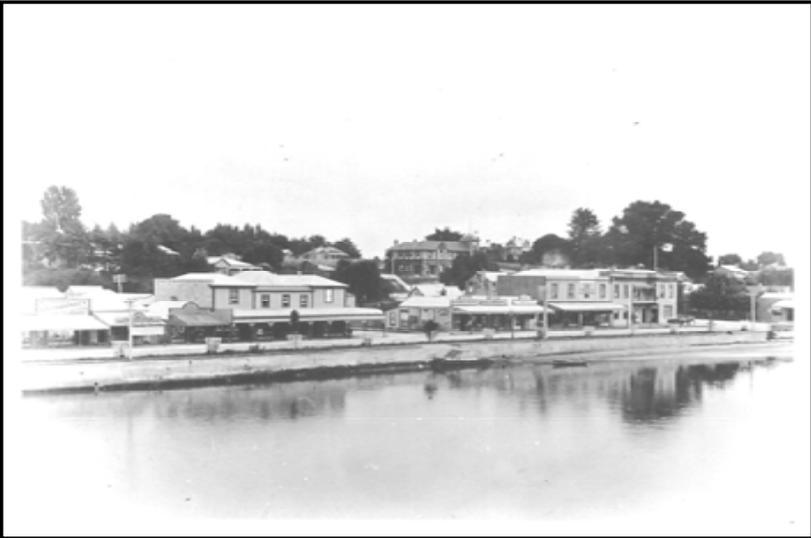
CH5 The Strand Sea Wall

| <p>Physical description</p> <p>Sea Wall</p> | <p><i>Accurate location information</i></p> <p>Now underneath lawn on the Strand. Redevelopment from Spring Street to Harrington Street, Tauranga. Site covers an extensive area and the boundaries need to be accurately defined.</p> <hr/> <p><i>Location (NZMG, Geodetic Datum 1949)</i></p> <p>E 2789802 N 6386185</p> | <p style="text-align: center;"><i>Northern end of the Strand Waterfront C1910</i></p> <p style="text-align: center;"><i>(Photo – Tauranga Library Collection)</i></p> |

| CRITERIA | Comments |
|---|---|
| <p>Integrity The condition, quality and state of original features of a place or area. Comparison with other examples of its class. The quality of any restoration, addition or modification of the place or area.</p> | Intact remnants. |
| <p>Fragility or Vulnerability The components, form and structure of the place or area and the effect of this on its survival. Its vulnerability to deterioration or destruction. The degree to which it is threatened and its context in terms of protection and services.</p> | Vulnerable to further modification. |

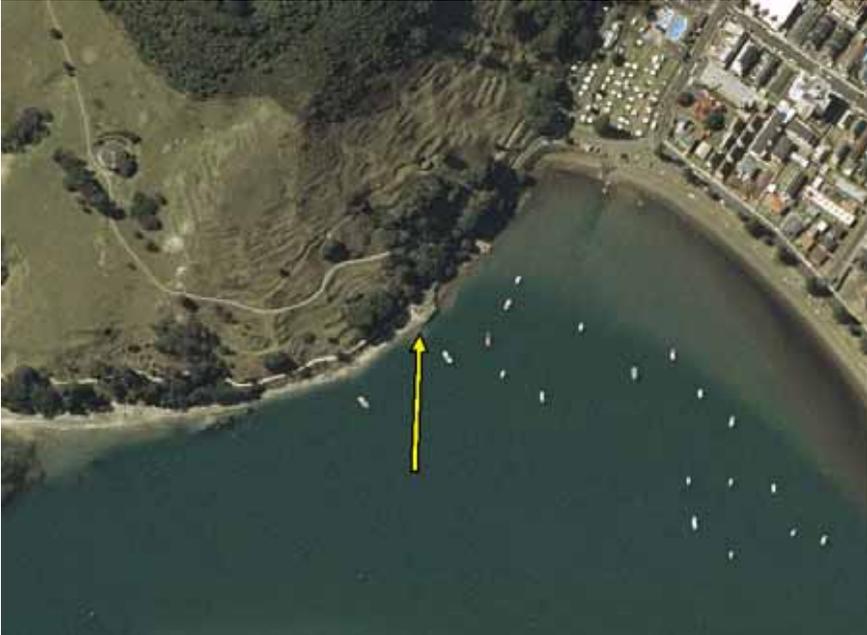
CH6 Stone Jetty, Mount Maunganui.

| <p>Physical description</p> <p>Jetty made of rhyolite boulders from the vicinity and surfaced with concrete. Built for small boat landings during excursions. 15 metres long. Moturiki Datum - bolt and arrow in concrete - survey point for harbour survey.</p> | <p><i>Accurate location information</i></p> <p>Pilot Bay, Mount Maunganui Sec 3. 12 Pt.1 Blk VI Tauranga SD.</p> <hr/> <p><i>Location (NZMG, Geodetic Datum 1949)</i></p> <p>E 2790260 N 6391430</p> | |
| <p><i>Condition of site</i></p> <p>Excellent - Visible features are intact and clearly defined. Reconstruction/restoration so extent of intact fabric is difficult to assess.</p> <hr/> <p><i>Identification of threats (e.g. earthquake or structural risk), conservation constraints and opportunities.</i></p> <p>Further reconstruction. Coastal erosion.</p> | | |

| CRITERIA | Comments |
|---|---|
| <p>Integrity The condition, quality and state of original features of a place or area. Comparison with other examples of its class. The quality of any restoration, addition or modification of the place or area.</p> | More research required - reconstructed/restoration. |

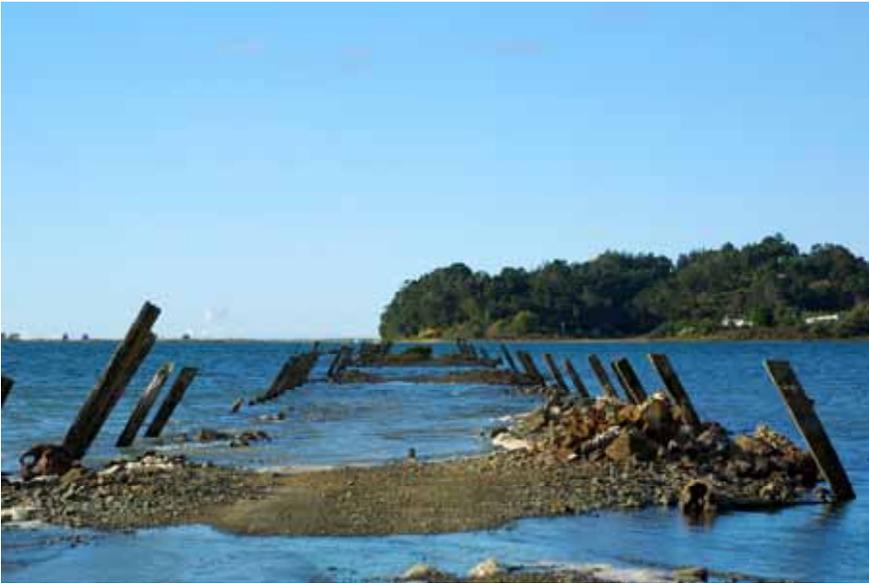
CH7 Kutarere Wharf

| <p>Physical description</p> <p>Long timber causeway built over mudflats - wharf shed near deep end.</p> | <p><i>Accurate location information</i></p> <p>Kutarere on Ohiwa Harbour.</p> <hr/> <p><i>Location (NZMG, Geodetic Datum 1949)</i></p> <p>E 2873072 N 6343594</p> | <p><i>Photograph/sketch</i></p> |

| CRITERIA | Comments |
|---|---|
| <p>Integrity The condition, quality and state of original features of a place or area. Comparison with other examples of its class. The quality of any restoration, addition or modification of the place or area.</p> | Some intact fabric. |
| <p>Fragility or Vulnerability The components, form and structure of the place or area and the effect of this on its survival. Its vulnerability to deterioration or destruction. The degree to which it is threatened and its context in terms of protection and services.</p> | Vulnerable to erosion/modification. |

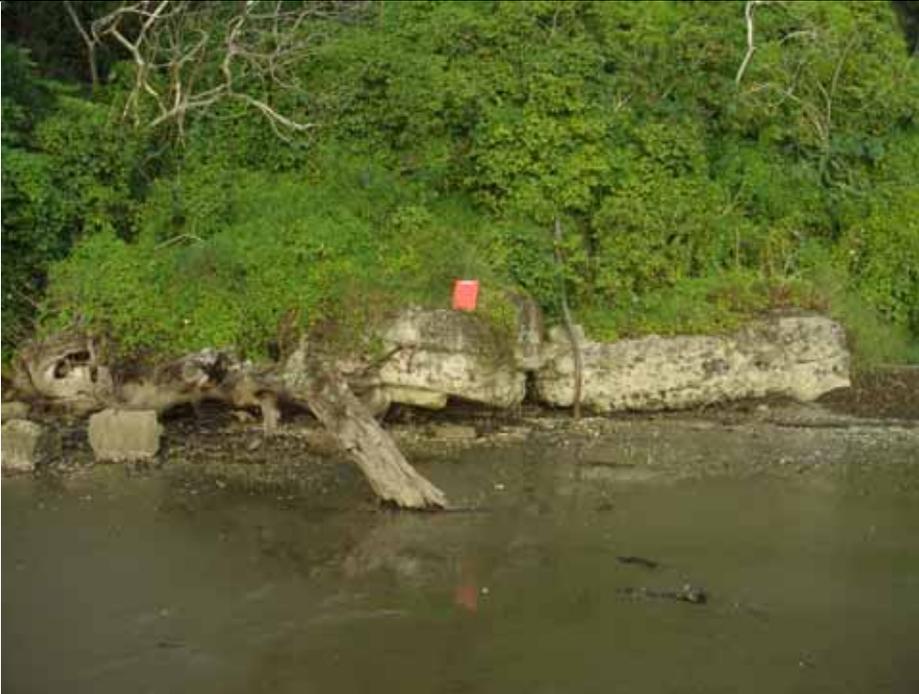
CH8 Mount Stewart Jetty (Bob Blakeney's Wharf)

| <p>Physical description</p> <p>Remnants of timber wharf.</p> | <p><i>Accurate location information</i></p> <p>Ongare Point.</p> <hr/> <p><i>Location (NZMG, Geodetic Datum 1949)</i></p> <p>E 2772513 N 6407589</p> | |

| CRITERIA | Comments |
|---|---|
| <p>Integrity The condition, quality and state of original features of a place or area. Comparison with other examples of its class. The quality of any restoration, addition or modification of the place or area.</p> | Some intact fabric. |
| <p>Fragility or Vulnerability The components, form and structure of the place or area and the effect of this on its survival. Its vulnerability to deterioration or destruction. The degree to which it is threatened and its context in terms of protection and services.</p> | Vulnerable to erosion/modification. |

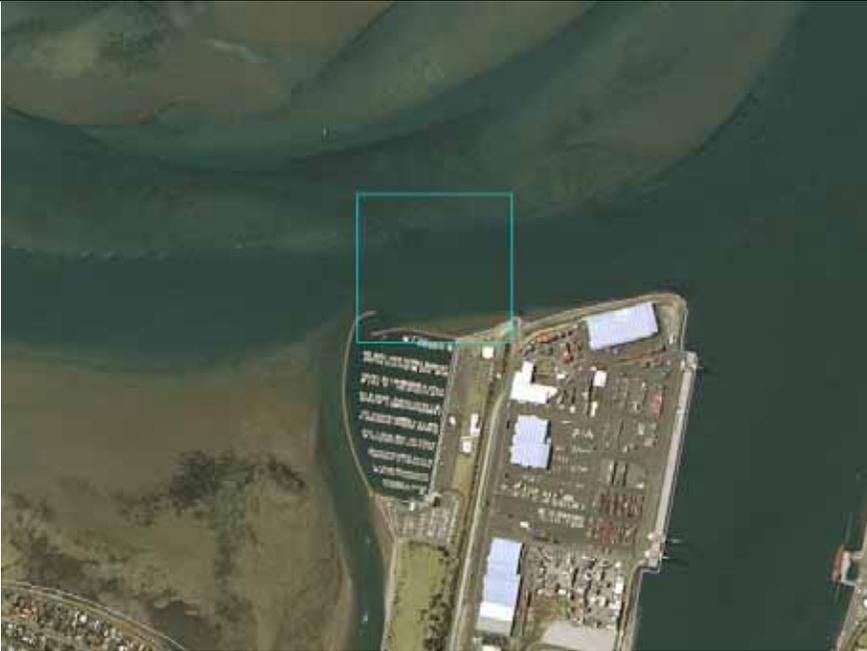
CH9 Martha

| <p>Physical description</p> <p>Shipwreck. American whaler about 100 ft long. Built in USA c1805. Sank at mooring after years as a hulk.</p> | <p><i>Accurate location information</i></p> <p>Off Sulphur Point marina near rock retaining wall. Highly likely that at least half of the hull is buried under the northern breakwater wall.</p> <hr/> <p><i>Location (NZMG, Geodetic Datum 1949)</i></p> <p>Probable location in area between E 2789409 N 6389131; E 2789836 N 6389131; E 2789836 N 6388724; E 2789409 N 6388724</p> | <p><i>Probable location of the "Martha"</i></p> |

| CRITERIA | Comments |
|---|---|
| <p>Integrity The condition, quality and state of original features of a place or area. Comparison with other examples of its class. The quality of any restoration, addition or modification of the place or area.</p> | Some intact fabric. |
| <p>Fragility or Vulnerability The components, form and structure of the place or area and the effect of this on its survival. Its vulnerability to deterioration or destruction. The degree to which it is threatened and its context in terms of protection and services.</p> | Vulnerable to modification and/or destruction. |

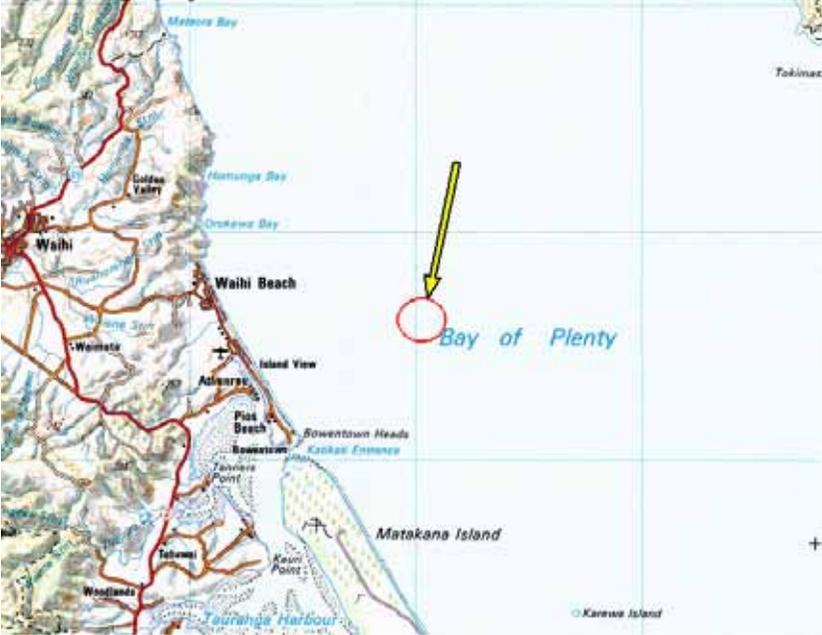
CH11 Taupo

| <p>Physical description</p> <p>Shipwreck</p> | <p><i>Accurate location information</i></p> <p>In 38 fathoms between Mayor Island and Bowentown Heads.</p> <p><i>Location (NZMG, Geodetic Datum 1949)</i></p> <p>Approximate location E 2780200 N 6416200</p> | <p><i>Approximate location.</i></p> |
| <p><i>A brief history of the site including major events associated with it and major additions/modifications. This section should be fully referenced, preferably to primary materials, where possible.</i></p> <p>Steamer. 1879 holed at Stony Point, sank while being towed. Ship only 4 years old commanded by Capt. James Macfarlane. First struck a rock in Tauranga harbour, refloated after 2 years and left for Auckland under tow in 1881. Developed a leak and sank between Mayor Island and Bowentown Heads.</p> <p><i>References:</i></p> <p>Ingram, C.W.N., compiler, N.Z. 195 Years of Disaster at Sea, 7th revised edition, Beckett Publishing. Auckland 1990. p.191. Heath, Eric, & McLean Gavin, Shipwrecks Around New Zealand, Grantham House, Auckland, 1994.p.16. Locker-Lampson, Steve & Francis, Ian, The Wreck Book, Rediscovered New Zealand Shipwrecks, Halcyon Press, Auckland 1994. p.105</p> | | <p><i>Condition of site</i></p> <p>Not visible - Surface evidence has been obliterated, however, there is likely to be subsurface material.</p> <p><i>Identification of threats (e.g. earthquake or structural risk), conservation constraints and opportunities.</i></p> <p>Wave action/storm events. Divers? Previously damaged by explosives, subject of HPA prosecution in 1983.</p> |

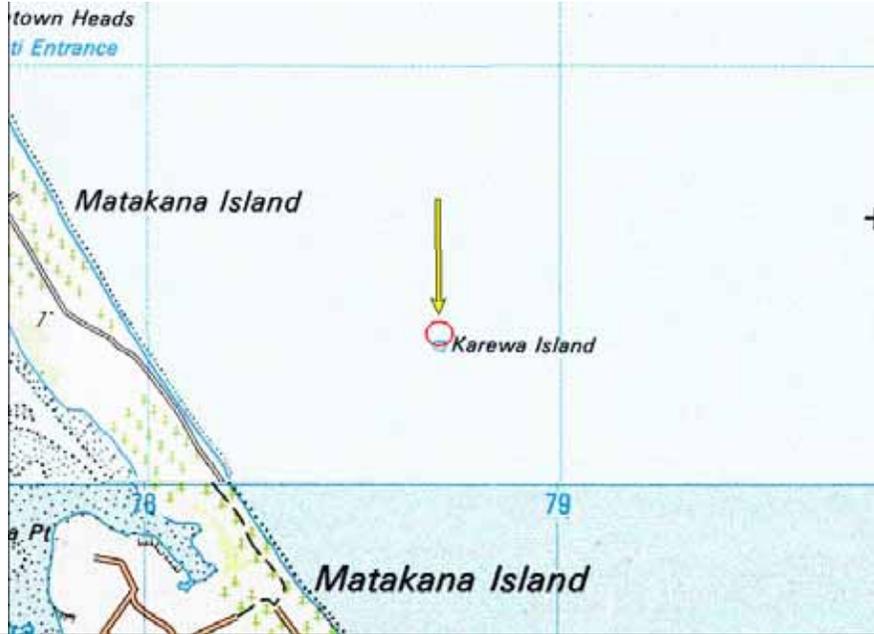
CH12 Taranaki

| <p>Physical description</p> <p>Shipwreck</p> | <p><i>Accurate location information</i></p> <p>Sunk at Karewa Island BOP.</p> <hr/> <p><i>Location (NZMG, Geodetic Datum 1949)</i></p> <p>Approximate location E 2787083 N 6403579</p> | <p><i>Photograph/sketch</i></p> |
| <p><i>A brief history of the site including major events associated with it and major additions/modifications. This section should be fully referenced, preferably to primary materials, where possible.</i></p> <p>327 ton Steamer built in Scotland in 1865. Sank in 1878 while carrying passengers from Auckland in dense fog. No loss of life.</p> <p><i>References:</i></p> <p>Ingram, C.W.N., compiler, N.Z. 195 Years of Disaster at Sea, 7th revised edition, Beckett Publishing. Auckland 1990. p.190. Locker-Lampson, Steve & Francis, Ian, The Wreck Book, Rediscovered New Zealand Shipwrecks, Halcyon Press, Auckland 1994. p.100</p> | | <p><i>Condition of site</i></p> <p>Not visible - Surface evidence has been obliterated, however, there is likely to be subsurface material.</p> <hr/> <p><i>Identification of threats (e.g. earthquake or structural risk), conservation constraints and opportunities.</i></p> <p>Wave action/storm events. Divers?</p> |
