Mangatawa

Sub-Catchment Action Plan 2012

The Mangatawa Sub-Catchment Action Plan is one of a series about the sub-catchments surrounding Tauranga Harbour. This action plan provides an analysis of the current land management issues, a summary of the available physical resources in the Mangatawa sub-catchment, and planned action for land and resource use of the sub-catchment.

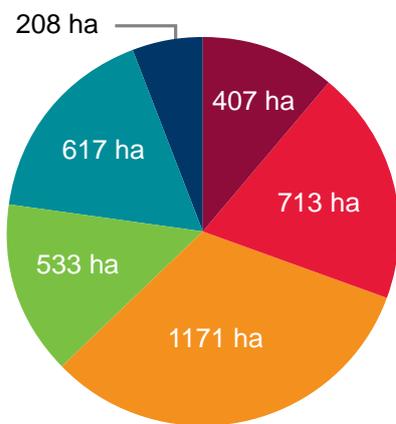
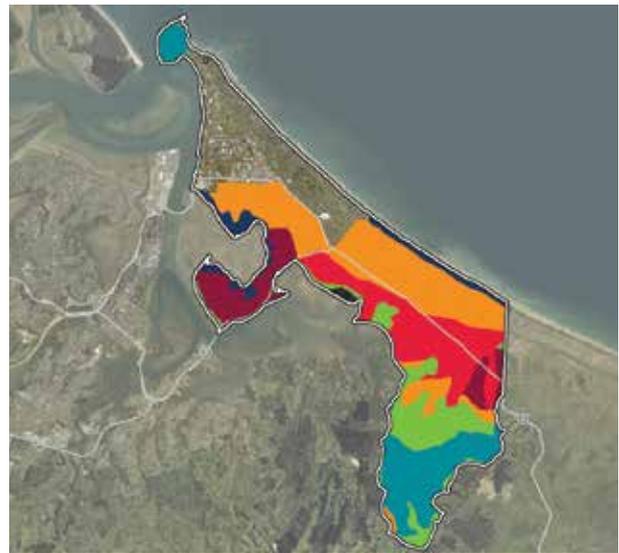
Land use capability classification in the Mangatawa sub-catchment

The majority of land in this sub-catchment is Land Use Capability (LUC) Class 2, 3 and 4 – flat to gently rolling landscapes. In this sub-catchment, these landscapes are generally summer dry (high sand content) or very wet in low lying areas that are poorly drained. LUC Class 6 and 7 lands are located in the middle and upper catchment.

LUC Class	LUC Units	Percent
2	2e 1, 2s 1, 2w 1	9
3	3e 1, 3w 1	15
4	4e 1, 4e 2, 4s 2	25
6	6e 1, 6e 2, 6e 3, 6e 7, 6s 3+4s 2, 6w 1	11
7	7e 1, 7e 2, 7e 8, 7e 11	13
8	8e 1, 8w 1	4

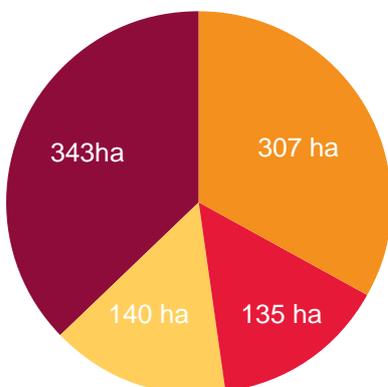
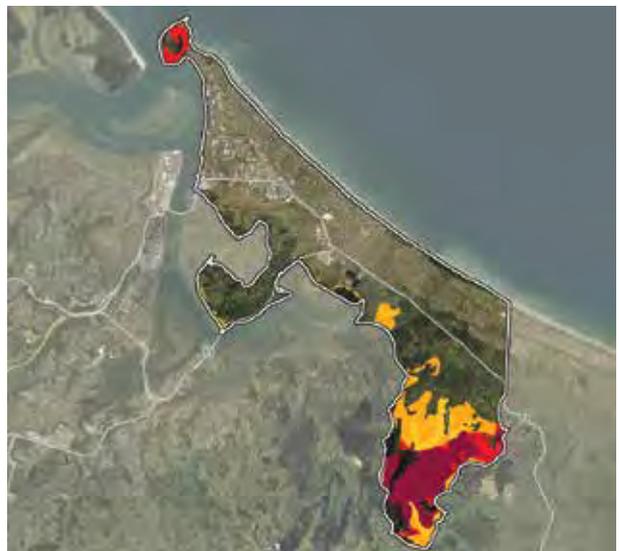
Erosion risk in the Mangatawa sub-catchment

A high proportion of Land Use Capability Classes 6 & 7 land in the Mangatawa sub-catchment is medium to high risk erosion-prone land due to pastoral land use. Forestry located on these classes of land has a medium to high risk of erosion during the post-harvest phase.

Land Use	Risk	percent
Pasture	Medium	7
Pasture	High	3
Exotic forest	Medium	3
Exotic forest	High	7

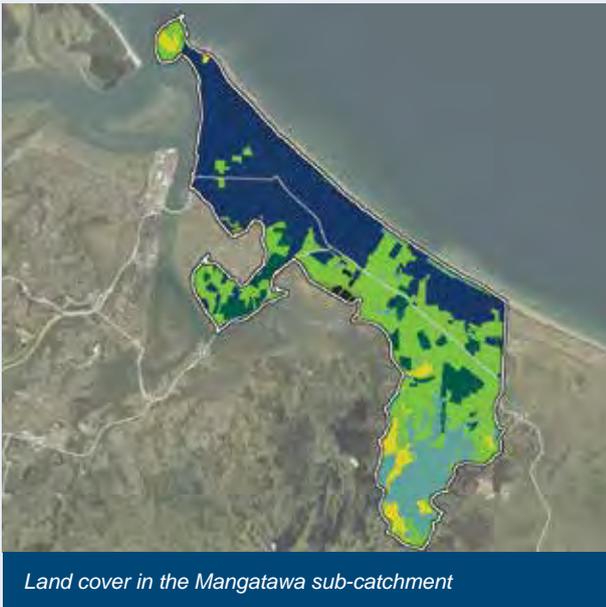
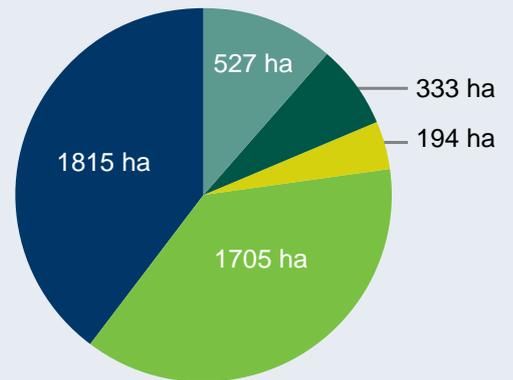
Land cover in the Mangatawa sub-catchment

Vegetation	Percent
Exotic	11
Horticulture	7
Indigenous	4
Pasture	36
Urban	39

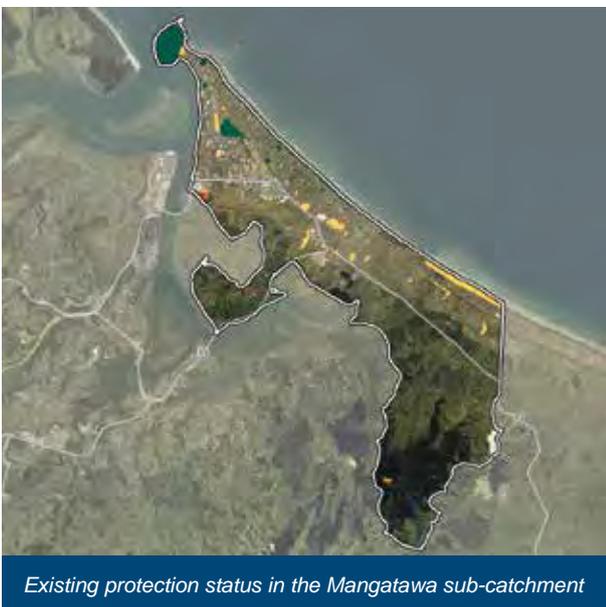
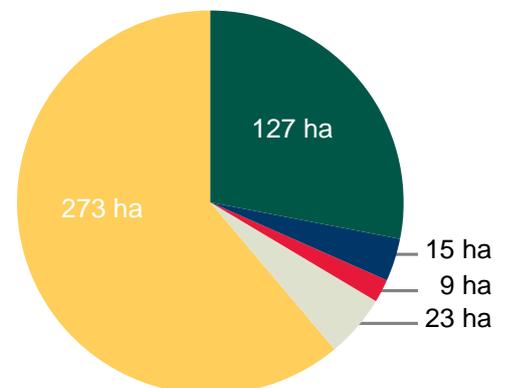
Existing protection status in the Mangatawa sub-catchment

Class	Percent
DOC	3
BOPRC Covenant	0.3
Māori	0.2
Regional Park	1
District Reserve	6
