Oturu

Sub-Catchment Action Plan 2012

The Oturu Sub-Catchment Action Plan is one of a series about the sub-catchments surrounding Tauranga Harbour. This action plan provides an analysis of the current land management issues, a summary of the available physical resources in the Oturu sub-catchment, and planned action for land and resource use in the sub-catchment.

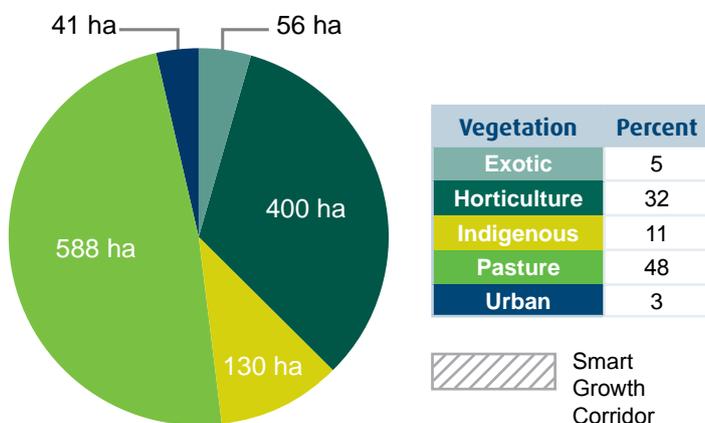
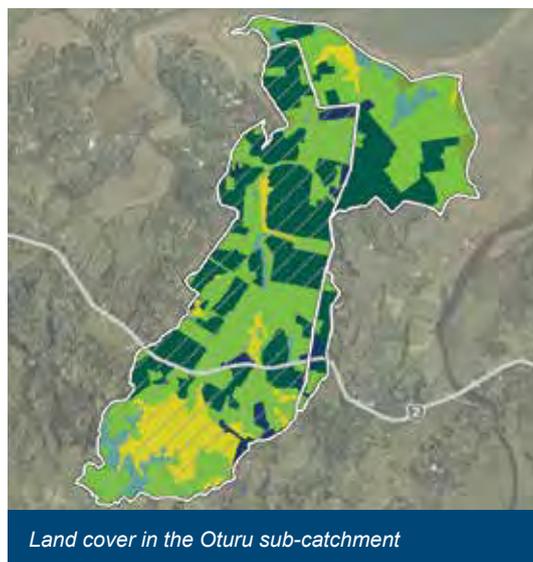
Land cover in the Oturu sub-catchment

The most widely spread class of vegetation cover in the sub-catchment is pastoral vegetation at 47 percent. Indigenous land cover (bush) is largely confined to the upper slopes of the Minden Hill, (10 percent). Horticultural land covers 33 percent and is in the middle and lower sub-catchment. Exotic forestry is located in the upper sub-catchment (five percent) Moderately large areas of estuarine wetlands surround the Waikaraka estuary.

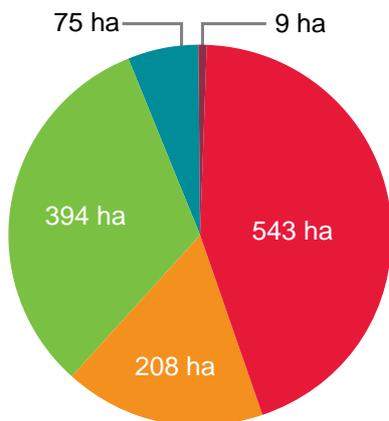
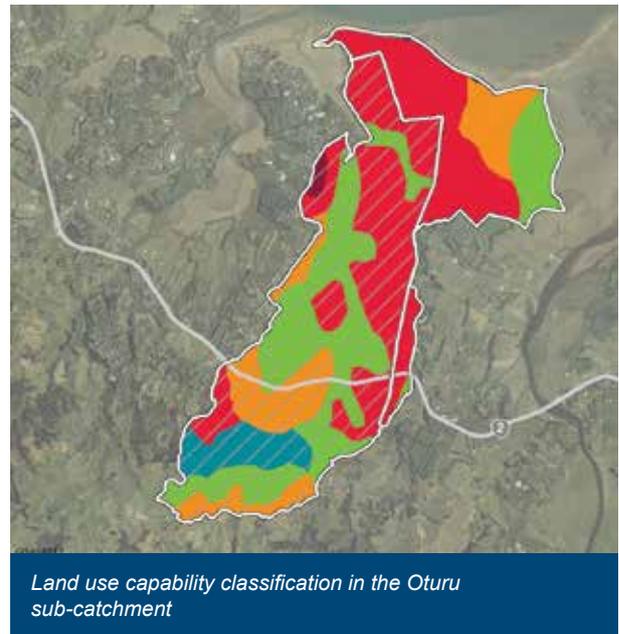
Land use capability classification in the Oturu sub-catchment

The majority of land in this sub-catchment is highly productive Land Use Capability (LUC) Class 3 and 4 – gently rolling to rolling landscapes. Both LUC Class 6 and 7 lands are found on the erosion prone slopes of Minden Hill or adjacent to the Wairoa where the ground is frequently saturated.

LUC Class	LUC Units	Percent
2	2e 1	1
3	3e 1	44
4	4e 1, 4w 1	17
6	6e 1, 6e 2, 6w 1	32
7	7e 4	6

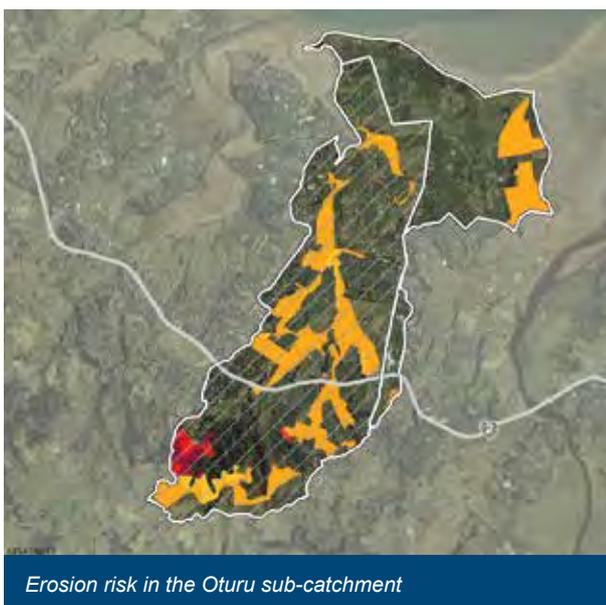
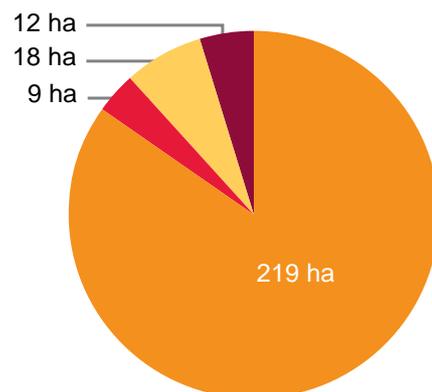
Erosion risk in the Oturu sub-catchment

A high proportion of Land Use Capability Class 6 land in the Oturu sub-catchment has a medium risk of erosion due to pastoral land use. Forestry located on Class 6 and 7 lands has a medium to high risk of erosion during the post-harvest phase.

Land Use	Risk	Percent
Pasture	Medium	18
Pasture	High	1
Exotic forest	Medium	1
Exotic forest	High	1

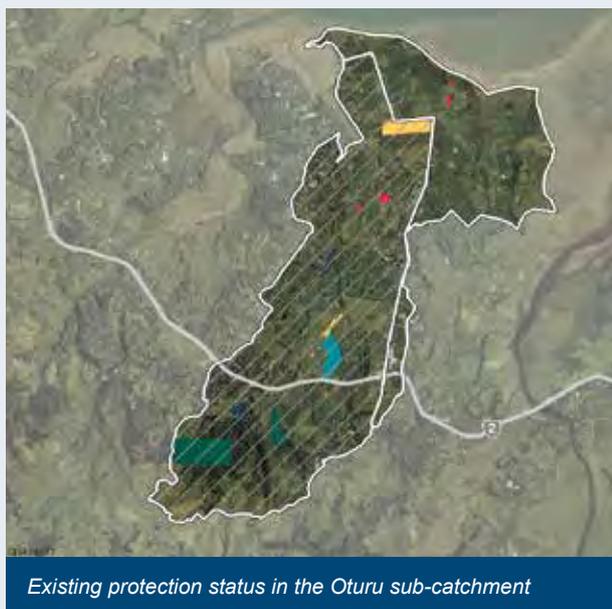
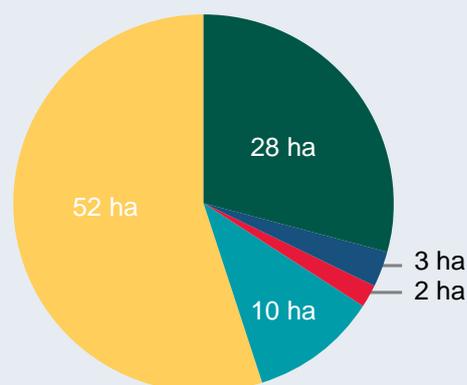
Existing protection status in the Oturu sub-catchment

Class	Percent
DOC Reserve	2
BOPRC Covenant	0.2
Māori	0.2
QEII	1
District Reserve	4

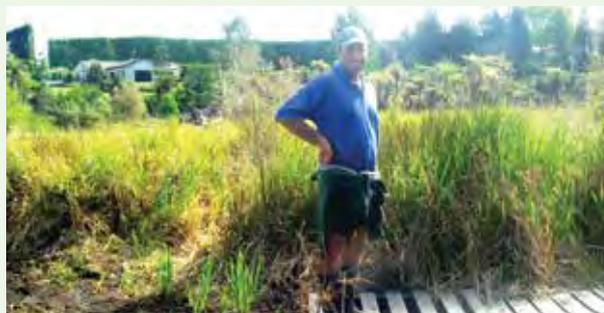
Graham Hill in front of a section of wetland dominated by Reed Sweet Grass

In 2009, landowners Graham and Pin Hill approached the council for advice and funding assistance with restoring a highly degraded wetland at the rear of their property in Te Puna. The Oturu Creek flows through the property and enters the Tauranga Harbour at Waikaraka Estuary. Pest plants such as grey willow and green goddess lily needed to be removed and native plants within the wetland were being smothered out by reed sweet grass.

Council staff worked with Graham and Pin to draw up a five year management plan which aimed to return suitable native plant species to the wetland. Funding provided under the plan allowed the them to start removing the pest plants and to source 1,750 native plants from a local nursery and to grow them on until planting time the following year. The pest plant control and planting regime is now being repeated in the remaining half of the wetland.
