# Te Rereatukahia

## Sub-Catchment Action Plan 2012

The Te Rereatukahia Sub-Catchment Action Plan is one of a series about the sub-catchments surrounding Tauranga Harbour. This action plan provides an analysis of the current land management issues, a summary of the available physical resources in the Te Rereatukahia sub-catchment, and planned action for land and resource use in the sub-catchment.

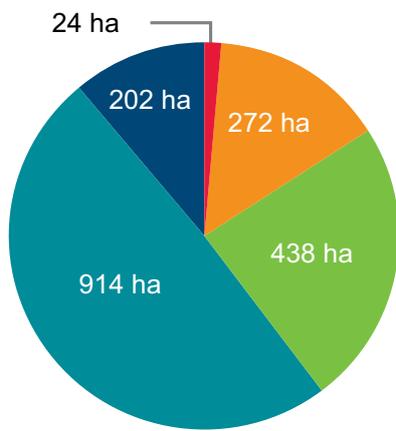
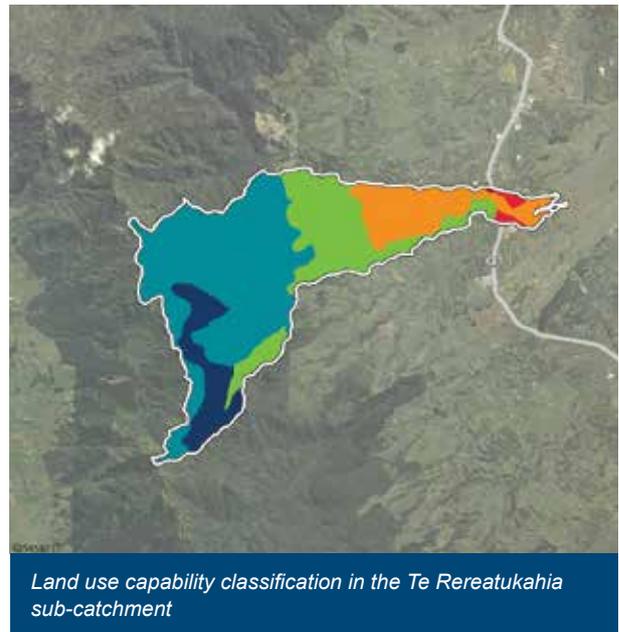
## Land use capability classification in the Te Rereatukahia sub-catchment

The majority of land in this catchment is classified as moderate to highly erodible Land Use Capability (LUC) Class 6, 7 and 8 lands – strongly rolling, steep and very steep landscapes. The remaining land is highly productive (LUC) Class 3 and 4 lands – undulating to rolling landscapes – that is found throughout the lower sub-catchment.

LUC Class	LUC Units	Percent
3	3e 1	1
4	4w 1	15
6	6e 1, 6e 2, 6e 2+8e 2	24
7	7e 8	49
8	8e 4	11

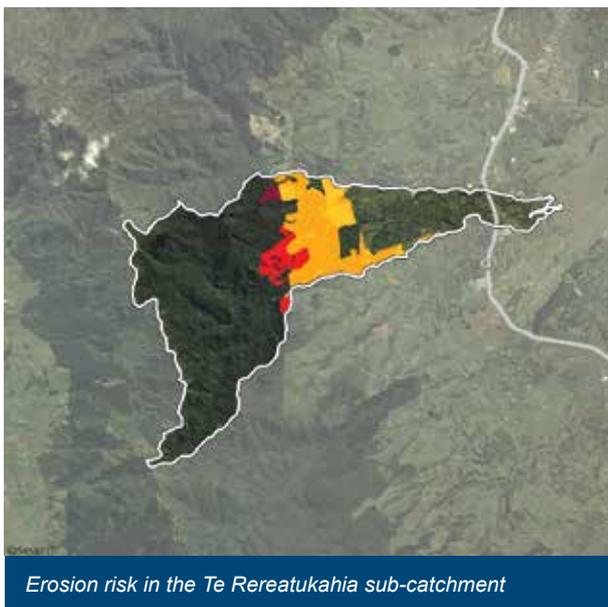
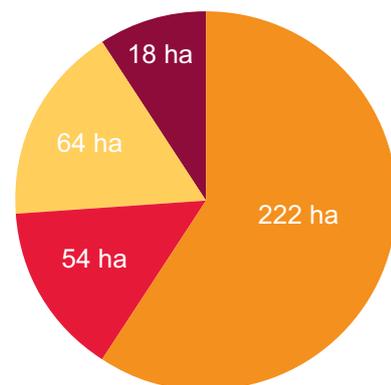
## Erosion risk in the Te Rereatukahia sub-catchment

A high proportion of Land Use Capability Class 6 land in the Te Rereatukahia sub-catchment is has a medium risk of erosion due to pastoral land use.

Land Use	Risk	Percent
Pasture	Medium	12
Pasture	High	3
Exotic forest	Medium	3
Exotic forest	High	1

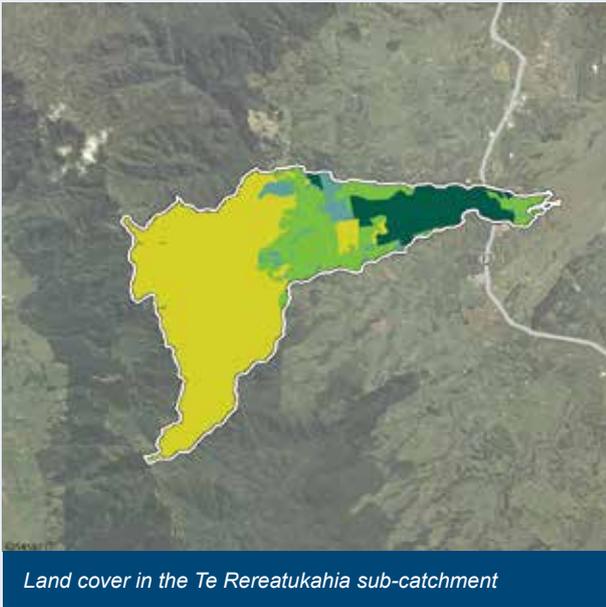
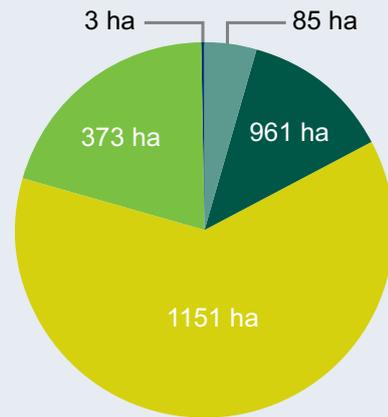
## Land cover in the Te Rereatukahia sub-catchment

Vegetation	Percent
Exotic	5
Horticulture	13
Indigenous	62
Pasture	20
Urban	0.1

The most widely spread class of vegetation cover in the sub-catchment is indigenous vegetation at 62 percent of total area. There are large tracts of pasture land cover in the middle sub-catchment (20 percent), and horticultural land cover (13 percent) is restricted to the mid-lower sub-catchment. Exotic forest is found in the mid sub-catchment (five percent).

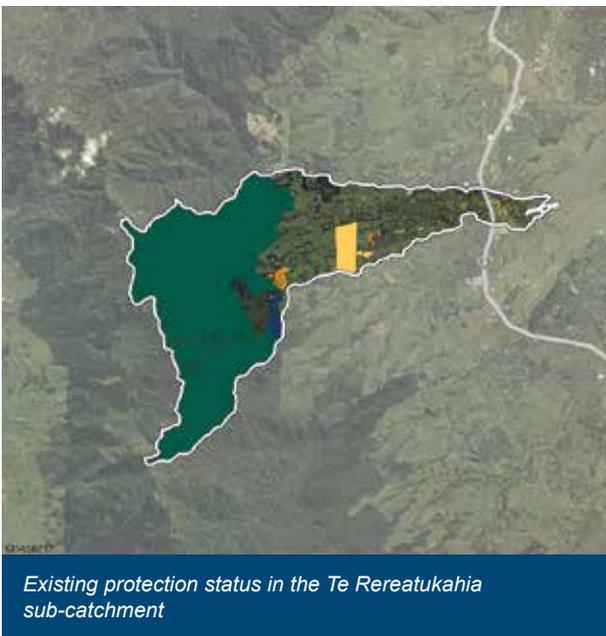
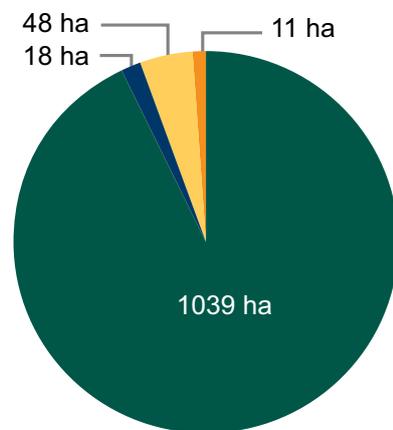
## Existing protection status in the Te Rereatukahia sub-catchment

Class	Percent
DOC	56
BOPRC Covenant	1
District Reserve	3
WBOPDC Covenant	1

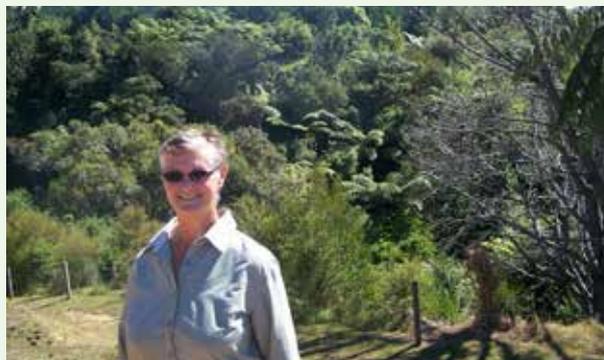
Helen Brownlie in front of her retired stream gully.

"Down the back of the property I saw the need to fence off the stream and the small bit of bush on the steep slope. I get satisfaction from seeing the bush recovering and I've also now planted out the margins. I haven't retired the whole area though; I have a small woodlot of eucalypts and kanuka that I use for firewood."
