Waitekohe

Sub-Catchment Action Plan 2012

The Waitekohe Sub-Catchment Action Plan is one of a series about the sub-catchments surrounding Tauranga Harbour. This action plan provides an analysis of the current land management issues, a summary of the available physical resources in the Waitekohe sub-catchment, and planned action for land and resource use of the sub-catchment.

Published September 2012

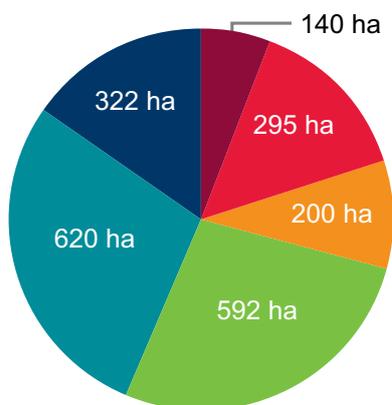
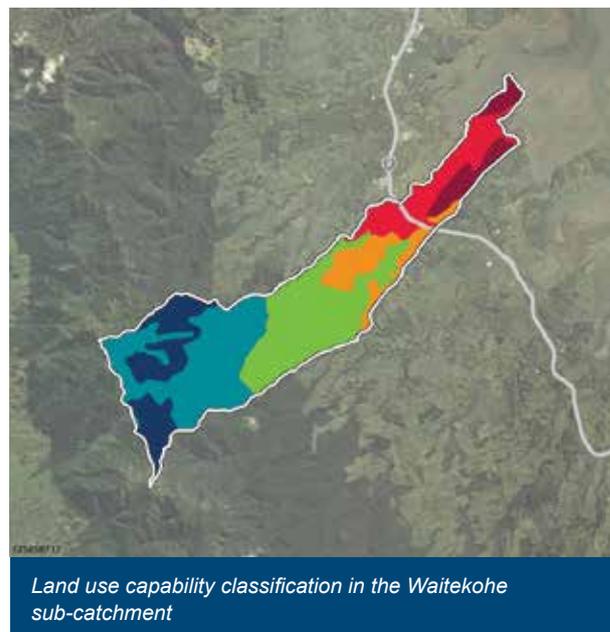
Land use capability classification in the Waitekohe sub-catchment

The majority of land in this sub-catchment is Land Use Capability (LUC) Class 6 and 7 - rolling, steep and very steep landscapes respectively. Both LUC Class 6 and 7 lands are located in the middle and upper catchment. Highly productive LUC Class 2, 3 and 4 land - gentle to rolling lands - are primarily restricted to the lower catchment.

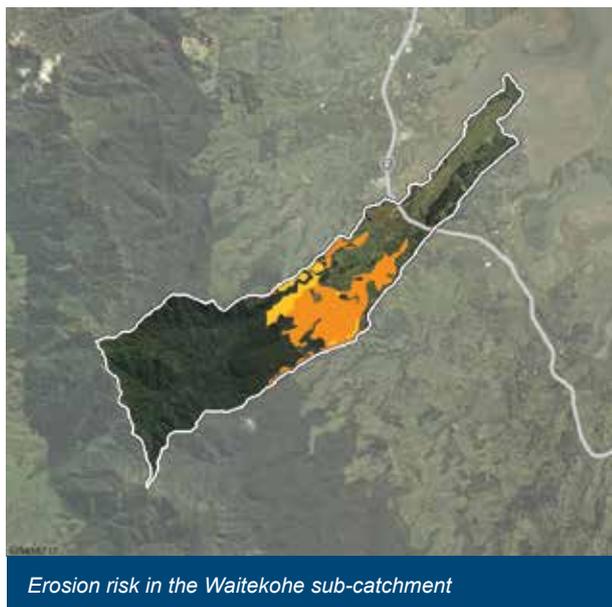
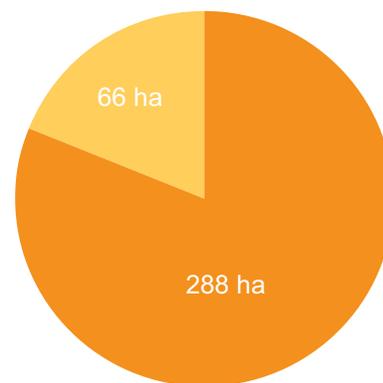
Erosion risk in the Waitekohe sub-catchment

A high proportion of Land Use Capability Classes 6 & 7 land in the Waitekohe sub-catchment is medium to high risk erosion-prone land due to pastoral land use. Forestry located on this class of land has a medium risk of erosion during the post-harvest phase.

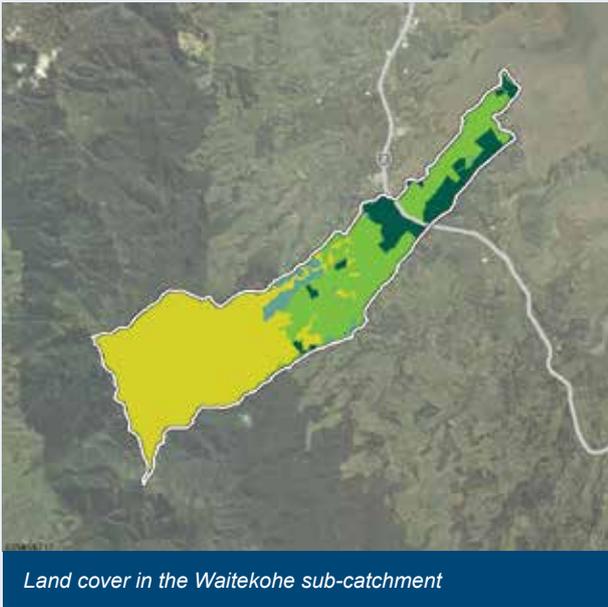
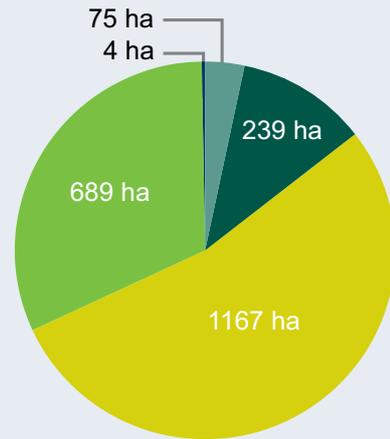
Land cover in the Waitekohe sub-catchment

A large proportion of the sub-catchment vegetation land cover is pastoral. The majority of this land cover is found in the middle and lower sub-catchment of the Waitekohe. A smaller but significant proportion of the sub-catchments' land cover is horticultural and found primarily in the lower catchment.

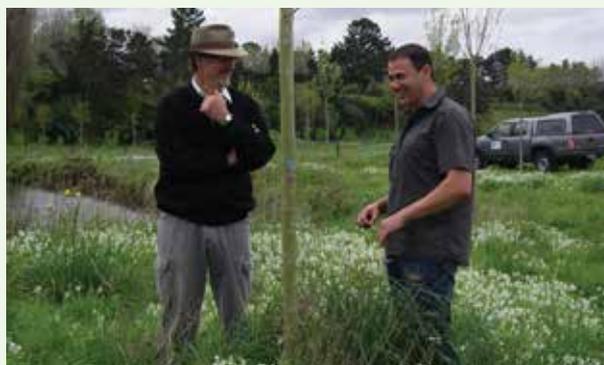
Grant Donald (left) discusses the challenges of planting willow trees in gravel soils with Regional Council staff.

Willow species have been established throughout the riparian margin on Grants property and continue

downstream into their neighbours' property. Stabilising the stream with this fast growing tree species allows for gradual under-planting with native grasses such as flax.
