Lake Okareka Hornwort Management Plan 2013

Bay of Plenty Regional Council
Operations Publication 2015/03

July 2015

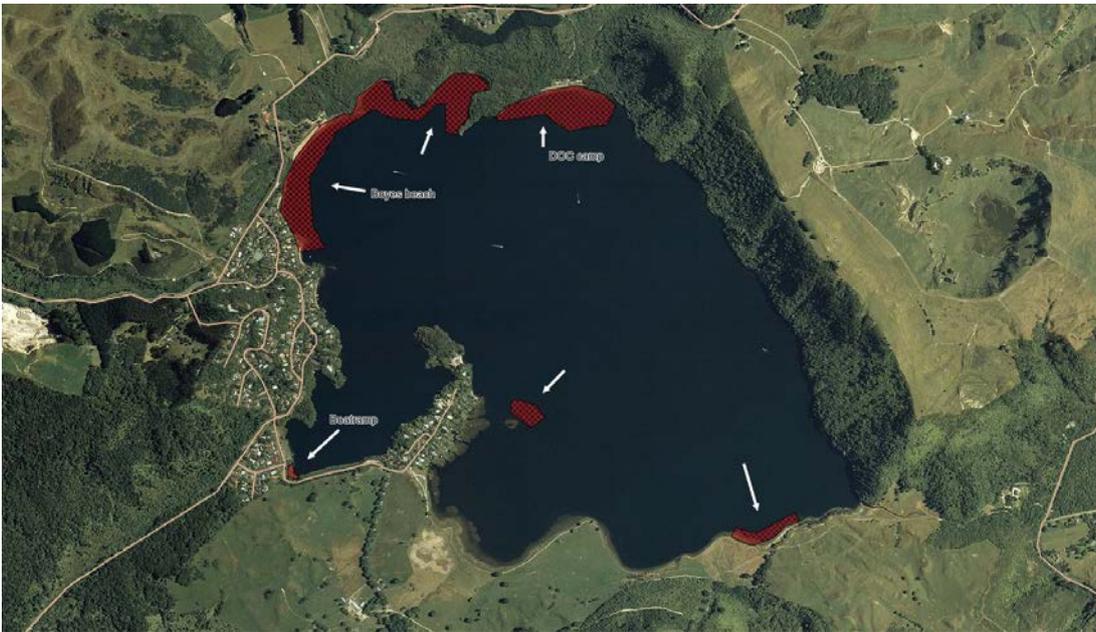
Results of the surveillance revealed two additional hornwort infestation areas to those detected in 2012 (Figure 1).

The majority of the new infestations occupied the northern end of the lake and ranged from scattered plants (5-10 m²) to established beds approximately 50 m² in size, plants were found in depths ranging from two to eight metres. The entire Boyes Beach area has been classed as one site as it contained scattered plants, some up to 50 m² in size.

Two plants were found at the southern reach of the lake; one small plant at the outlet that connects to Lake Tarawera, and one small plant within the bay to the eastern side of Acacia Road Point. Plants here were found in depths ranging from four to eight metres.

Figure 1 Lake Ōkāreka with areas marked where hornwort was located during the 2012 and 2013 surveillance period

The current delimited estimation of hornwort presence within Lake Ōkāreka is 17.5 ha. Broken down, this equates to:

- Boyes Beach - 9 ha, medium density.
- Department of Conservation campsite - 4 ha, medium density.
- Combined remaining sites – 4.5 ha, low density.

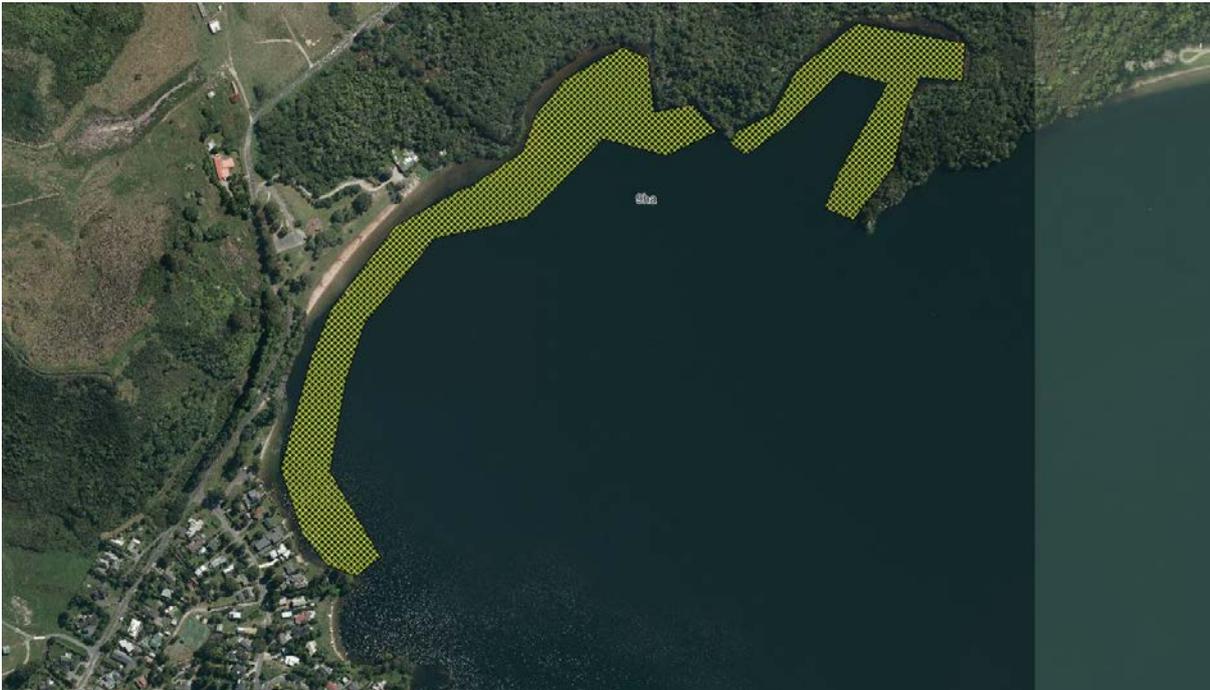
Boyes Beach –proposed area for spraying (9 ha)

Site	Method	Area (ha)	Dollars
Boyes Beach	Boat and boom	9	\$12,600
DOC campsite	Boat and boom	4	\$5,600
Southern Outlet	Boat and boom	2.5	\$3,500
Acacia Point Bay	Boat and boom	1.5	\$2,100
Acacia Bay boat ramp	Boat and boom	0.5	\$700
TOTAL		17.5	\$24,250

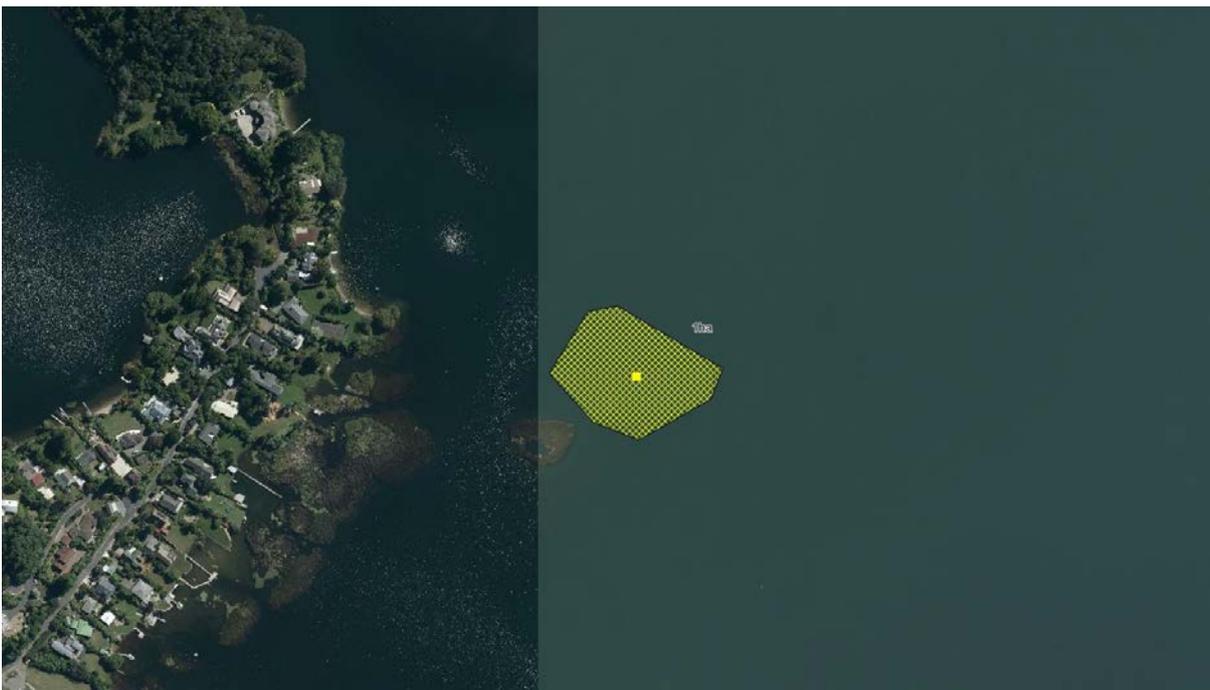
Bay east of Acacia Point Road – proposed area for spraying (1.5 ha)

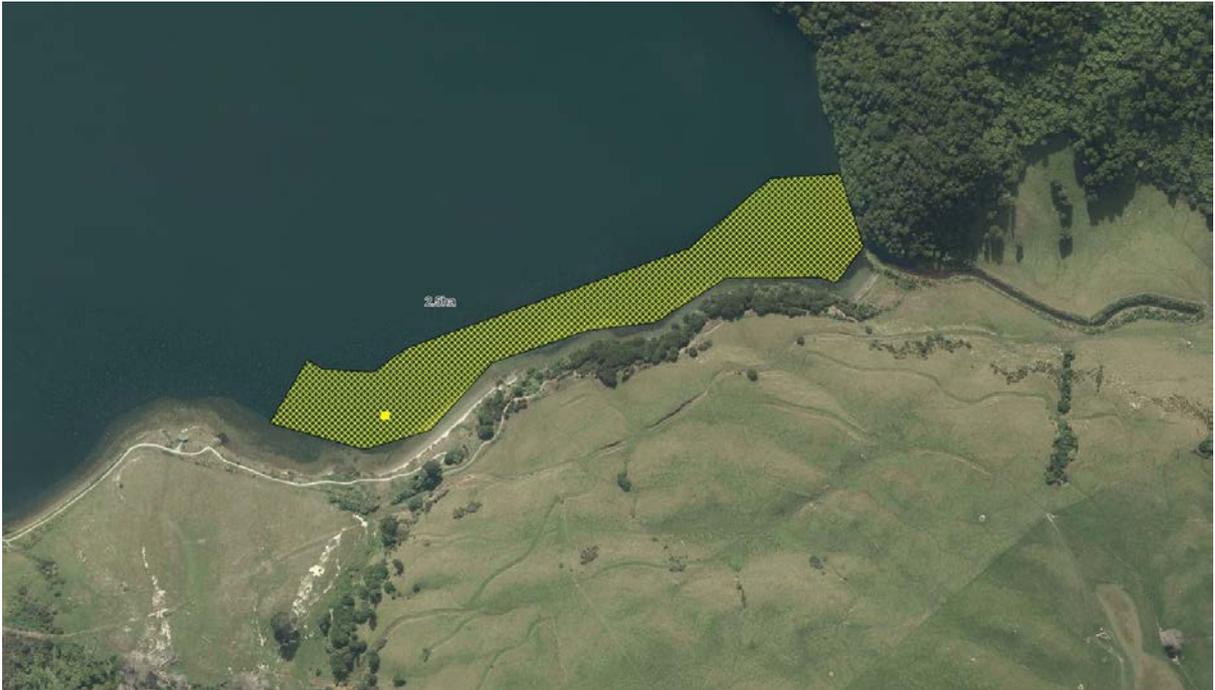
Southern Outlet – proposed area for spraying (2.5 ha)

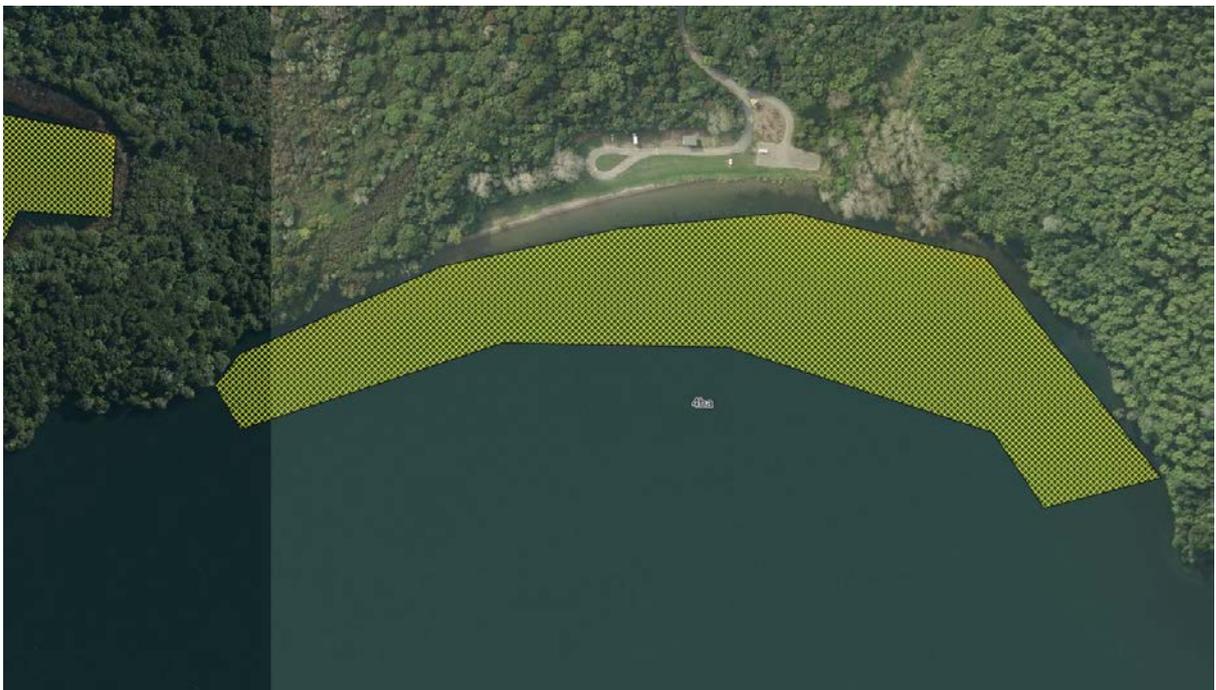
Department of Conservation Campsite – proposed area for spraying (4 ha)

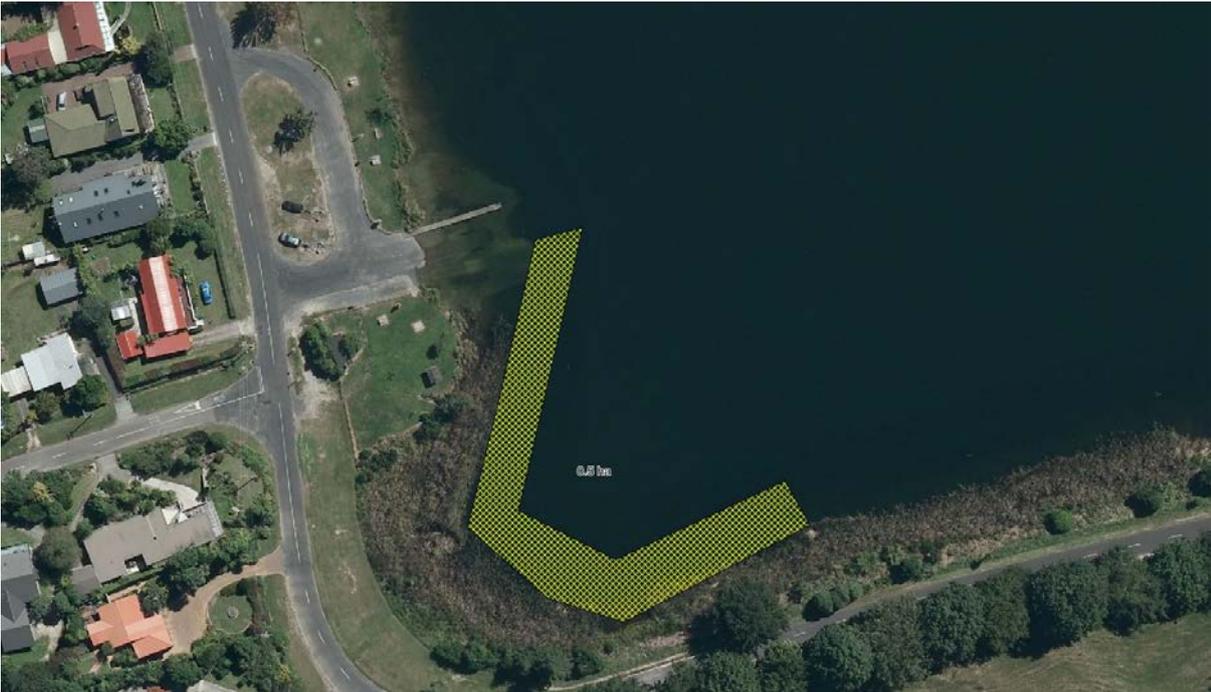
Weed Cordon and boat ramp (0.5 ha) – proposed area for spraying
