What has been happening?

Bay of Plenty Regional Council established a coastal beach monitoring programme in 1990 and profiles 53 sites annually. The shape of the beach is measured and the position of key features such as the frontal dune documented. The volume of sand on the beach is also calculated. This monitoring covers 135km of sandy coastline. No changes in trend have been calculated since last year's report.

Waitahanui Stream position over time

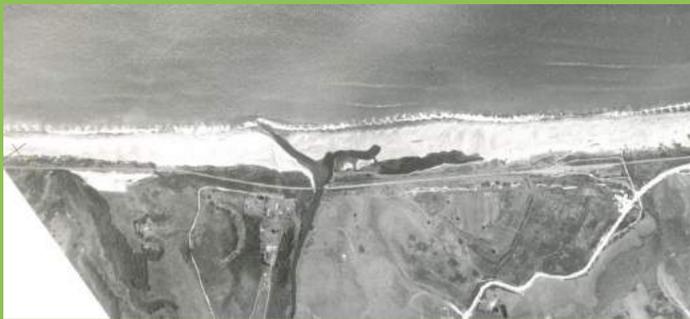
March 1943: Earliest photography showing confinement structure on right.

The migration of this stream can cause localised erosion and reduced drainage ability in the lower parts of the catchment.

The aerial photography record documents the extent of this migration and is a useful resource when discussing management options with interested parties.

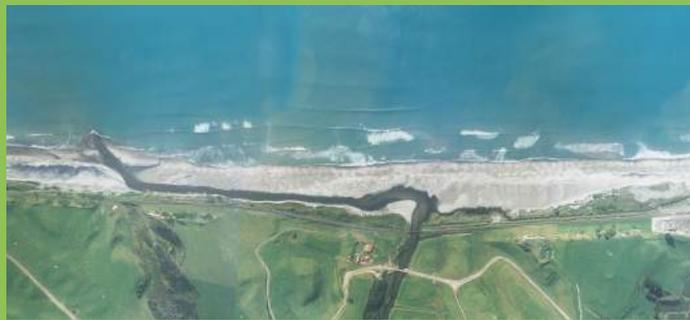
May 2000: Strong westward migration of approximately 900m.

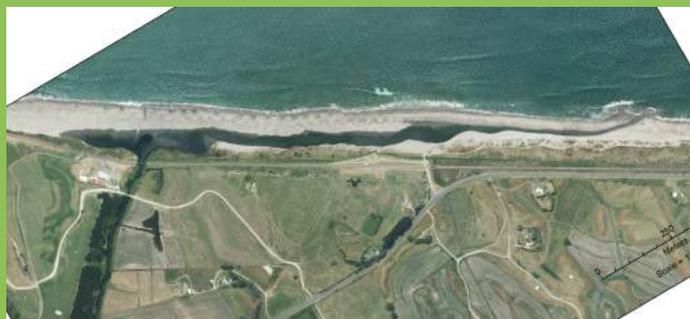
January 2015: Strong westward migration of approximately 1400m.
