MEMORANDUM

FROM: JIM DAHM, ECO NOMOS LTD

SUBJECT: KAITUNA RIVER RE-DIVERSION AND ONGATORO/MAKETU ESTUARY
ENHANCEMENT PROJECT: EFFECTS ON COASTAL AND RIVERBANK EROSION
AND MORPHOLOGY

DATE: 11 JUNE 2014

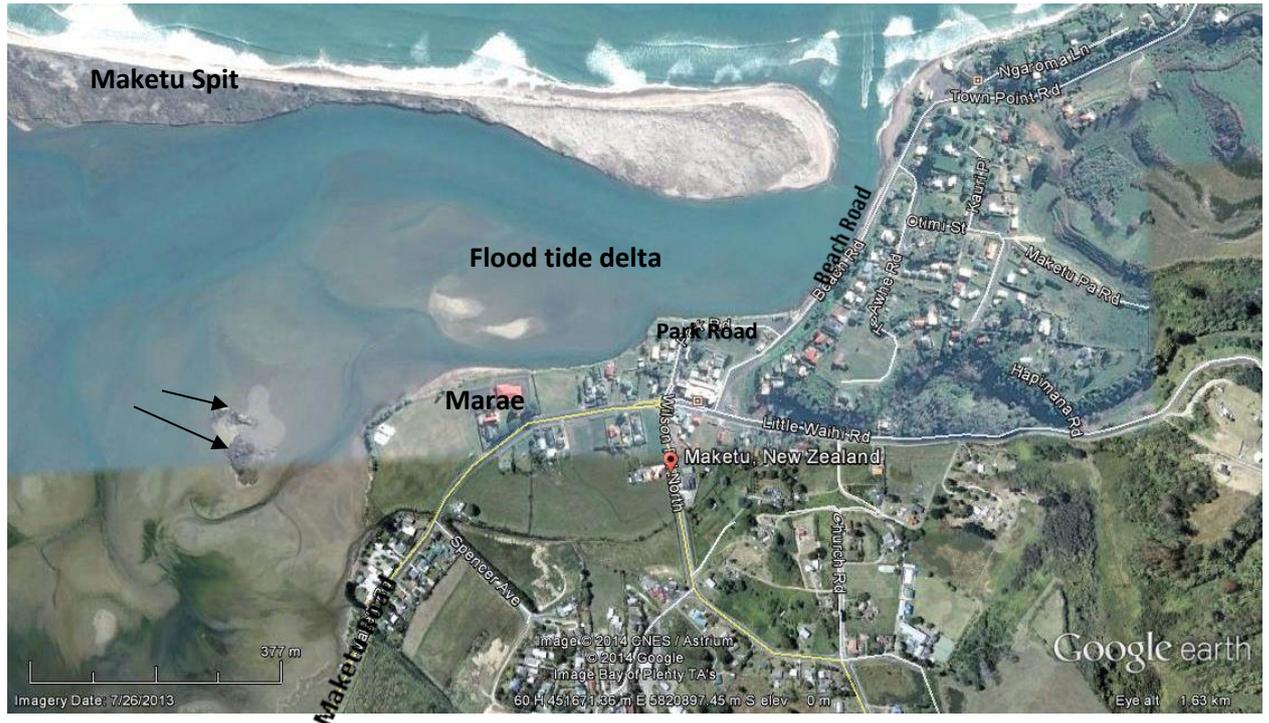
The foreshore of the lower estuary encompasses the shoreline around the landward edge of the extended flood tide delta system – including Beach Road, township foreshore, Maketu Road and the spit from the Maketu entrance to about 1.5 km further north (Figure 1).

Figure 1: Lower area of Ongatoro/Maketu Estuary showing harbour and shoreline areas. The harbour shorelines discussed in Section 1 include the entire shoreline from the entrance to Maketu Road and the landward margin of Maketu Spit. The chenier island features referred to in Section 1.6 are arrowed. (Photo Source: Google Earth imagery – flown 26 July 2013).

A further period of flood tide delta expansion is presently occurring, causing severe erosion and narrowing of the spit in the area approximately 600-800 m from the entrance (Figure 1). This may lead to further breaching of the spit in the next few years. Any breaching is most likely to occur during a severe storm event with elevated sea levels and storm-wave overtopping.

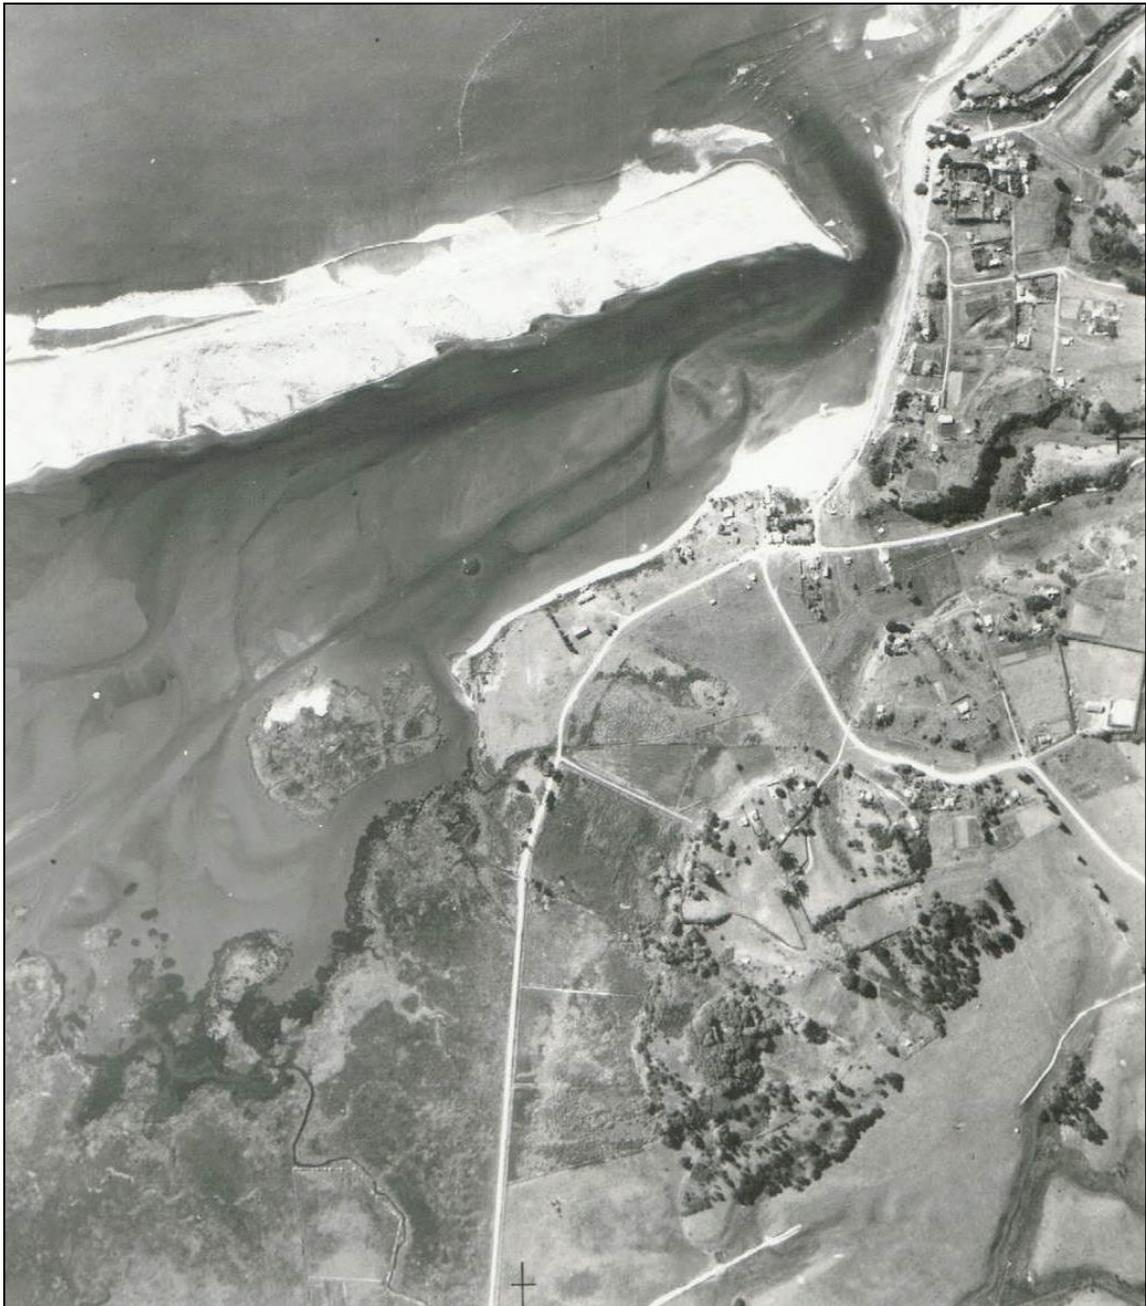
Prior to diversion, most of the estuary tidal prism was infilled by river flows which also augmented ebb discharges on outgoing tides. At this time, the flood tide delta was a relatively minor feature (Figure 2).

Figure 2: Vertical aerial photograph from April 1939, prior to diversion of river from the estuary (see text for discussion).

Examination of historic vertical and oblique aerial photography dating from 1939-1955 indicates that prior to the diversion the spit in this area was consistently wide, with no sign of any severe erosion along the landward margin despite the full river flow through the estuary (e.g. Figure 2).

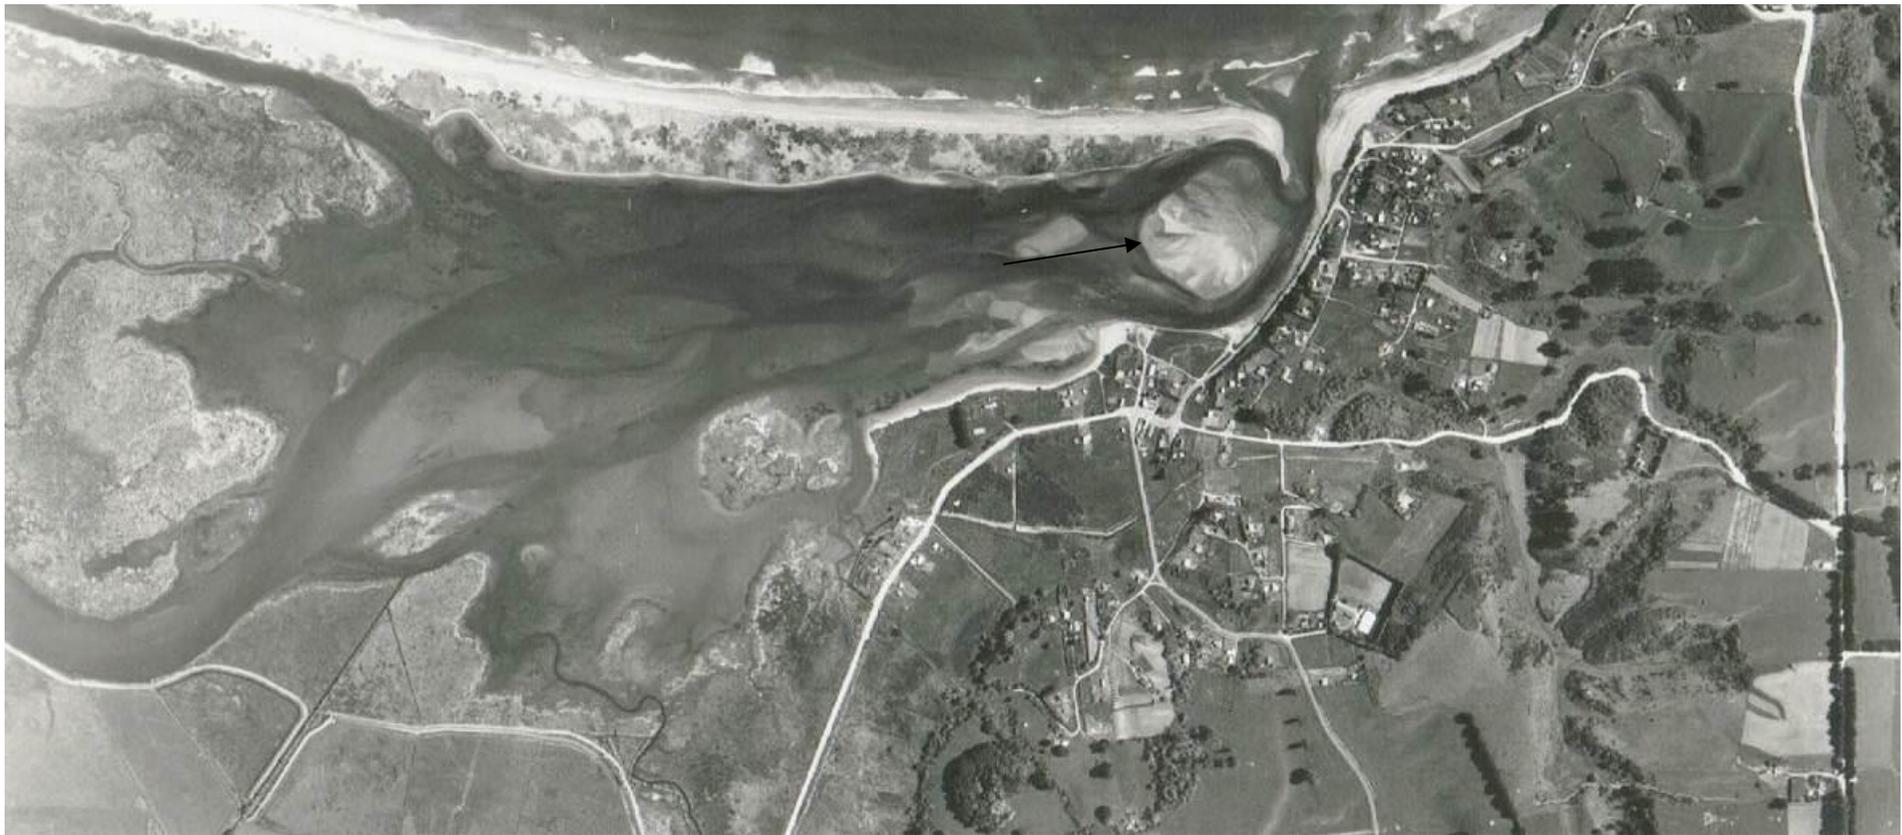
Following the diversion of the river through Te Tumu Cut, flood tide inflows markedly increased to compensate for the loss of river flows; significantly changing the balance between inflows and outflows and causing significant expansion of the flood tide delta (Figure 3).

Figure 3: Aerial photograph of estuary dating from November 1959, shortly after diversion showing the enlarged flood tide delta (arrowed). See text for further discussion

Following diversion, the increased flood tide inflows formed a channel along the foreshore and this channel also moved landward as the flood tide delta expanded (Figure 3). This resulted in rapid erosion of the foreshore in the years immediately following the 1956 diversion at Te Tumu. This erosion, caused by the effects of the diversion, eventually led to rock protection being placed to protect the eroding foreshore and township – rock protection being evident in aerial photos dating from at least 1963. The erosion and the placement of the rock protection resulted in loss of the beach along the foreshore.

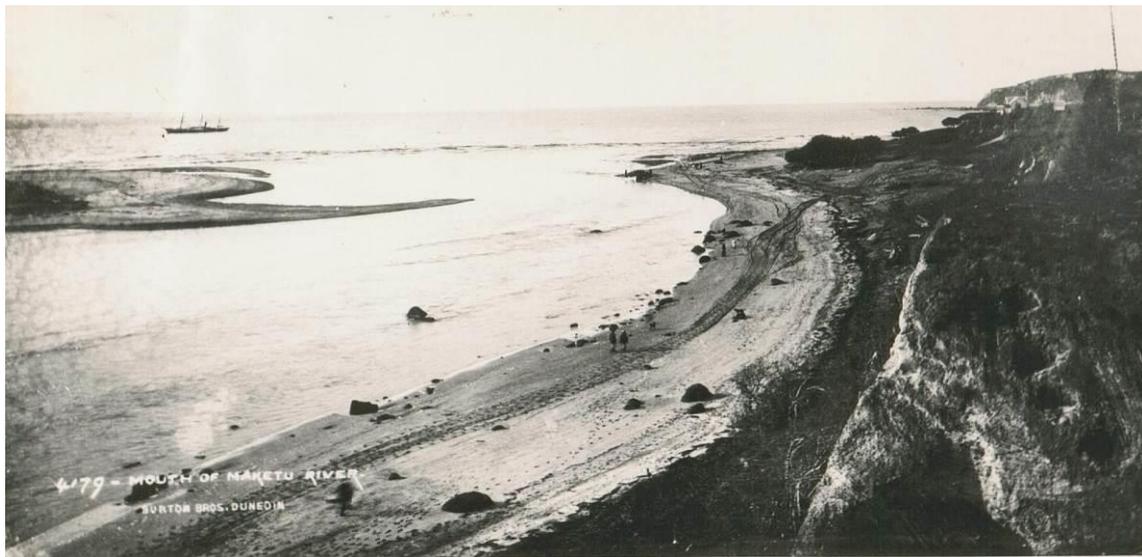
In its original natural condition before road construction, a narrow estuarine beach occurred along this area (Figure 4). This beach overlies a shore platform formed by historic erosion of the higher banks to landward; the original cliff faces now vegetated. As the beach formed, it protected the cliffs from further erosion. Rock outcrops sacred to local iwi outcrop in the channel along the seaward edge of the beach.

Figure 4: View of Beach Road and lower estuary in 1880's.

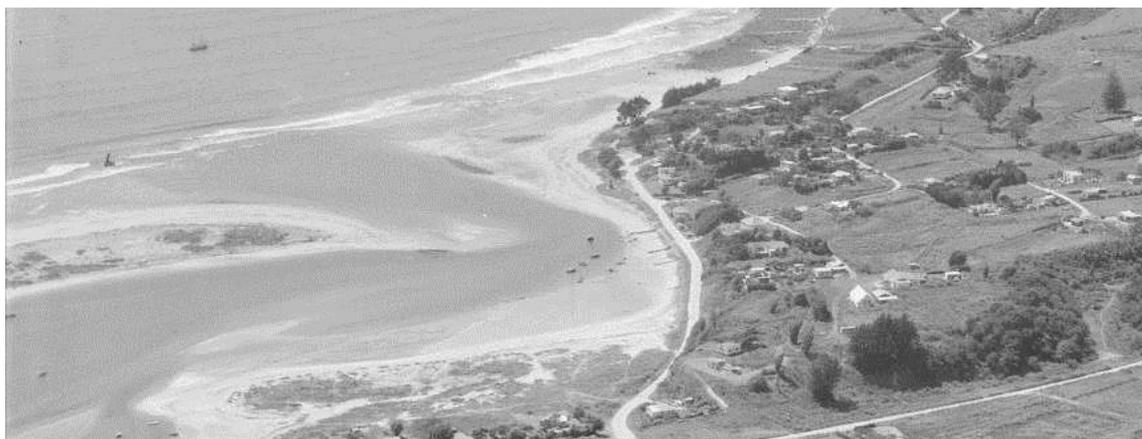
The formation of the original road encroached over much of the beach area above high tide within the estuary, except at the township and seaward ends. Accordingly, the road was subject to periodic erosion even prior to diversion of the river in the late 1950's – as evidenced by shore perpendicular groynes placed to protect the road shown in historic photos (Figure 5).

Figure 5: View of lower estuary in 1955 (Whites Aviation photo, Alexander Turnbull Library).

However, prior to diversion of the river in the 1950's, the channel adjacent to the beach extended only along the outer and central areas of Beach Road - being fronted by shallow intertidal areas at the township end (Figure 5). Following the diversion, the channel extended further landward and around the front of the township due to the increased flood tide inflows (Figure 3). The enlargement of the flood tide delta also tended to push this channel towards adjacent shorelines (Figure 3). These changes in wave and tidal forces on the shoreline aggravated erosion and contributed to the need for early rock sea wall protection evident by the late 1960's.

Prior to the diversion of the river from the estuary in the late 1950's, the main township foreshore was fronted by a wide sandy beach and shallow intertidal areas (Figure 5). The wide sandy beach underwent minor dynamic shoreline changes over time but is evident in all available aerial photos prior to the diversion (including vertical and oblique aerial photos dating from 1939, 1948, 1953 and 1955).

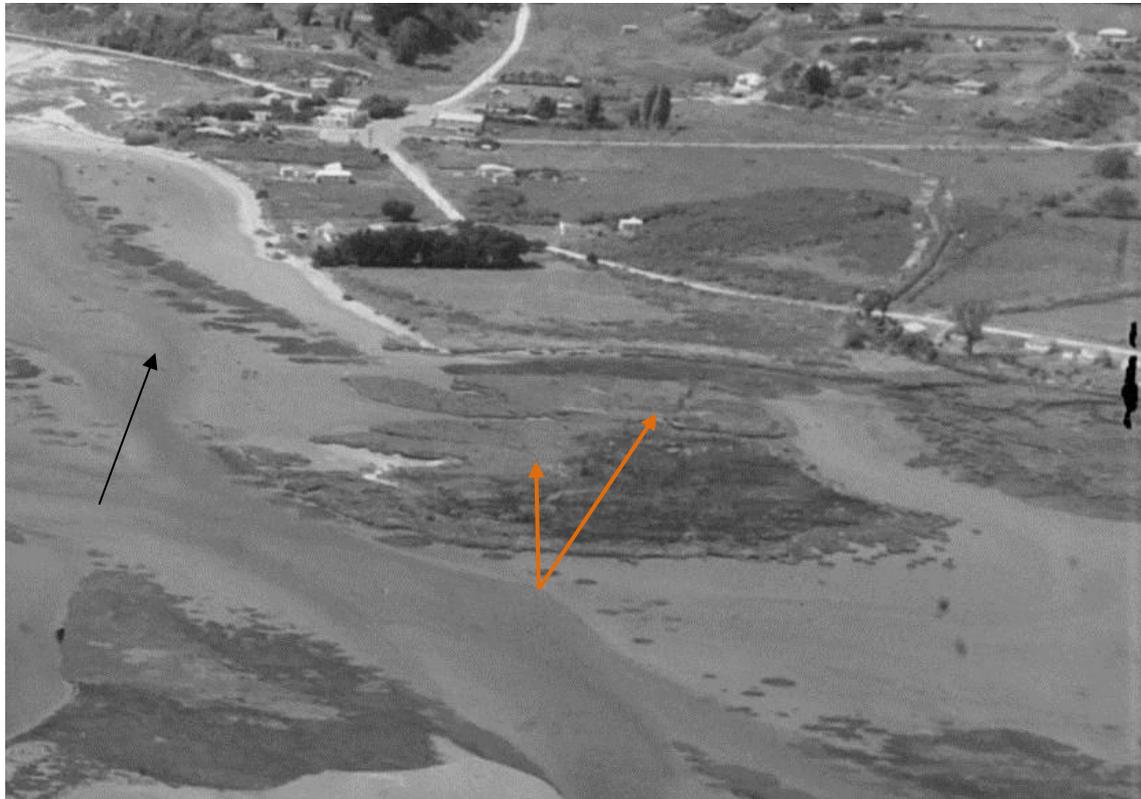
Prior to the diversion of the river from the estuary, this shoreline was characterised by a sandy beach fronted by a shallow intertidal flat, with shallow low tide channels located further offshore (see black arrow in Figure 7). This morphology is consistent in all aerial photos pre-dating diversion of the river (e.g. Figure 2).

Figure 7: View of marae and southern township foreshore in 1955 (Whites Aviation photo, Alexander Turnbull Library). See text for discussion of arrows.

Prior to the diversion, this area of shoreline was extensively protected by large areas of rushland located immediately offshore (see Figure 2 and orange arrows in Figure 7). Little to no loss of this rushland is evident in aerial photographs pre-dating the 1956 diversion (Park, 2014).

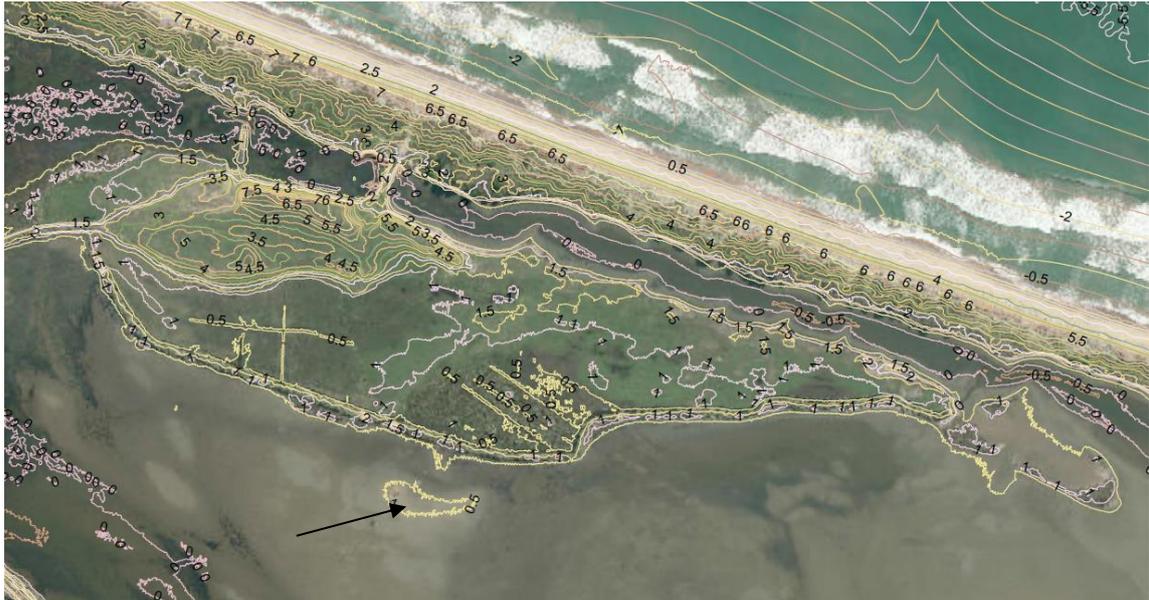
Field observations and LiDAR data (Figure 13) indicate that Papahikahawai Island can be broadly subdivided into two geomorphic units:

Figure 13: LiDAR survey data for Papahikahawai Island and adjacent areas (The arrow points to a small remnant patch of rushland (largely oioi) discussed in the text).

There is also evidence that bed level lowering causing erosional retreat of the rushland was a factor in some areas. In particular, a small isolated remnant of rushland (largely oioi) remains out in the estuary directly south of Papahikahawai Island (Figure 13 and Figure 17). The remnant has survived as sand levels around it are higher than the surrounding intertidal flats. However, even within the remnant high area the elevated sand levels are lower than the sediments in the rushland and the remnant is being gradually eroded (Figure 17).

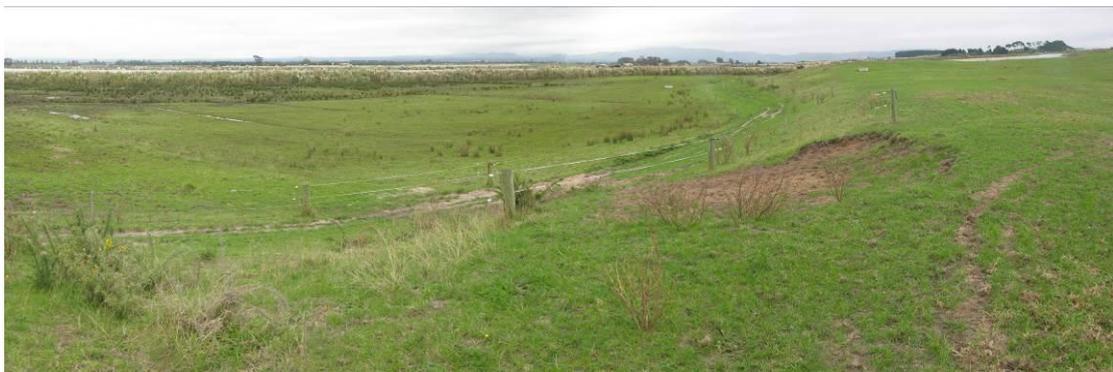
- **An area of elevated sand dunes** – occurring along the seaward side of the island (Figure 13 and Figure 14). The dunes extend along most of the seaward side of the island (separated from the spit by Papahikahawai Creek) but are most notable at the northern end where they commonly rise to elevations of 3-5 m above mean sea level, with maximum elevations up to about 7.5 m (Figure 13). In central and southern areas of the island, the dunes are much lower – with typical maximum heights of about 1.5 m above mean sea level.

- **A low-lying area of peaty soils and sands** along the landward half of the island (Figure 13 and Figure 14), where elevations are typically 0.5-1 m above mean sea level (Figure 13). This area is the modified (i.e. drained and grazed) remains of an extensive area of wetlands that occurred prior to diversion (Figure 15). A human-constructed sand bund (stopbank), vegetated largely (though not exclusively) in pampas, lies along the landward and estuary margin of the island, separating the low-lying area of the island from the estuary (Figure 16).

Figure 14: View of Papahikahawai Island looking north from near centre of the island – showing high dunes to seaward and the low lying land bordering the estuary.

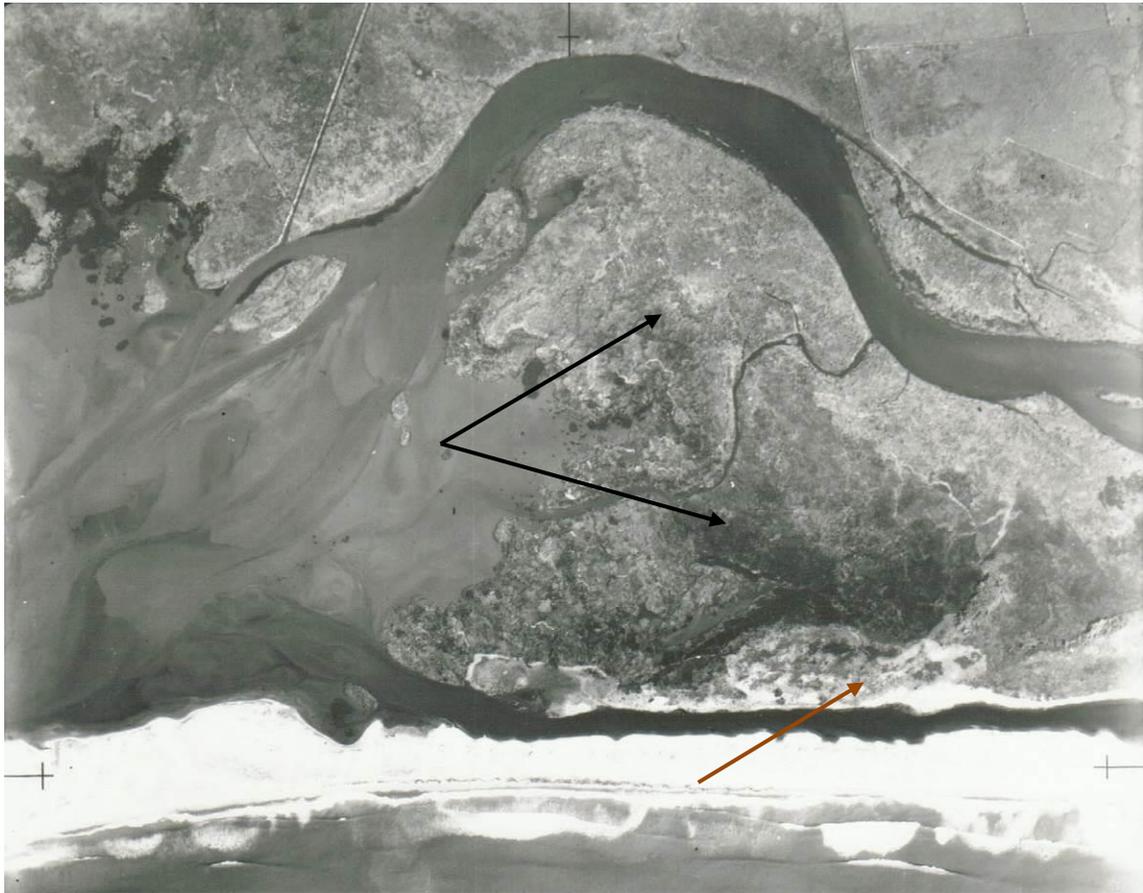
Figure 15: View of upper estuary in April 1939 prior to diversion of the Kaituna River from the estuary - showing the sand dunes of Papahikahawai Island (orange arrow) and the large area of wetland vegetation on the estuary margin of the island (black arrows).

The low-lying areas of the island were originally part of the extensive rushland and other wetlands that occurred prior to the river diversion in 1956; extending from the sand dunes of Papahikahawai Island southwards to the main river channel (Figure 15). Following the diversion of the river in 1956, these large areas of vegetated wetlands were progressively lost (Park, 2014). This extensive loss of rushland is likely to have been caused by various mechanisms but increased salinity following diversion is believed to have been a major factor, causing die-off of freshwater and possibly other rushland and vegetation (Park, 2014). Once the plants died off, the peat soils would have been broken down not just by physical erosion but also by oxygenation, microbial actions and other physical and biological changes which sped up erosion (Stephen Park, pers. comm).
