# Effluent discharge receiving water impact report 2008

Prepared by Paul Scholes  
Environment Bay of Plenty  
Environmental Publication 2008/10

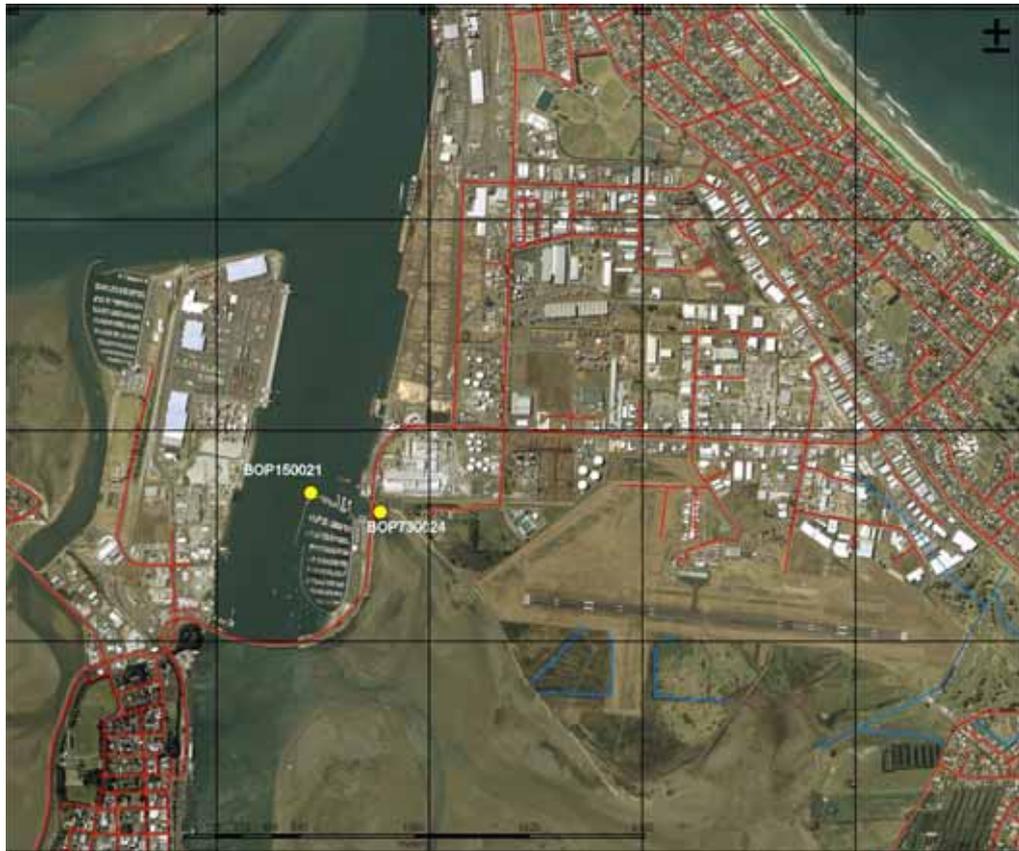
Figure 2.1.1 Site location photo, Tauranga Harbour.

Figure 2 compares results from two monitoring sites within the Port Tauranga vicinity (Figure 2.1.1). One site is located close to the central channel (BOP150021) and the other site at the Whanaroa Point boat ramp (BOP73024) in a channel that has been shown to contain preferential flow paths for stormwater outlets from around the east side of the Port (Bioreserches 2002). Sampling has occurred predominantly on an incoming tide.

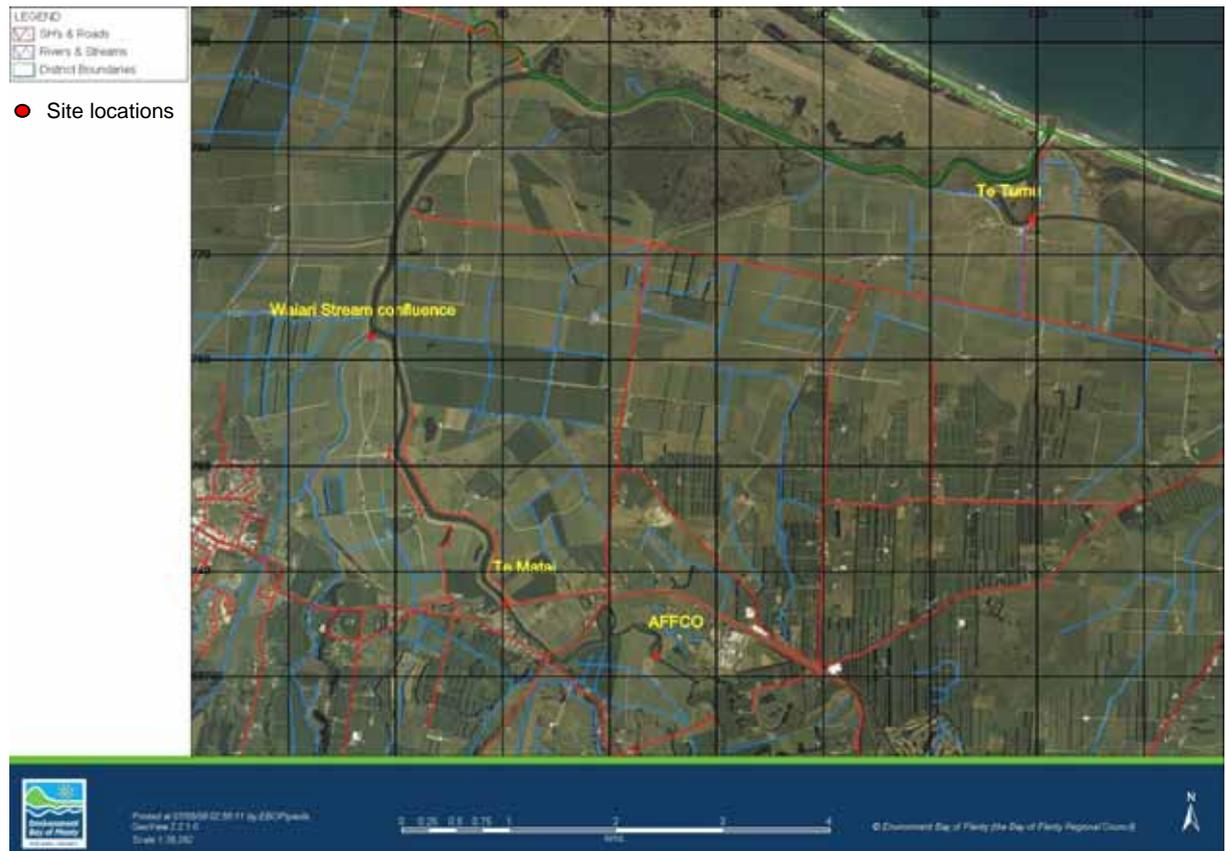
Figure 2.2.1 Site location map

The lower Kaituna River is sampled at three sites to monitor the impact of the effluent discharge from the freezing works of AFFCO New Zealand Limited near Te Puke and the discharge of treated sewage effluent from Te Puke township. There is a site just upstream of the AFFCO discharge, one site downstream at State Highway 2 and a site near the river mouth at Te Tumu. The sampling programme changed in 1996, when river mouth sampling was absorbed into Environment Bay of Plenty's estuarine sampling programme. Sampling at Te Tumu has been on a different day to the other two sites and the tidal effects at this site must also be taken into consideration in any data analysis. Site locations are shown in Figure 2.2.1.

The AFFCO New Zealand Limited Rangioru meat processing facility discharges its treated waste water to the Kaituna River above Te Matai (Figure 2.2.1). There is a daily limit on discharge volume of 6,500 m<sup>3</sup>/day, and a median volume of under 3,000 m<sup>3</sup>/day has been experienced in the last few years (Figure 2.2.2).
