**Community-based Dune Management for the Mitigation of Coastal Hazards and Climate Change Effects:**  
A Guide for Local Authorities

**April 2005**

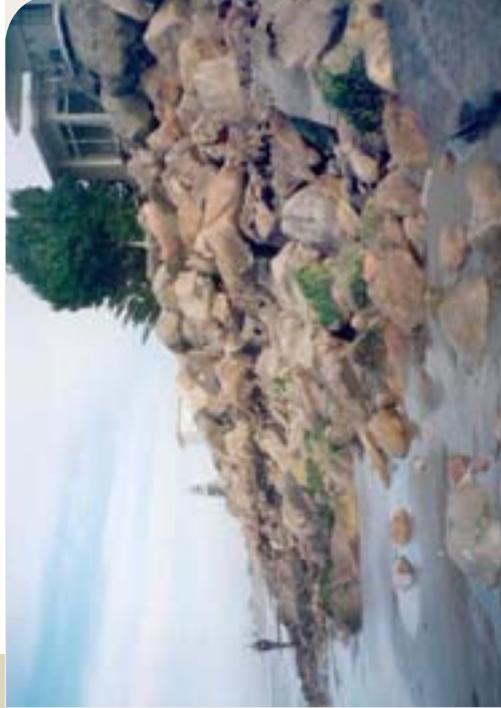
**Figure 1:**

Seawall at Waihi Beach. At higher stages of the tide, the sea is hard against this wall and there is no high tide beach.

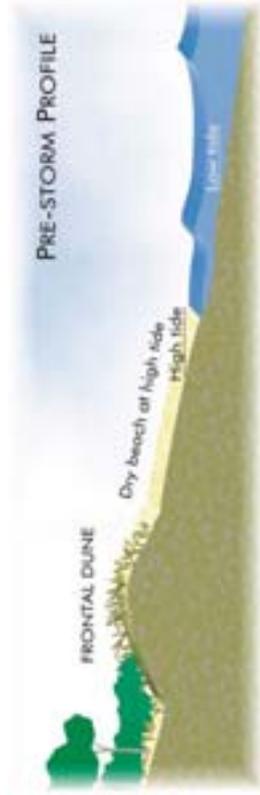
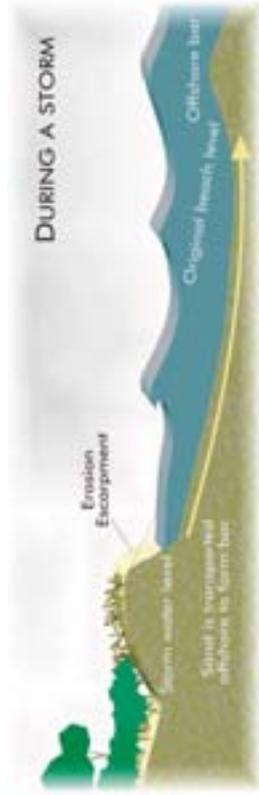
**Figure 2:** Schematic illustration of the natural cycles of beach and dune erosion and recovery that characterise sandy beaches (from Environment Waikato, 2001).

For instance, dunes provide a natural buffer that can absorb the impact of erosion, thereby protecting areas further landward. The wider and higher the dunes between development and the sea, the greater the level of natural erosion protection provided. Dunes do not “stop” wave erosion; rather, an adequate dune buffer enables communities to live with natural shoreline movements – the dune erodes during erosional phases (Figure 2b) and repairs/builds during accretionary periods (Figure 2d).

The self-repairing capacity of natural dune systems (Figure 2c,d) is also very important for the mitigation of coastal erosion – as this natural dune building and repair reinstates the protective dune following severe storm erosion. Dune repair is characteristic of most New Zealand beach-dune systems, except the very rare beach systems experiencing relatively rapid rates of long-term retreat. However, the process of natural dune repair takes time (usually several years) and during periods with a higher than normal frequency of erosion events, regular erosion may prevent any significant dune recovery for several years.

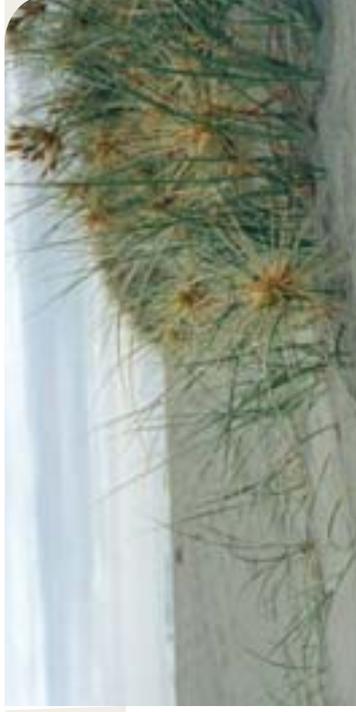
**Figure 3a:**

Spinifex  
(*Spinifex sericeus*)

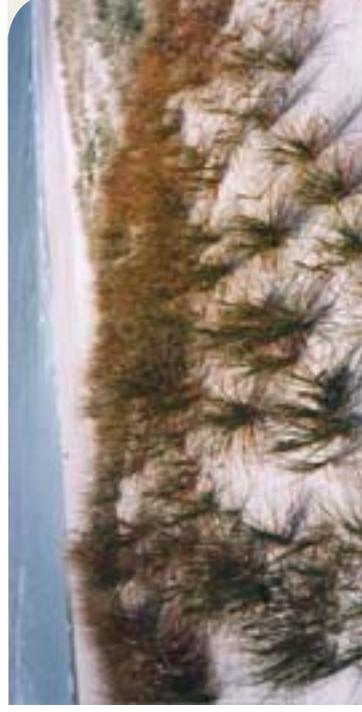
**Figure 3b:**

Pingao  
(*Desmoschoenus spiralis*)

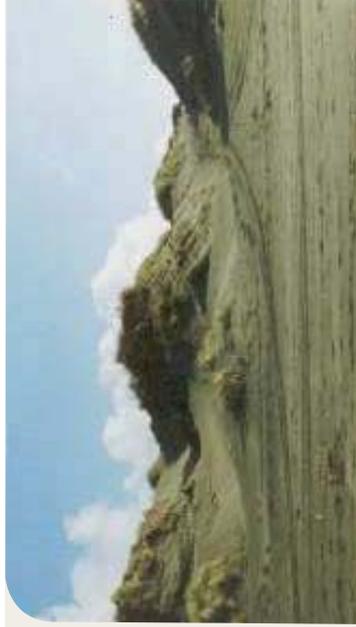
**Figure 4a:**

Serious wind erosion damage at Port Waikato in the early 1990's associated with disruption of spinifex cover by motorbikes on dunes. Large tongues of sand migrated inland from these blowouts, causing problems for houses and properties further inland.

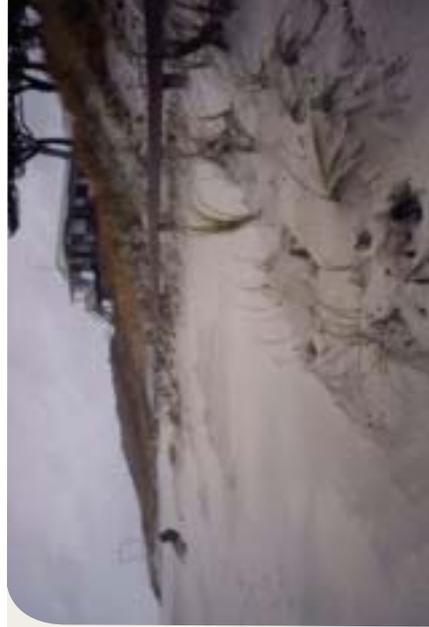
**Figure 4b:**

In contrast, the restored dune plants at Papamoa Domain are demonstrating considerable sand trapping abilities on the seaward dune face during this severe storm, preventing loss of sand from the active beach system. The fence in this photo has been moved twice towards the sea (a total of 12m) and was originally 80cm above the sand. Since this photo was taken, the fence has been almost entirely buried by the continually expanding incipient dune, with ropes and bollards installed to provide an effective visual barrier only to pedestrians and beach users.

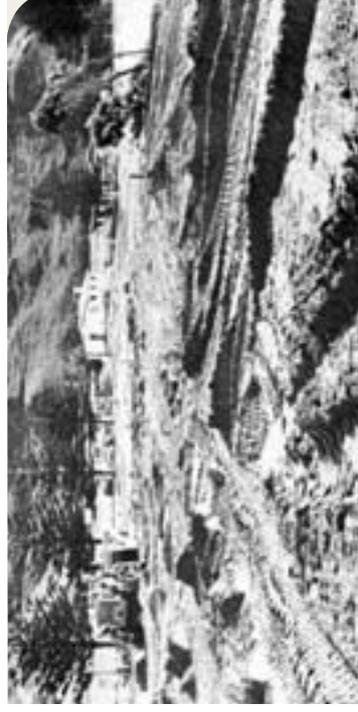
**Figure 5:**

Dunes being bulldozed at Mount Maunganui in 1965

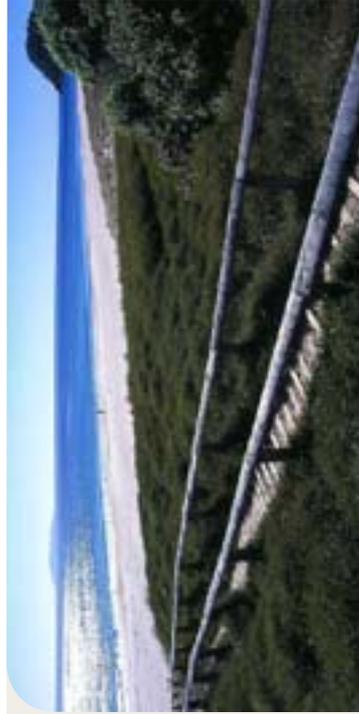
**Figure 6:**

Simple board and chain accessway at Whiritoa Beach. Note the vigorous plant growth in areas protected from human trampling.

Many different types of access structure are used, with the most appropriate structure normally determined on the basis of site-specific requirements. However, a simple board and chain accessway (or "sand ladder") is common (Figure 6) and has many advantages – being relatively easy and cheap to construct and readily repaired after coastal erosion. They can even be rolled up prior to storms to minimise damage.

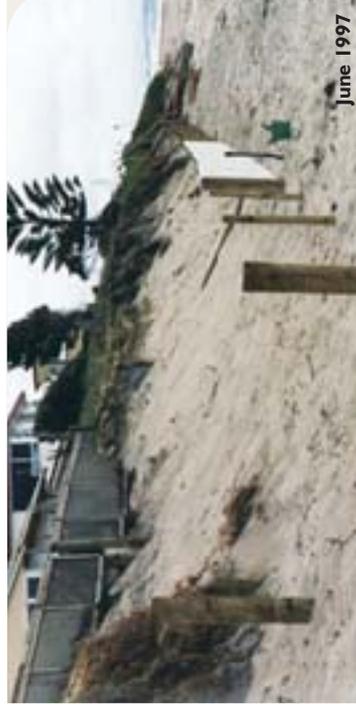
**Figure 9:**

Degraded frontal dune at Papamoa East in early 1990's. Note dune has been levelled and is vegetated with Kikuyu, with little to no native sand binding species on the seaward face. See figure 10 for the positive impact of restoration at this exact site.

Notwithstanding the serious potential hazard issues, the frontal dune was often in a very degraded condition in the early 1990's (Figure 9), largely due to the original dune being bulldozed back into a natural stream bed immediately inland to create flat sections in 1958. Typically, there was often only a sparse cover of native sand binders and in some areas the dune had been further levelled and vegetated with exotic grasses such as kikuyu – which are almost completely ineffective for natural dune building and repair.

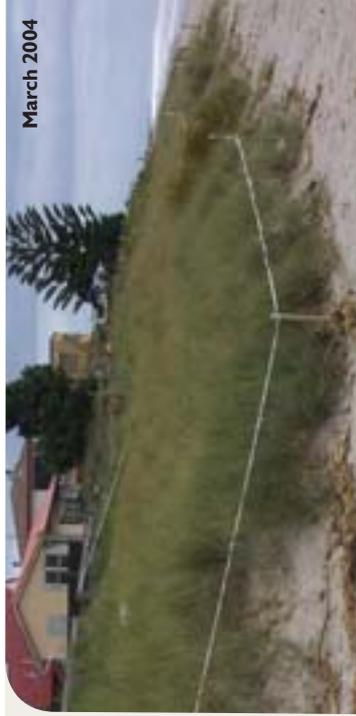
**Figure 10:**

Dunes at Papamoa East after restoration work – the seaward face now has a good cover of native sand binding species and has advanced seaward 10-15m, and elevated 1-2m since planting was completed. This photo was taken the day after the impact of the 10 m storm waves generated by Cyclone Ivy.

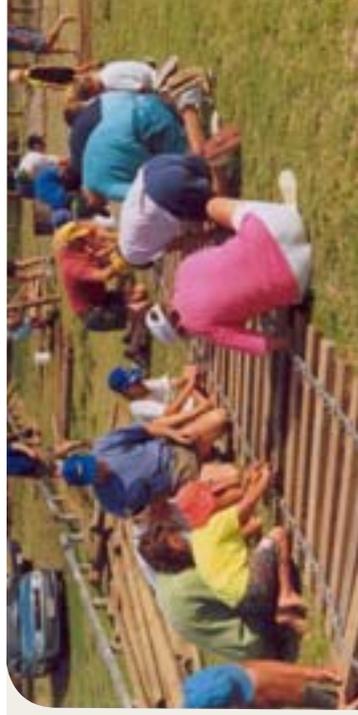
**Figure 11:**

Community working bee assembling a sand ladder accessway at Whiritoa Beach

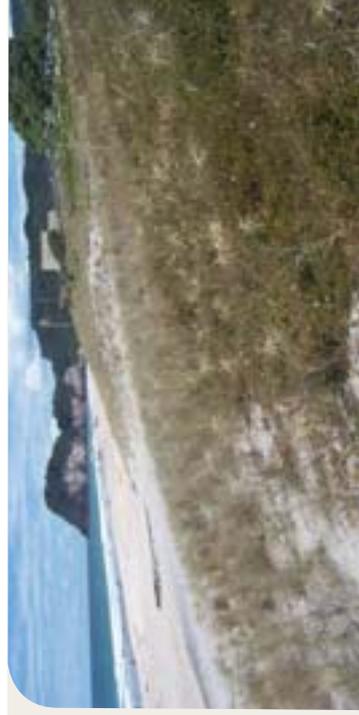
**Figure 12:**

Successful restoration of sand grass cover on Whiritoa dunes

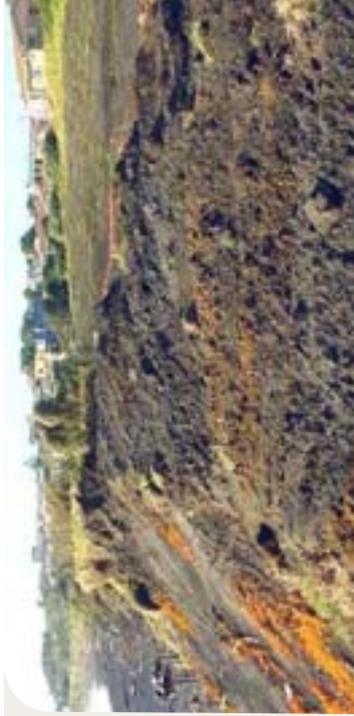
**Figure 13:**

**Severely degraded dunes** at East End Beach before restoration works

East End Beach within New Plymouth City was backed by a severely degraded dune system in the early to mid 1990's (Figure 13), with very limited natural dune building and repair. The natural and amenity values of the site were also seriously degraded.

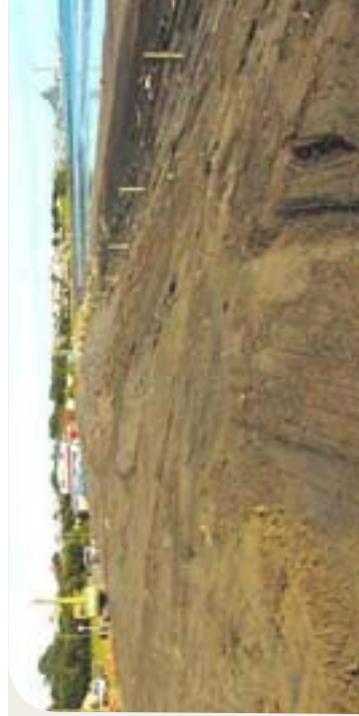
**Figure 14:**

East End Beach dunes after reshaping and recent planting of mainly spinifex.

- Earthworks to remove fill, clear inappropriate vegetation and to restore a natural dune shape and sandy substrate (Figure 14).
- Extensive planting of native sand binders.
- Installation of a range of access management measures (conveniently located accessways, fencing as required, signage, etc) to protect the sensitive vegetation.

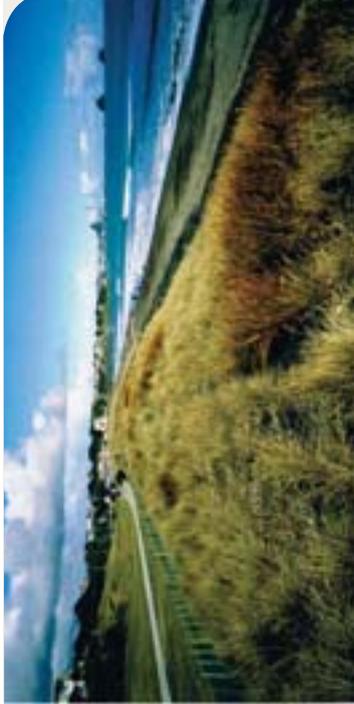
**Figure 15:**

East End dunes after restoration works
